TECHNICAL SERVICE BULLETIN

05MY-15MY CONVENTIONAL J08 ENGINE CYLINDER HEAD GASKET

Group:	11-Engine
Bulletin No.:	SB-15-026
Issue Date:	06-02-2015

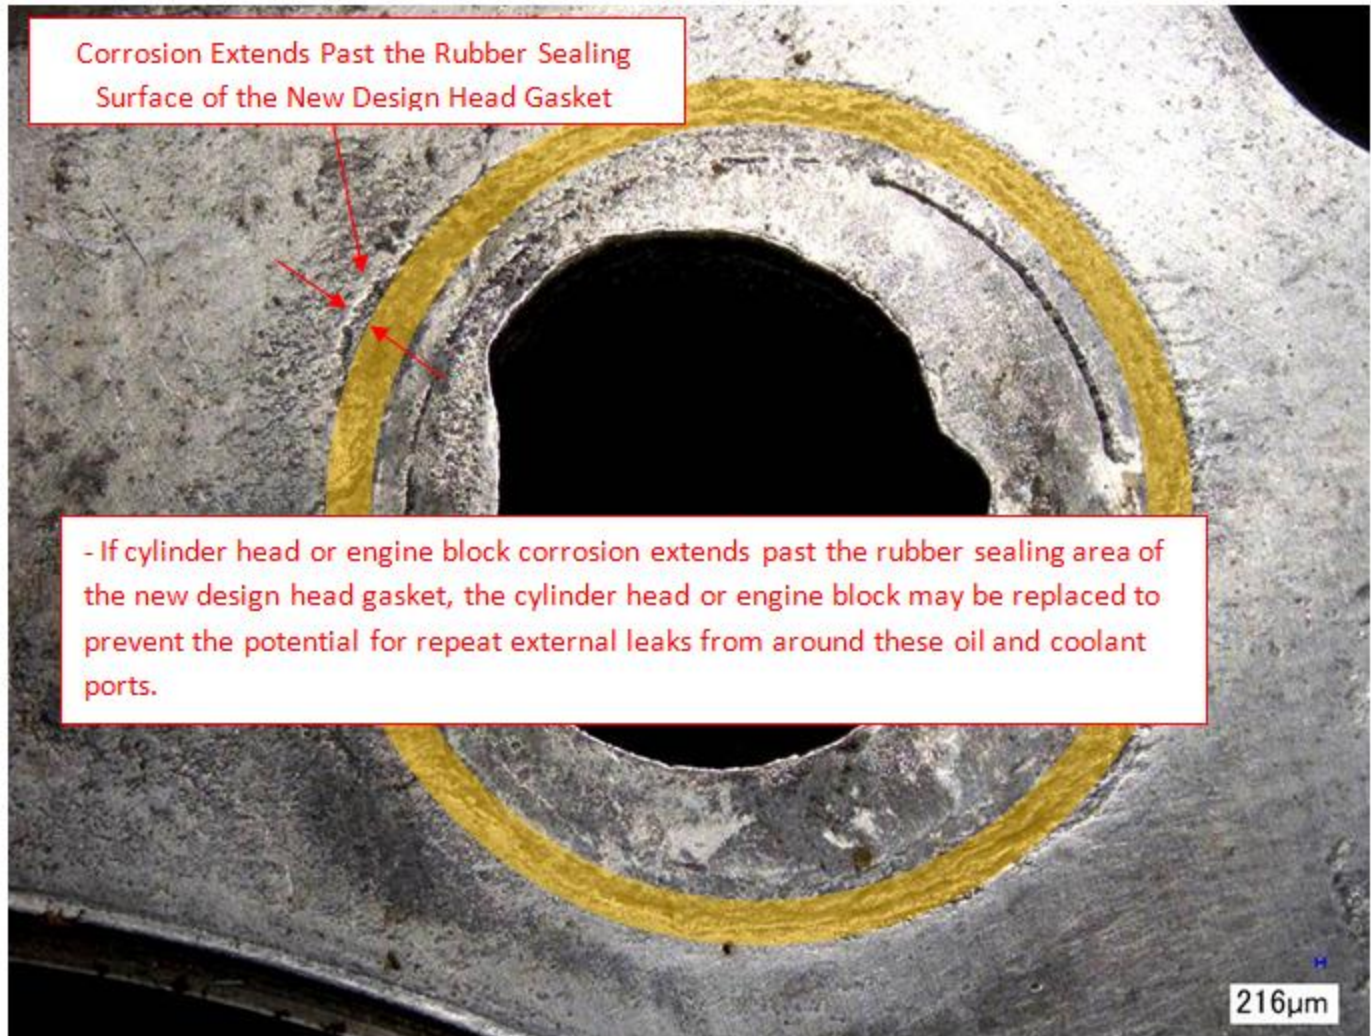
- In rare cases, corrosion or fretting may occur around the engine oil return ports and engine coolant ports. There are 24 corresponding ports which are located on the cylinder head and engine block. The locations correspond to the rubber seals which were added to the new design head gasket. Refer to the corresponding locations using the new cylinder head gasket as a template.

4. Proceed to the final inspection section to complete this technical service bulletin.
