Group:	SERVICE MANUAL UPDATE
Bulletin No:	SB-15-034
Issue Date:	8-12-2015

## Subject: CORRECTION OF WORKSHOP MANUAL FOR HINO COE Revision of Troubleshooting Procedure for the DTC P0A84 (TC66)

**RELEVANT MODEL:** 14MY-15MY Hino 155, 195, 155h, 195h

Troubleshooting information and inspection procedure of the DTC P0A84 (TC66) were revised.

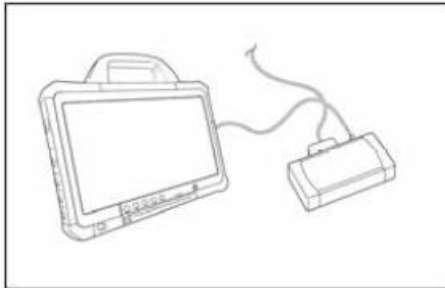
SHTS03ZZZ0300113

### 1 Reading the DTC [HINO DX II]

1. Set the starter key to the "LOCK" position.
2. Connect the diagnosis tool (HINO DX II) to the vehicle.
3. Set the starter key to the "ON" position.
4. On the diagnosis tool screen, check if any of the following DTC related to malfunction of HV battery start relay is detected.
  - P33B1-64, P33B2-63
