Technical Bulletin

87 15 02 March 5, 2015 **2037255** Supersedes Technical Bulletin V871406 dated June 19, 2014 to update air distribution box production date.

Whistle Noise from Center Vent Area; Blower Set On 3 or 4 with Full Heat Selected

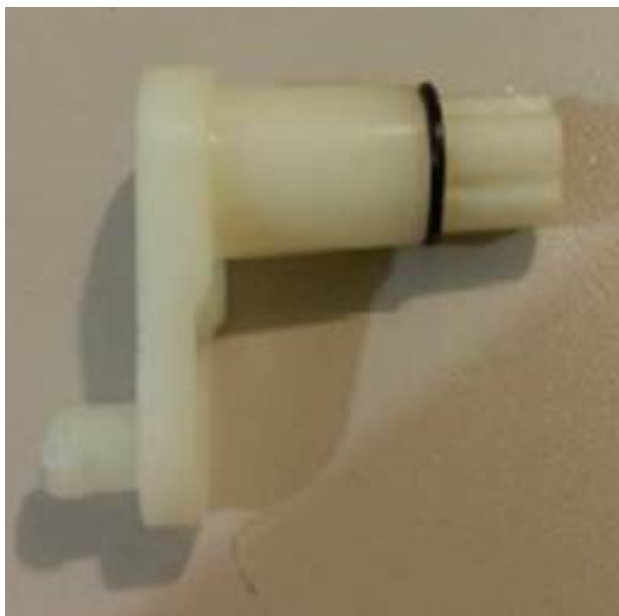
Installation of driver side temperature flap lever (White).

Set the temperature to full cold position to set the temperature flaps. This will aid in the installation.

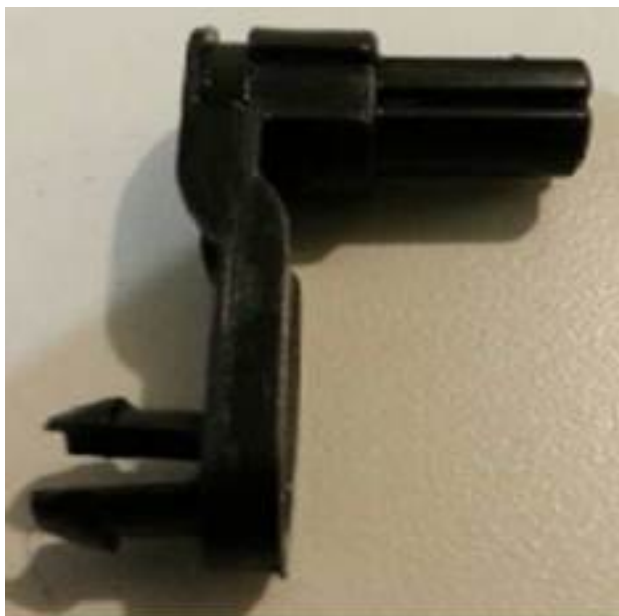
Installation of the passenger side temperature flap lever. (Black)
