# Tech Tips

TT 96-14-05

Date: August 22, 2014

## 2015 Golf, GTI – Immobilizer Key / Key Remote Adaptation Test Plan

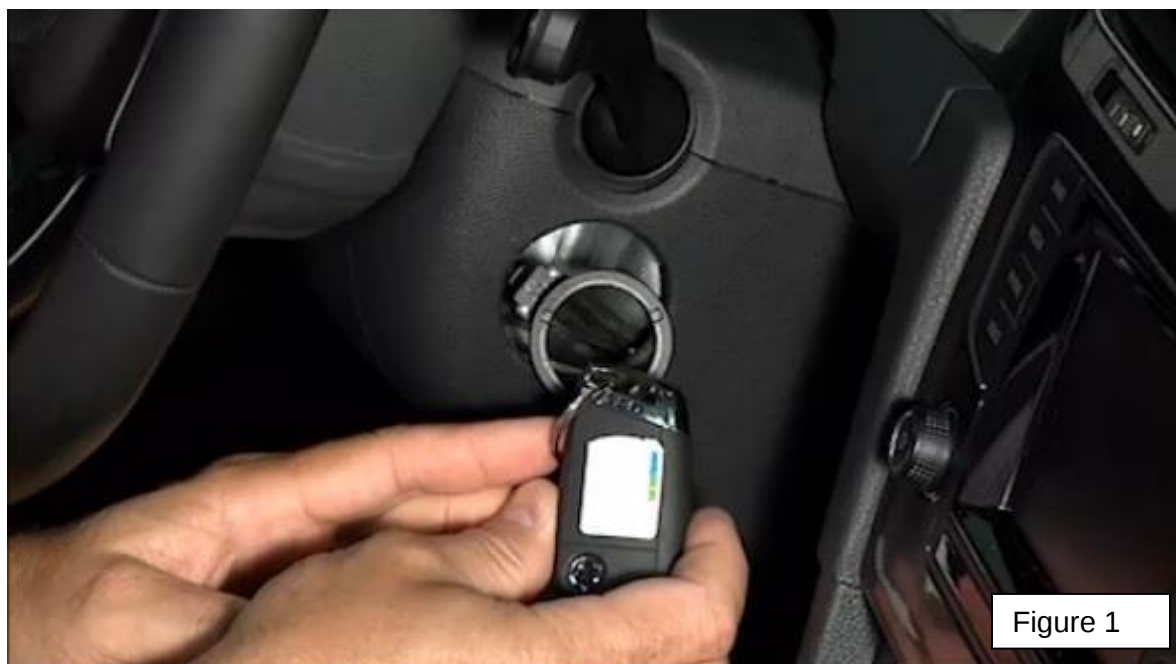
Figure 1

To adapt keys to a 2015 Golf or Golf GTI, it is necessary to complete the “Adapt Immobilizer” test plan. **Kessy Vehicles:** Verify that the reader coil (figure 1) is removed from the steering column and the key is touching the reader coil during key adaptation. Bladed key vehicle, it is not necessary to remove the reader coil. The test plan can be found under the ODIS Special Functions Tab (figure 2) or by navigating to “Immobilizer functions” under “Elect. Immobilizer 5A” after clicking the “Select self test” button in the Test Plan tab (figure 3). This procedure adapts both the remote and immobilizer functions of the key.

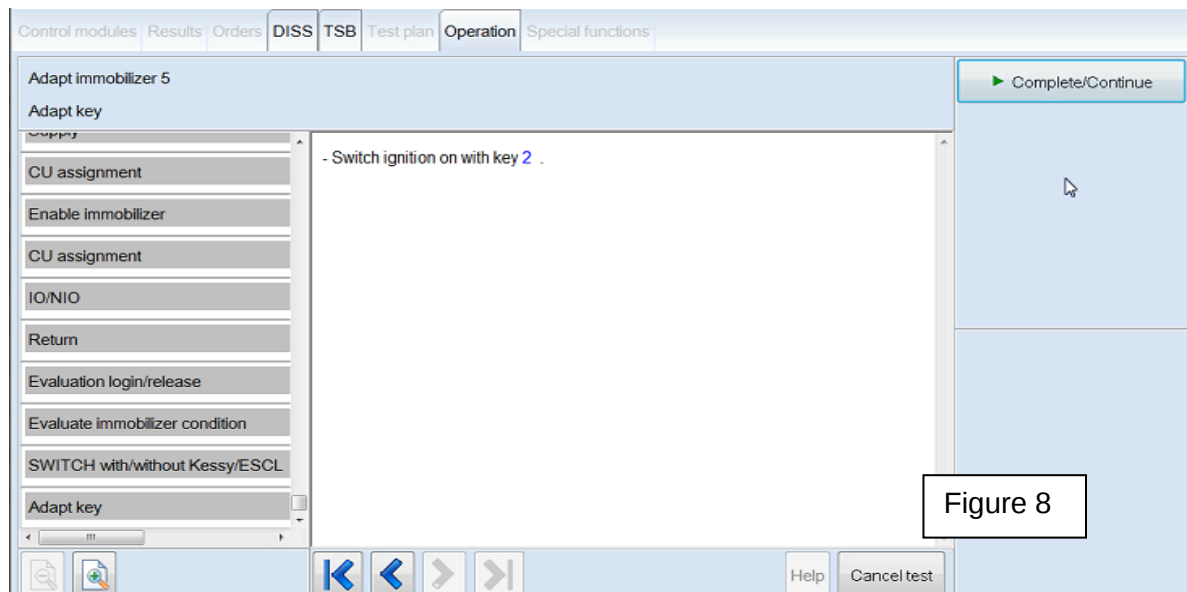
Vehicle doesn't start and or warning lights on after immobilizer / key adaptation. Check for faults related to modules that may no longer be coded.

Continue to follow test plan instructions to complete key adaptation (figure 8).

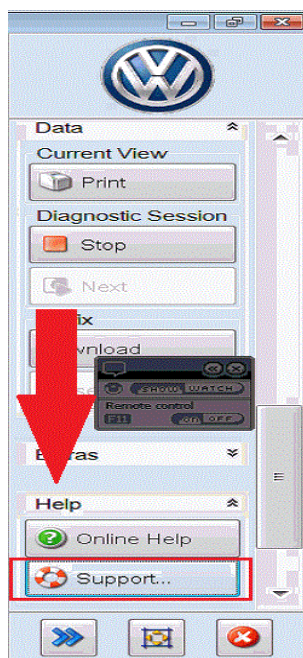
If a control module is no longer coded, the test plan for immobilizer / key adaptation has failed. If the scan tool being used is up to date, please submit feedback for the failed test plan using the Help tab and Support button in the right column of the scan tool.

It will be necessary to recode all modules that are no longer coded. Code modules online under the special functions tab, "Code online control module". Modules may include, but not limited to ECM, ABS, TCM.
