Technical Service Bulletin

91 MMI3G+ Audi connect only reaches 2G service - Telephone module replacement instructions for A4,A5,A5 cab,Q5,Q7,A8

91 15 21 2039476/5 October 16, 2015. Supersedes Technical Service Bulletin Group 91 number 15-06 dated July 28, 2015 for reasons listed below.

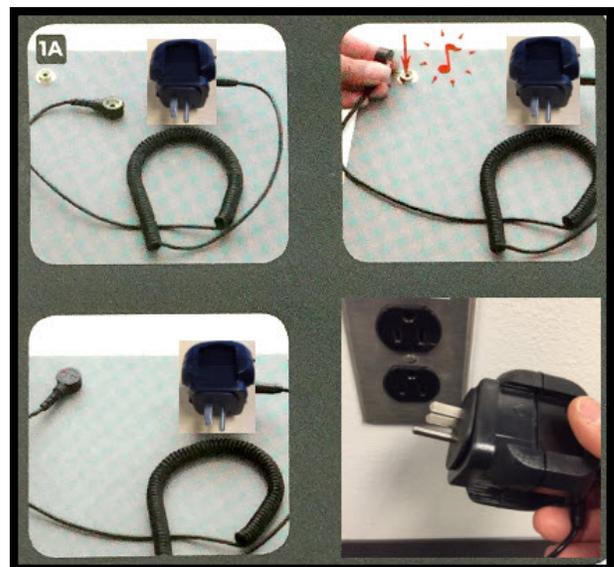
Figure 2. VAS6613 ESD work surface grounding plug.

3. Place the ESD anti-static mat onto the surface. Ensure that all three grounding straps are securely strapped to the ESD mat.
4. Ground the ESD mat by plugging the 110V grounding strap into a wall socket or power strip (Figure 2). If a power strip is used, it must be plugged into a grounded wall outlet. (See attached user instructions for VAS6613 titled "VAS6613 ESD Workspace Guide.pdf".)

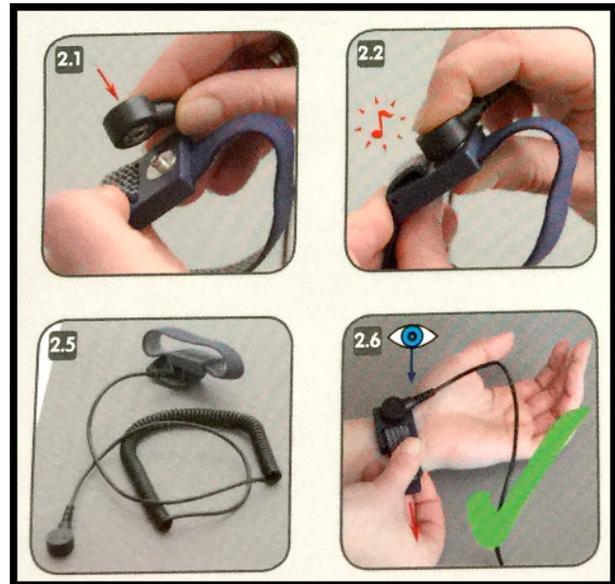
Figure 3. VAS6613 ESD work surface grounding wrist strap.

5. Ground yourself by placing the elastic strap around your wrist. Make sure it is securely touching your skin. It cannot be loose-fitting or over your shirt cuff (Figure 3).

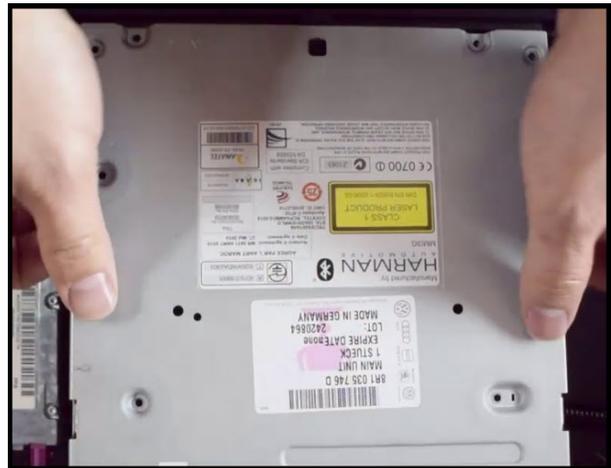
Figure 7. Pry top cover off with fingers.

9. Using a flat head screw driver, your fingers or a plastic wedge trim tool, remove the top cover by prying it from the back of the cover at the location seen in Figure 8. If a flat head screw driver is used then touch the tool to the ESD mat to discharge the tool prior to touching the main unit.

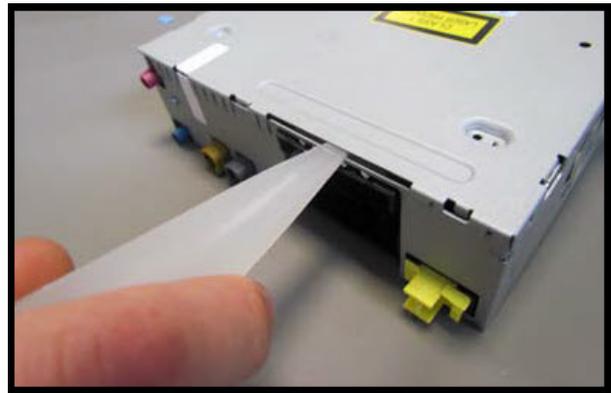
Figure 8. Pry top cover off using plastic trim wedge tool.
