- PCJ OIL PRESSURE SENSOR REPLACEMENT
- PISTON COOLING REDUCTION VALVE REPLACEMENT
- ATS DOSER MODULE REPLACEMENT

Prevost vehicles

## PART 1 - PCJ OIL PRESSURE SENSOR REPLACEMENT

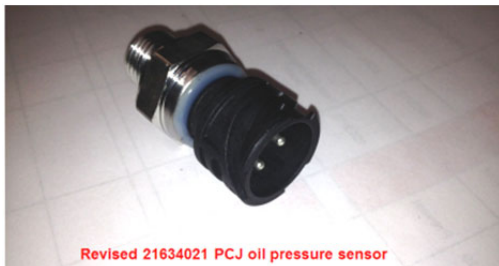
On the vehicles affected by this bulletin, the PCJ oil pressure sensor has to be replaced with an updated pressure sensor to avoid erroneous low oil pressure diagnostic codes.

- 2) Unscrew the sensor from the oil filter housing.
- 3) Clean out the electrical connector pins and sensor mounting surface with contact cleaner.
- 4) Install the new PCJ sensor (p/n 21634021). Torque:  $18.5 \pm 2$  ft-lb.
- 5) Reinstall the connector and rotate clockwise to lock.
- 6) Run the engine and check for leaks.
