**Document ID:** IK1201086

**Title:** EPA 2010 & 2013 (OBD) Maxxforce DT/9/10 EGR Cooler Diagnostics

**Applies To:** 2010 + MaxxForce DT, 9, 10, N9 & N10 (ESN 3,300,000 and later)

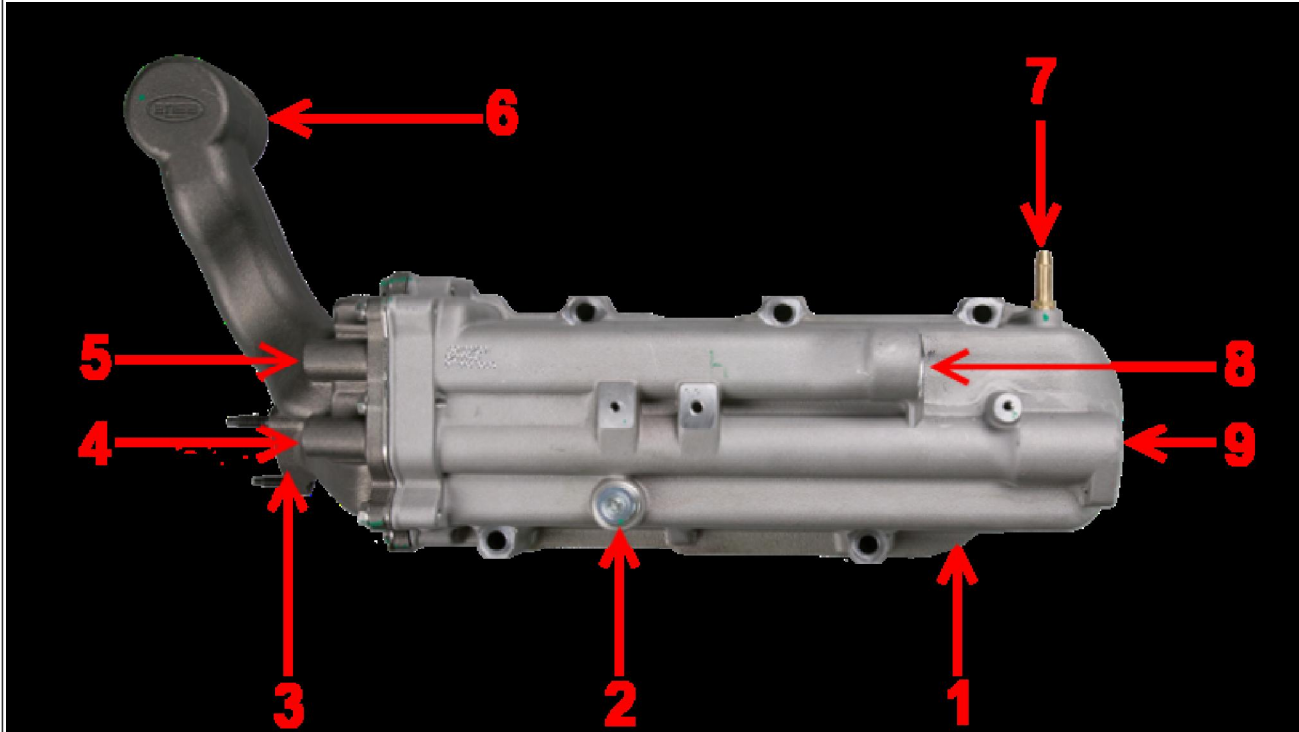
**Figure 1: 2010+ MaxxForce DT/9/10 EGR Cooler Assembly**

- Item 1: EGR Cooler Assembly
- Item 2: Coolant Drain Plug
- Item 3: EGR Outlet to Intake
- Item 4: Aftertreatment Fuel Injector (AFI) Coolant Inlet
- Item 5: AFI Coolant Outlet
- Item 6: Exhaust Inlet from the Exhaust Manifold
- Item 7: Coolant Dearation Port
- Item 8: Coolant Supply Inlet
- Item 9: Coolant Supply Outlet
