Service Bulletin

Subject: Driver and/or Passenger Power Seat Height Stuck in the Full-up Position, Intermittent Inoperative Seat Adjustment or Not Lowering

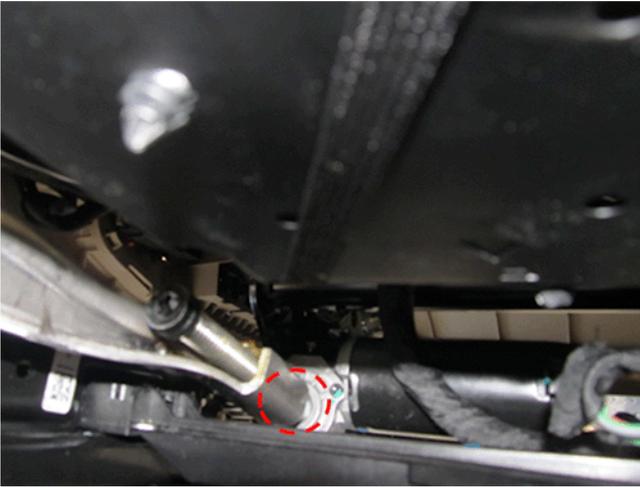
Note: The height adjuster motor is always on outboard side of cushion adjuster.

2. Locate the outboard height adjuster motor (1). The driver seat is shown in the example above.

Note: Depending on vehicle model, the retainer can be installed from the front or the rear, however in most cases it may be easier to visually see the install location from the rear.
