Technical Service Bulletin

87 Air conditioning does not cool and / or compressor is noisy

87 15 71 2038023/7 October 14, 2015. Supersedes Technical Service Bulletin Group 87 number 15-68 dated August 21, 2015 for reasons listed below.

Model(s)	Year	VIN Range	Vehicle-Specific Equipment
A3, A3 Cabriolet	2015	000001 - 106816	Not Applicable

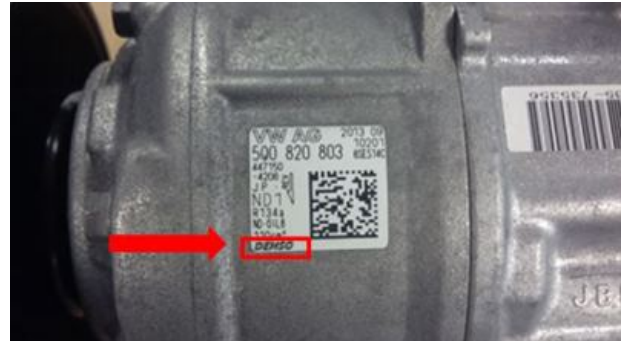
Denso A/C compressors are currently being installed in production (Figure 2 and Figure 3).

Figure 2. Denso compressor identification tag.

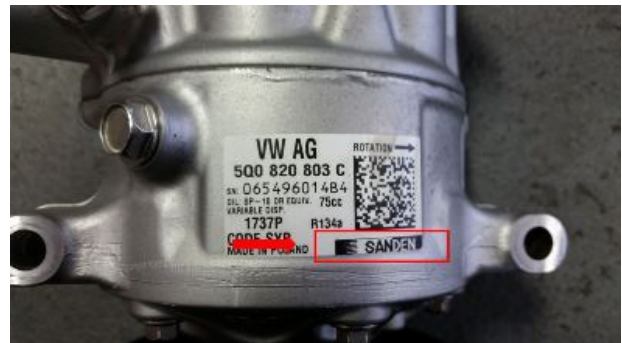
An improved N280 valve for the Sanden A/C compressor is now available as a replacement part (5Q0 260 839 A). Replacement of the entire A/C compressor is not necessary in most cases.

Figure 3. Sanden compressor identification tag.

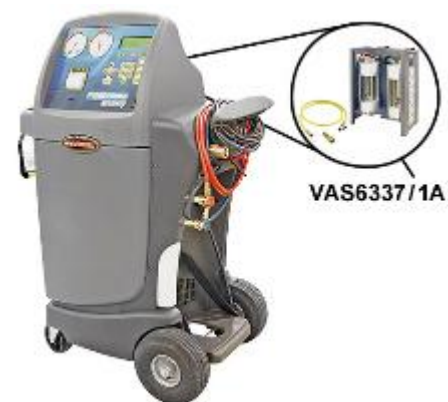
1. Connect both the refrigerant service station (Figure 4) and the diagnostic tester to the vehicle.

Figure 4. Robinair A/C Service Unit.

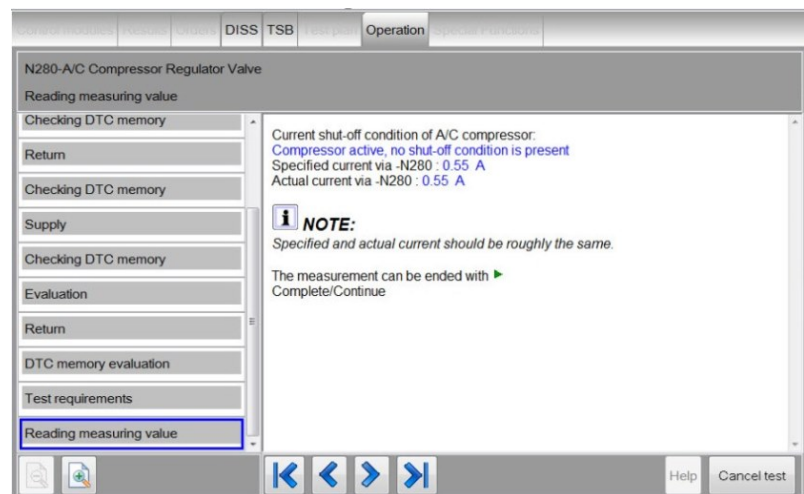
1. With the engine at idle, switch the climate control unit to full cold and full fan.
2. Using the diagnostic tester, go to Guided Functions.
3. Monitor the measuring value for the air conditioner compressor regulating valve N280 signal (Figure 5).

The actual and specified values will be plausible and will show a normal regulating range of current for cooling request (0.400 A – 0.680 A).

However, there will be equalized pressure readings on the high and low sides of the circuit (no pressure generation from the compressor).

Figure 5. Checking N280 signal value Measuring Value Block.

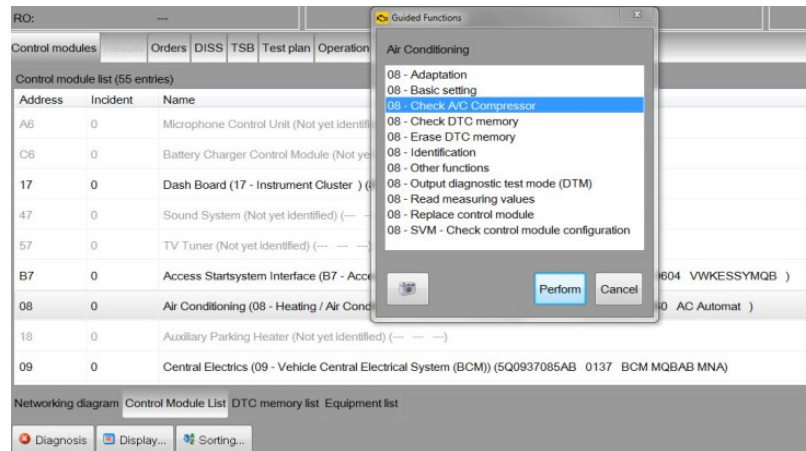
- Continuing in Guided Functions, select the test plan for “Check A/C Compressor” (Figure 6).

Figure 6. Selecting test plan for “Check A/C Compressor”.

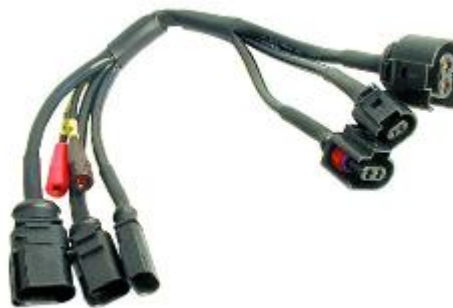
- Shut off the engine. Connect the breakout harness VAS 5256 (Figure 7) between the N280 valve and its connector.

Figure 7. VAS 5256 breakout harness.

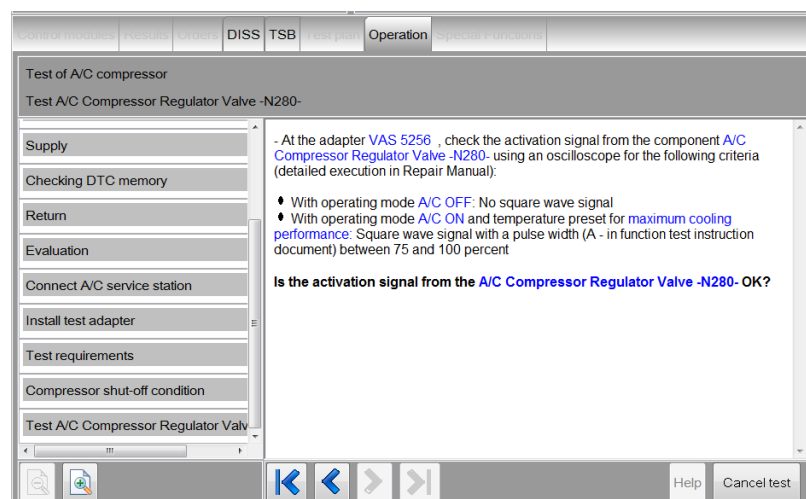
- Next, the signal wave form will be checked (Figure 8). The square wave signal should be between 75% and 100%.

Figure 8. Checking the N280 signal wave form.

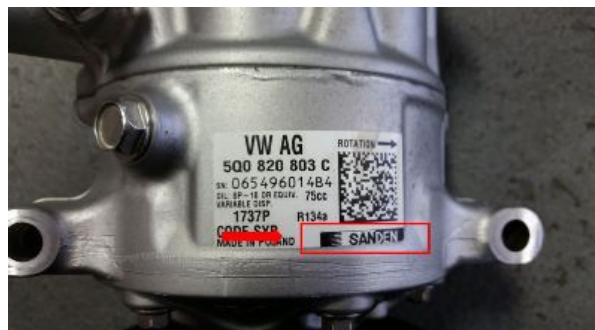
- As mentioned in the *Technical Background*, the originally-installed compressor on the MY 2015 A3 is manufactured by Sanden (Figure 13). The replacement compressor is manufactured by Denso (Figure 14).

When replacing the original Sanden compressor with a Denso compressor, be aware that while the refrigerant volume is the same regardless of the compressor installed, the PAG oil type and volume is not. Sanden and Denso compressors have specific PAG oils that must be used.

Figure 13: Sanden compressor identification tag.

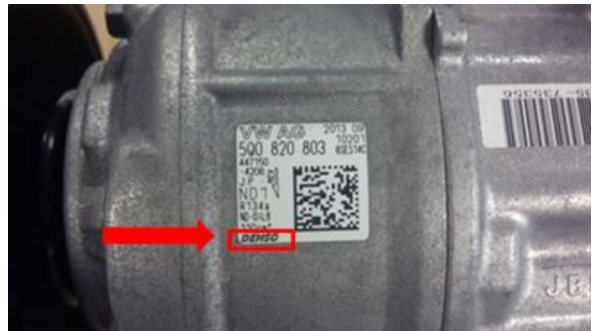
Figure 14: Denso compressor identification tag.

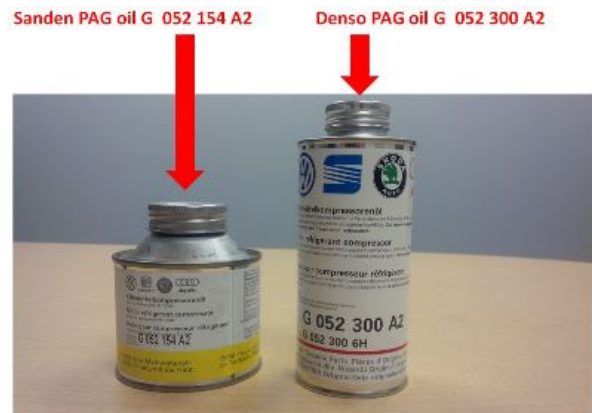
3. The replacement compressor will come with the specified type of PAG oil for the compressor (Figure 15). The amount of PAG oil supplied with the replacement compressor may not be the exact amount required to replenish the refrigerant circuit. Drain and measure the PAG oil in the replacement compressor to determine the required amount. If the amount needs to be adjusted, do so using the correct type of PAG oil specified in ETKA. Refer to Elsa for the correct oil capacity for the compressor being installed.

Figure 15: Compressor manufacturer specific PAG oils.
