Technical Service Bulletin

94 Daytime running light (DRL) inoperative (DTC 02895 or 02897)

94 15 72 2032184/6 August 19, 2015. Supersedes Technical Service Bulletin Group 94 number 15-68 dated June 29, 2015 for reasons listed below.

Model(s)	Year	VIN Range	Vehicle-Specific Equipment
Q5	2013 - 2016	All	Not Applicable

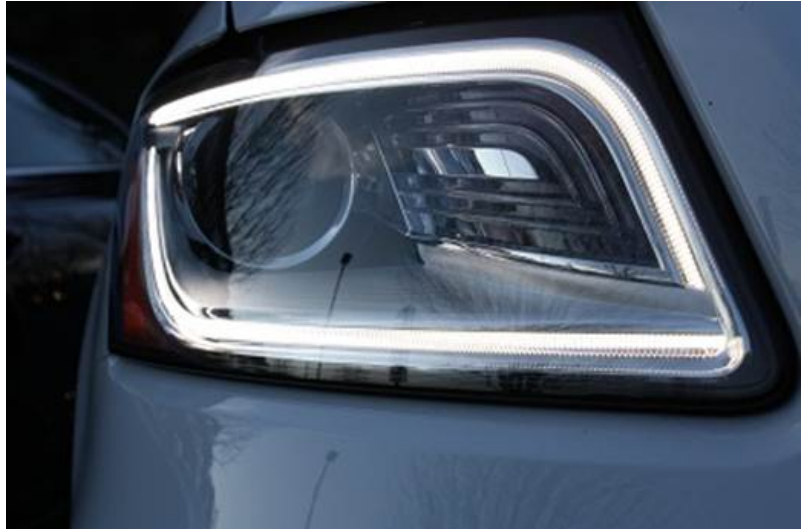
The MY2013+ Audi Q5 LED DRLs use light-emitting “pipes” or “guides” instead of multiple, individual LEDs. There are two light pipes per headlight. Each light pipe uses a single LED for illumination (Figure 1).

Figure 1. Upper and Lower light pipes illuminated.

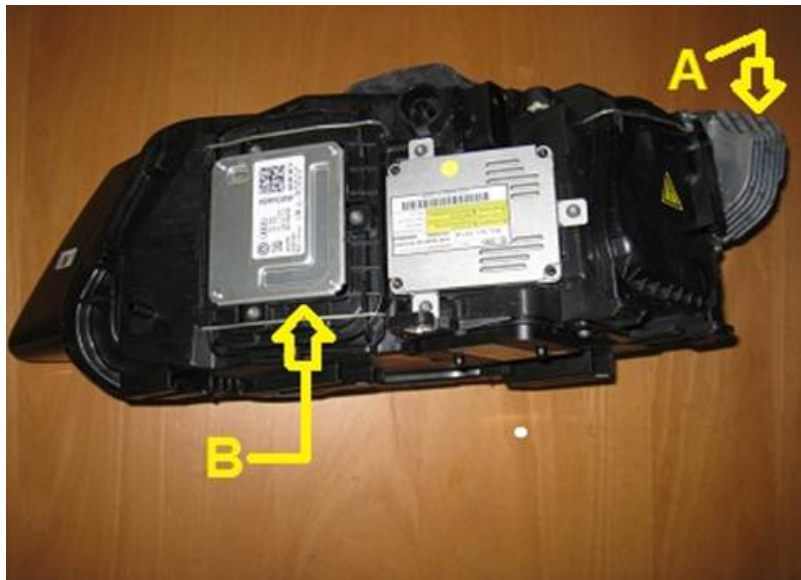
The LEDs with heatsinks are contained in a single module (Figure 2, A) mounted to the outer backside of each headlight.

Figure 2. Backside of headlight with LED heat sink (A) and LED control module (B).

The LED unit with heat sink utilizes a gasket and is keyed into the headlight housing to maintain proper alignment of each LED and light pipe. The LED units (L176 and L177, left and right, respectively) are controlled via a control module (J860 and J861, left and right, respectively) located separately on the backside of the headlight (Figure 2). These LED units and LED control modules are electrically interchangeable from side to side, but the LED units are mechanically specific to each headlight side.
