# Special Bulletin

# SP15-16

## REAR JUNCTION BOX INSPECTION AND COLOR GUARD APPLICATION

Prevost vehicles

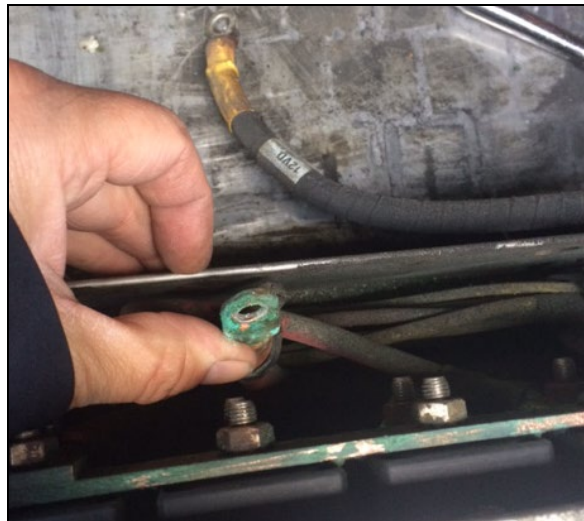
- 5) All the screw type connections in the following images must be **first cleaned with CRC Lectra-Motive Electrical Part Cleaner and cleaning brushes**. Let the cleaner dries and then **apply 2 coats of black Color Guard** (wait 20 to 30 min. between each coat) on all connections.

*If the terminals are showing heavy signs of corrosion they must be disassembled before being cleaned.*

*Clean both side of the terminals, also clean studs threads and hex nuts. Ensure that all traces of oxidation in the surrounding area are removed before reinstallation.*
