# Special Bulletin

# SP15-337B

LTD EXTENSION ON ENGINE CURBSIDE

Prevost vehicles

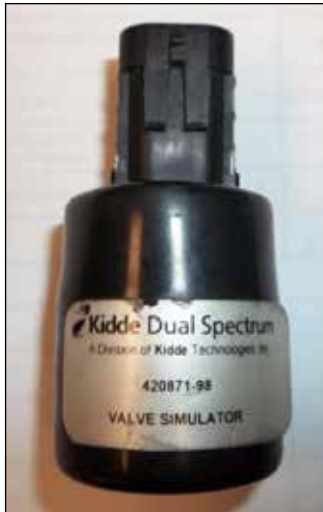
Figure 1 : Valve Simulator

The Valve Simulator is used to simulate the squib and discharging of an extinguisher. It plugs into the wiring harness of the extinguishing circuit and provides an audible warning (chirp) when a signal is received from the control panel to discharge the extinguisher.
