Special Bulletin

SP15-343D

SLIDING DOOR ADJUSTMENT AND HARDWARE REPLACEMENT

Prevost vehicles

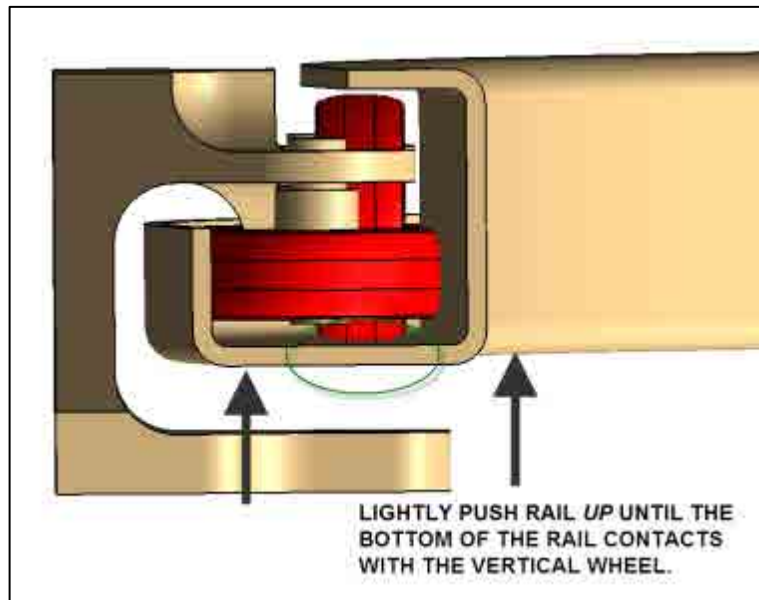
Figure 60

Lightly push the rail up to the point of contact with the vertical wheel without applying any additional force. (Figure 60)

Keep rail in this condition and proceed to next step.

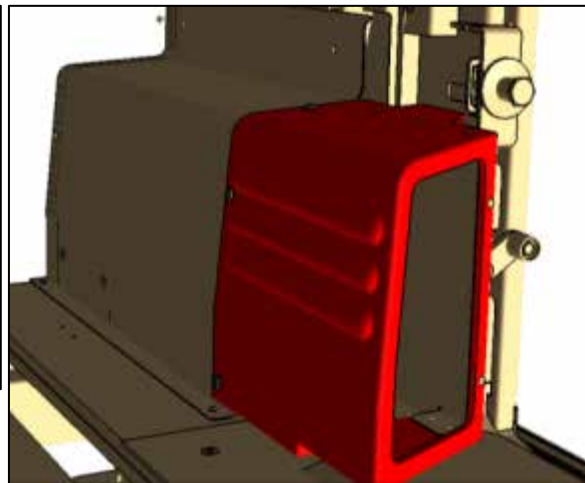
Figure 69: Careful not to squeeze cables and tubes.
