# Program Bulletin

## CUSTOMER SATISFACTION PROGRAM

**SUBJECT:** ECM Wire Harness Contact

**MODELS:** 2014 Cadillac CTS  
Equipped with 3.6L Twin-Turbo Engine (LF3)

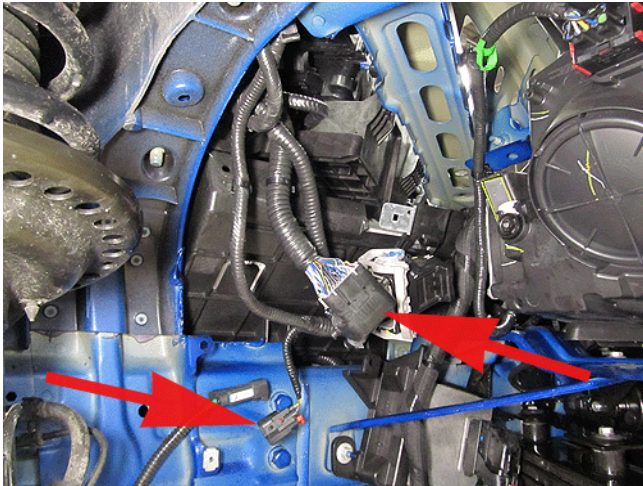
3905173

1. Disconnect the negative battery cable. Refer to *Battery Negative Cable Disconnection and Connection* in SI.
2. Remove the front compartment front sight shield. Refer to *Front Compartment Front Sight Shield Replacement* in SI.
3. Remove the right front wheelhouse liner. Refer to *Front Wheelhouse Liner Replacement* in SI

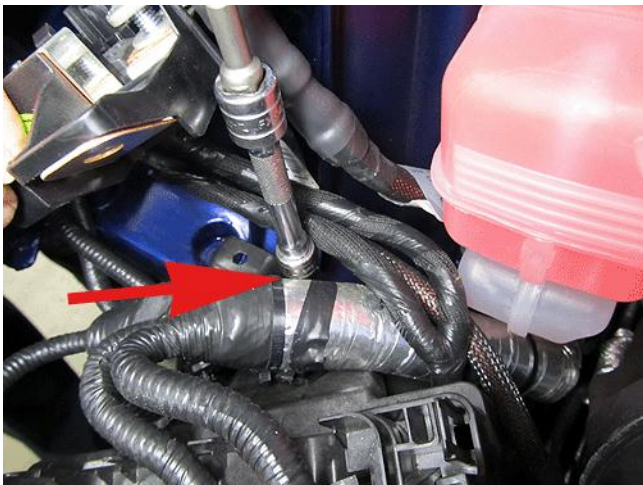
3905176

4. Disconnect the electrical connectors on the back of the front compartment fuse block and ECM as shown. This will assist removing the fuse block and harness.

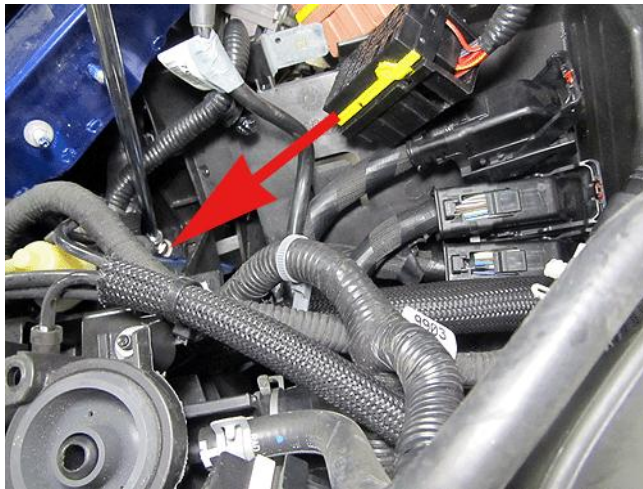
3905184

5. Remove the front compartment fuse block housing. Refer to *Front Compartment Fuse Block Housing Replacement* in SI. See photo for hidden fastener location.
6. Remove the Engine Control Module. Refer to *Engine Control Module Replacement* in SI.

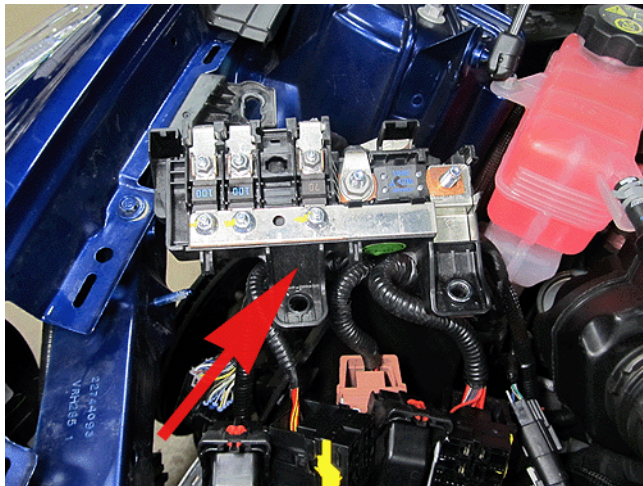
3905234

7. Remove the ECM bracket, note the hidden fastener shown in the photo.

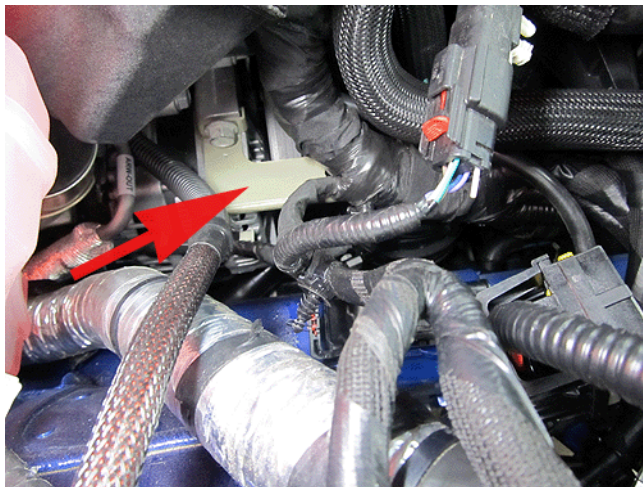
3905237

8. Remove the Pre-fuse block.
9. Position the ECM harness out of the bracket area.

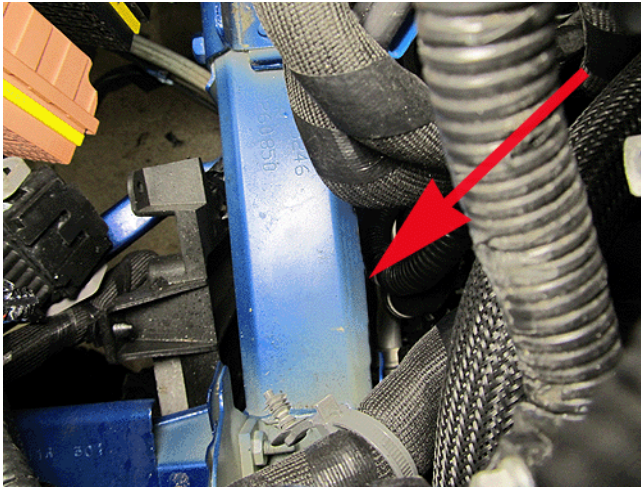
3925927

**Warning: The welds in the next step may be sharp, use care to not cut yourself.**

- 18. Locate the resistance spot welds on the inner right front frame rail.
