# Service Bulletin

**Subject:** GM of Canada OnStar® Cellular Communication Upgrade

**Models:** 2000-2014 GM Passenger Cars and Light Duty Trucks  
2015 Buick Enclave  
2015 Cadillac Escalade Models (Built W/O VV4)  
2015 Chevrolet Camaro, Express, Traverse  
2015 Chevrolet Silverado 2500/3500, Suburban, Tahoe (Built W/O VV4)  
2012 Chevrolet Colorado  
2015 GMC Acadia, Savana  
2015 GMC Sierra 2500/3500, Yukon Models (Built W/O VV4)  
2012 GMC Canyon  
2005-2010 Pontiac Vibe  
Equipped with OnStar® (RPO UE1)

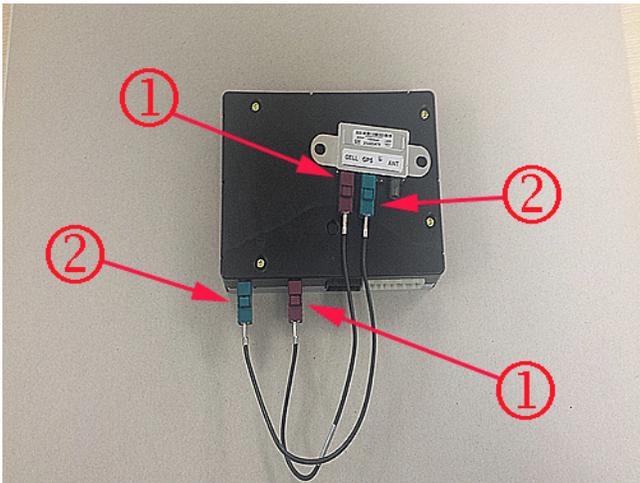
**Note:** During installation of the antenna cable and the cellular cable to the splitter, if the cables inadvertently become incorrectly installed, the technician may notice a red LED with DTCs B101D-3C and B101D-F0 set as current in the OnStar VCIM.

4. Connect the male to male cable (P/N 23310710 ) to the cellular connector (1) to the splitter as shown above.
5. Connect the male to male cable (P/N 23242477) to the GPS connector (2) to the splitter as shown above.
