Service Bulletin

Subject: Wind Noise and/or Water Leak at Front Roof or Windshield, Water Running Down Interior A-Pillar

Models: 2013-2015 Cadillac ATS

2014-2015 Cadillac CTS

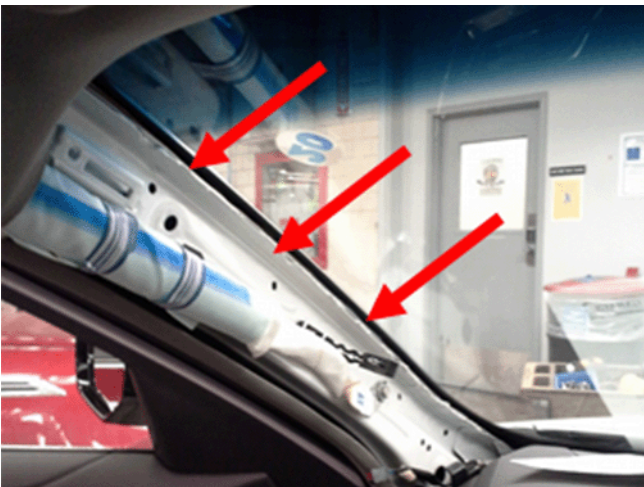
3. Perform a water leak test on the forward laser braze and upper windshield area using a water hose without the nozzle attached. An example of the area where to apply water is shown circled in the graphic above.

4. Continue to flood the area for up to five minutes, while having an assistant sit inside the vehicle observing the interior A-pillar for any evidence of water running along the pillar.
