Service Bulletin

Subject: Top Not Secure Message Displayed in Driver Information Center (DIC)

Models: 2011-2015 Chevrolet Camaro Convertible

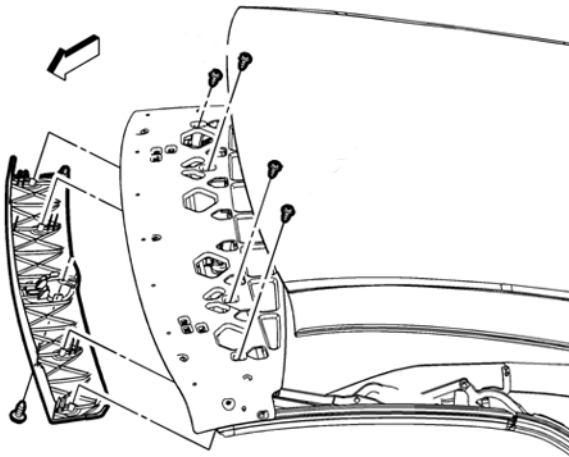
Note: This link rod adjustment is **only** to be performed on the driver's side.

When the above condition is found, do not replace the folding top front latch or striker. Adjust the driver's side folding top front latch link rod following the steps below:

1. Remove the folding top #1 bow garnish molding. Refer to Folding Top Number 1 Bow Garnish Molding Replacement in SI.
