## PRODUCT CAMPAIGN BULLETIN

**APPLICABILITY:** 2004-2005 Subaru Impreza, WRX, STI

**SUBJECT:** Takata Front Passenger Air Bag  
 Inflator Replacement

**NUMBER:** WQR-53R

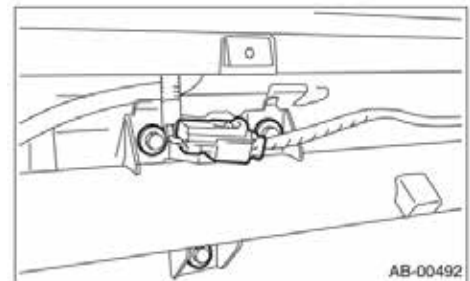
**NOTE:** There may be a Security Module secured with the lower airbag module mounting bolt on some models.

- Disconnect the airbag module harness connector from the support beam bracket.
- Remove the 3 retaining bolts and **CAREFULLY** remove the airbag module from the vehicle and place it on a clean cloth to protect the dash trim surface portion from damage.
