# **Service Information Bulletin**

SUBJECT	DATE
SPN 520999/FMI 7 (TCM)	August 2015

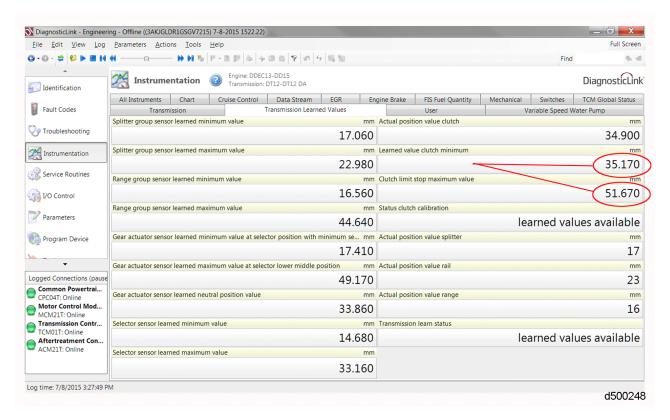
- 2. Start the engine and idle for two minutes.
- 3. Is the transmission air supply pressure greater than (689 kPa)100 psi?
  - a. Yes; Go to step 6.
  - b. No; Go to step 4.
- 4. Turn the ignition OFF.
- 5. Inspect transmission air supply lines and fitting for leaks. Repair as necessary; repeat all steps in this procedure.
- 6. Under the actions menu, select Transmission heading and then choose Clutch Apply Leak Test; execute routine. Does the result indicate a successful completion (test pass)? Note that test may have to be performed three times in order to get a pass result.
  - a. Yes; if fault is inactive, release vehicle. If fault is active, Go to step 7.
  - b. No; Go to step 7.
- 7. Under Instrumentation tab, select Transmission Learned Values. Is instrument Learn Value Clutch Minimum greater than 33 mm or Clutch Maximum greater than 51 mm?

- a. Yes; Go to step 8.
- b. No; obtain a driving log file and contact the Detroit™ Customer Support Center at 855-253-0428 for further assistance.
- 8. Remove the transmission. Refer to section "Removal of the Transmission".
- 9. Keep the pressure plate and clutch disk installed on the engine.
  - **a.** Lay a straightedge (1) on the raised portions on the pressure plate (2).
