STAR CENTER NEWS

March/April Announcements

March/April 2015

No. 87

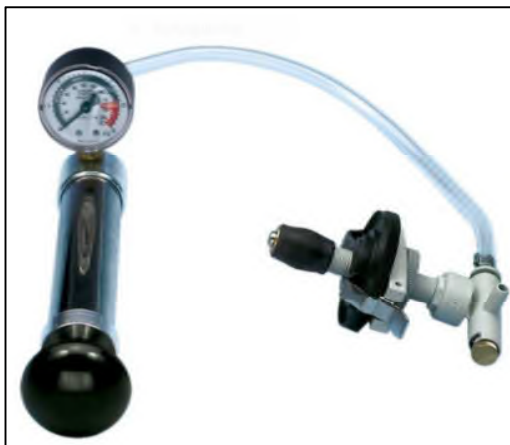
Fig. 1

There have been some reports of difficulty locating a suitable cooling system pressure tester adapter to fit certain FCA vehicles. Example vehicles include 14-15 BF, FF, 15 BU, VF and others. An alternative to using a specific adapter would be to use a bladder-type cooling system pressure tester (Figs. 1 and 2).

Bladder-type cooling system pressure testers can be purchased thru Snap-On (SVT-275) or other tool sources.

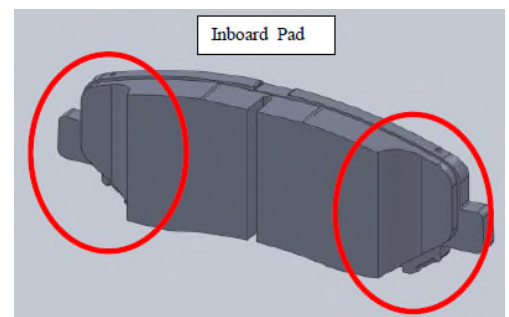
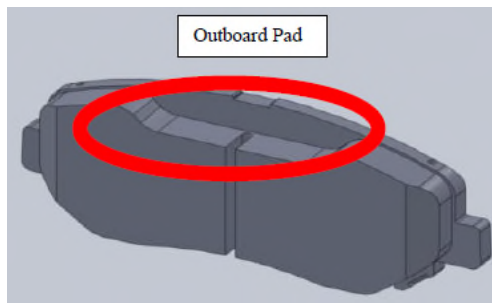
The front inboard and outboard brake pads on PF and UF vehicles have different friction pad shape when compared to each other. This difference is designed to help reduce noises from the braking system. The figures below show the proper orientation. The red circles in the images below highlight the differences.
