NUMBER: 08-032-15

GROUP: Electrical

RE9 Radio Software Enhancements

This bulletin involves updating the radio and navigation software, if required.

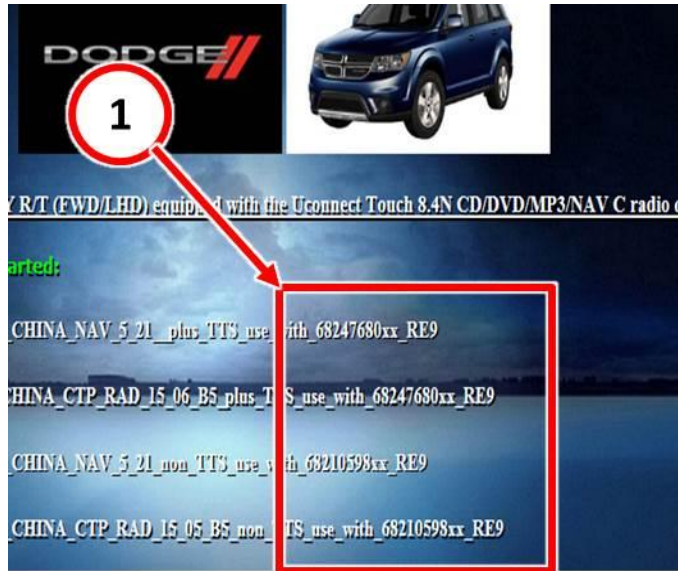
Fig. 3 Uconnect Main Portal Screen

1 - Radio Part Number Location

- 8. If multiple files are available for the selected VIN, use the radio ECU part number recorded in [Step #5](#) to select the correct software packages. See ([Fig. 3](#)) and ([Fig. 4](#)) for the location of the part number information.

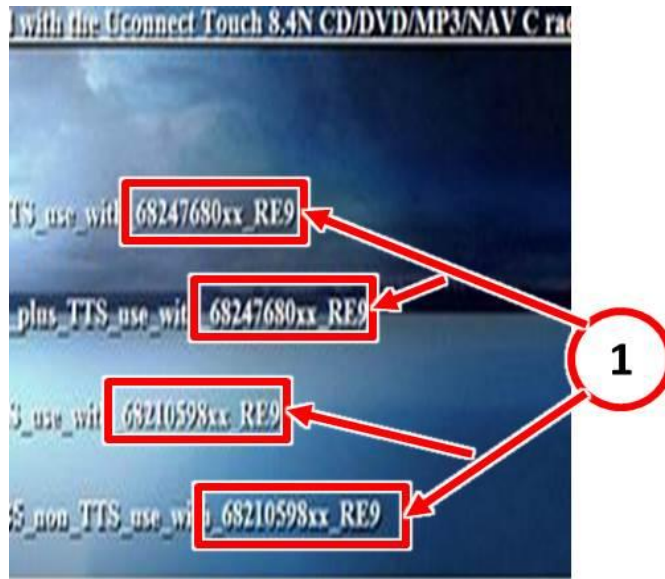
Fig. 4 Radio Software Selections

1 - Radio ECU Part Numbers

NOTE: Radio part numbers ending in XX indicate any letter combination AA through AN.
