TT7693EN  
August, 2015  
Page 1 of 8

SUBJECT: C3/C4 Bonded Piston P/N 29552373 Failure – Capture of Relevant Information

MODELS AFFECTED: 3000, 3500 Models (All Variants), B300, B400, T Series (All Variants)

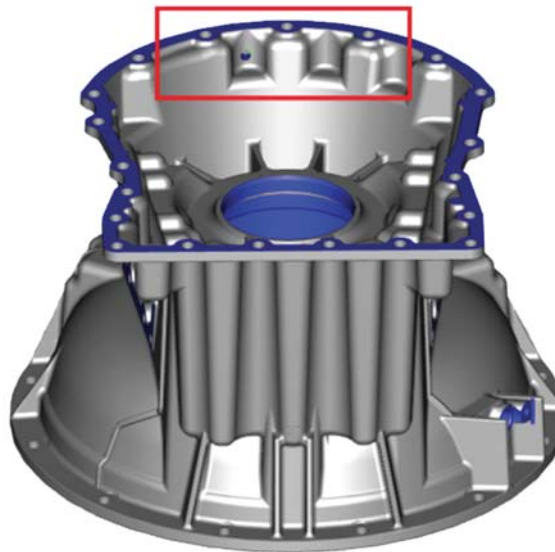
2883270

**NOTE:** The transmission breather port is located directly above the Front Support Assembly. When water enters the transmission through the breather port, often there is physical evidence inside the Torque Converter Housing and on the face of the Front Support Assembly of this water entry (refer to [Figure 4](#)).

2. Take photos inside the Torque Converter Housing showing traces of water entry as shown below (refer to [Figure 6](#) and [Figure 7](#)).

**Figure 6. Breather Location**
