STAR CENTER NEWS

STAR Center News

Nov/Dec 2015

No. 88

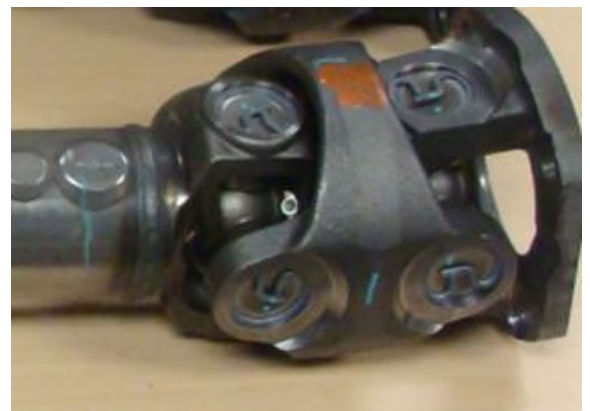
Since 2005 model year, 2500/3500 Ram 4X4 trucks have been using a double cardan universal joint on the front propeller driveshaft (pictured below).

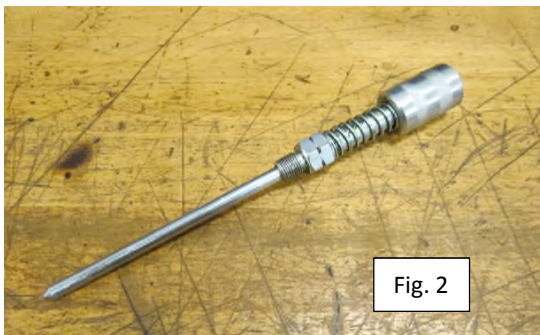
Fig. 2

The fitting is actually a conical depression in the joint that has a small steel check ball at the bottom.

The design and location of the fitting requires a special grease nozzle (Fig. 2) to access the lubrication point.

The Maintenance schedule in TechCONNECT and the Vehicle Owner's Manual indicates lubrication at every oil change.

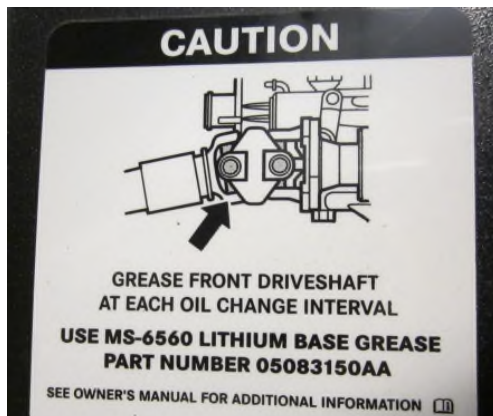
There is also a Caution Label on the left front fender that reminds of the required maintenance and the type of grease that should be used (see below).
