## Technical product information

<b>Topic</b>	Vibration humming noise in cabin front bulkhead
<b>Market area</b>	Bentley: worldwide (2WBE),Hongkong-Macau (5HK)
<b>Brand</b>	Bentley
<b>Transaction No.</b>	2040820/2
<b>Level</b>	EH
<b>Status</b>	Released for publishing
<b>Release date</b>	30-Jun-2015

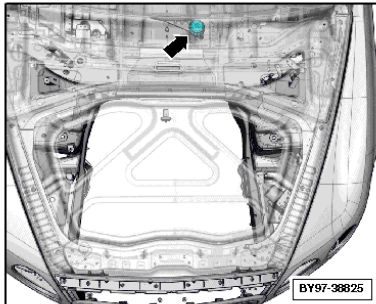
The engine sound actuator speaker (R257) and or associated wiring can, when operating 'Sport' mode only, foul on the HVAC casing or plenum cover. This component (R257) is located in the plenum adjacent to the HVAC system housing and when this foul occurs the vibration appears to emanate from behind the instrument panel
