Field campaign

Topic	Rear Seat Entertainment - field update (SC15/09)
Market area	Bentley: worldwide (2WBE)
Brand	Bentley
Transaction No.	2039381/1
Campaign number	EA30
Note	
Type	
US code

Flying Spur

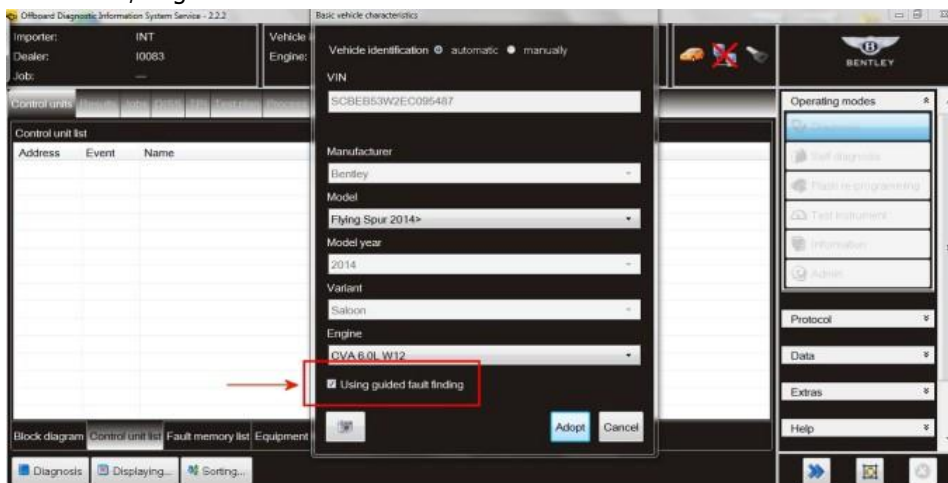
Figure 1

7. Using guided fault finding check and clear the vehicle of any fault codes (see Figure 1). NOTE: At this point when requested to Make a Target/Actual comparison do not perform this action select No
8. Using the TSR turn on both RSE screens

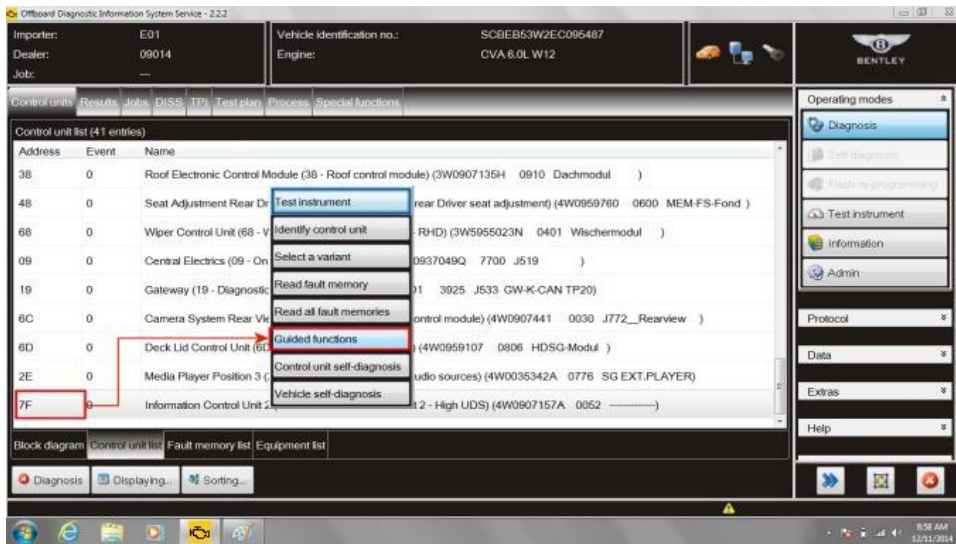
Figure 2

9. Within Control units – Select (single touch) 7F Information Control Unit 2 – Reveal drop down menu (extended touch and release), Select Guided functions (see Figure 2)

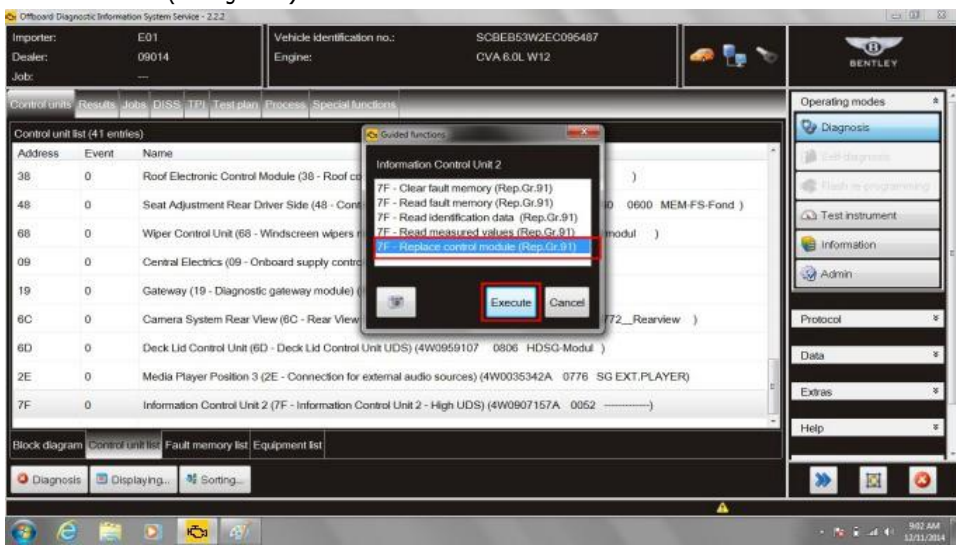
Figure 3

10. Within Control units, Information Control Unit 2, Select Replace control module and then Execute (see Figure 3)

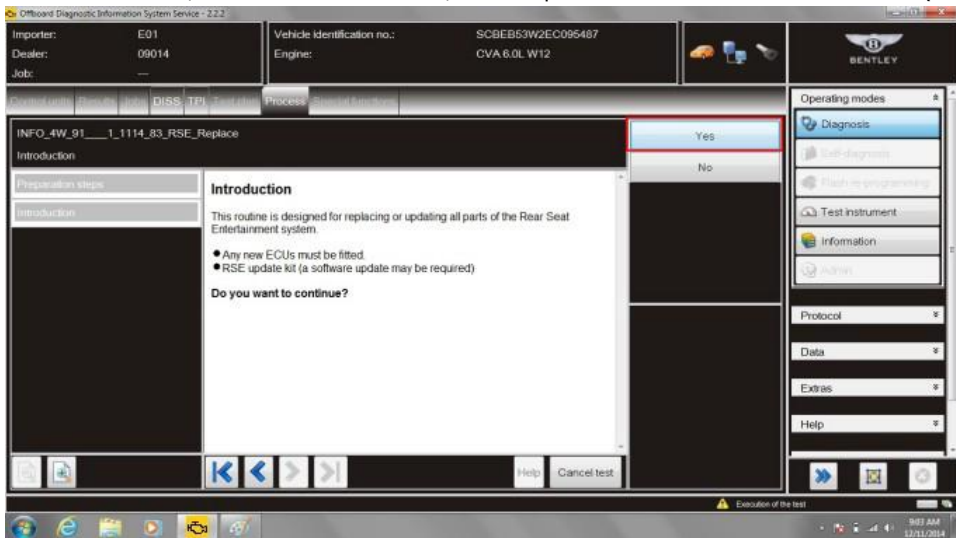
Figure 4

11. Select Yes at Introduction screen (see Figure 4)

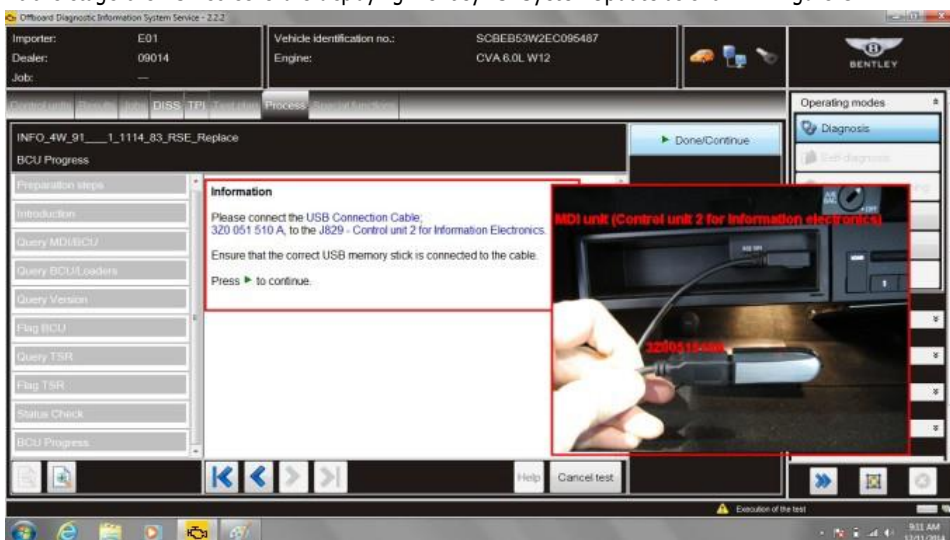
Figure 6

14. As requested connect the USB cable (part number 3Z0051510A) to the memory stick (part number WT10336A) and connect that assemble to the MDI unit (Control unit 2 for Information Electronics) located in the glove box. Once connected select Continue (see Figure 6)

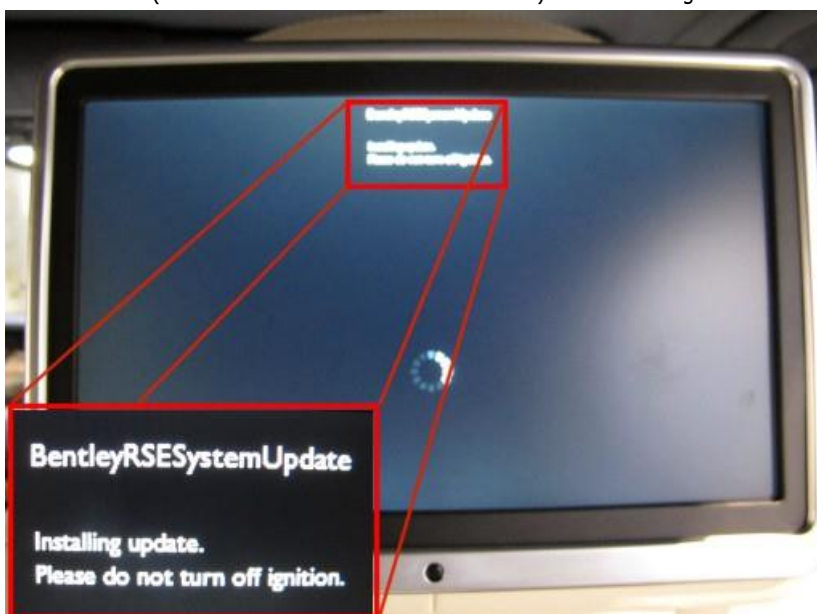
Figure 7

15. At this point the update will start as indicated in the RSE screens (see Figure 7)

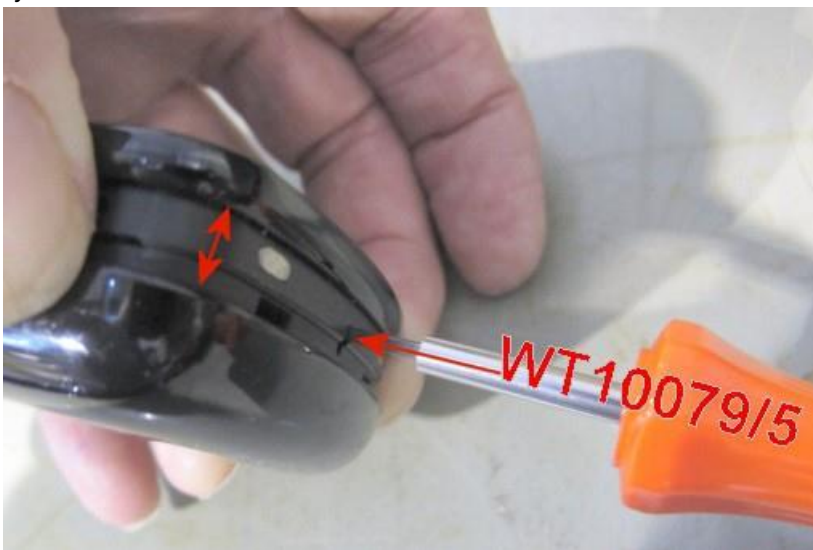
Figure 9

21. Remove the back from the TSR. Using a suitable tool depress the securing latch (WT10079/5 is suitable) whilst pulling the back off the unit (see Figure 9)

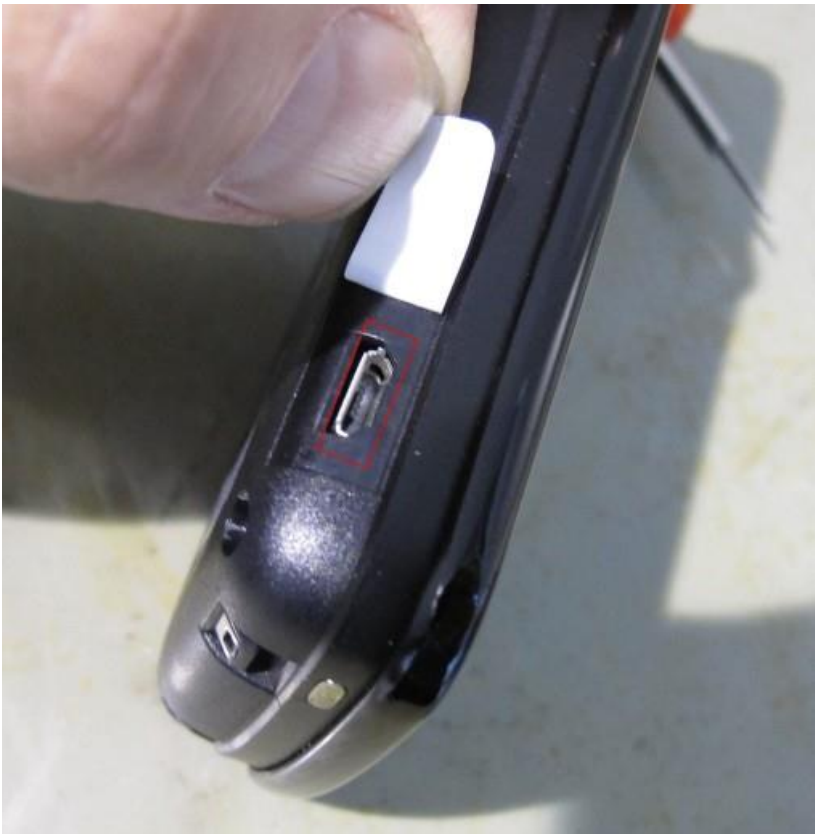
Figure 10

22. With the back removed from the TSR remove the tape covering the micro USB port (see Figure 10)

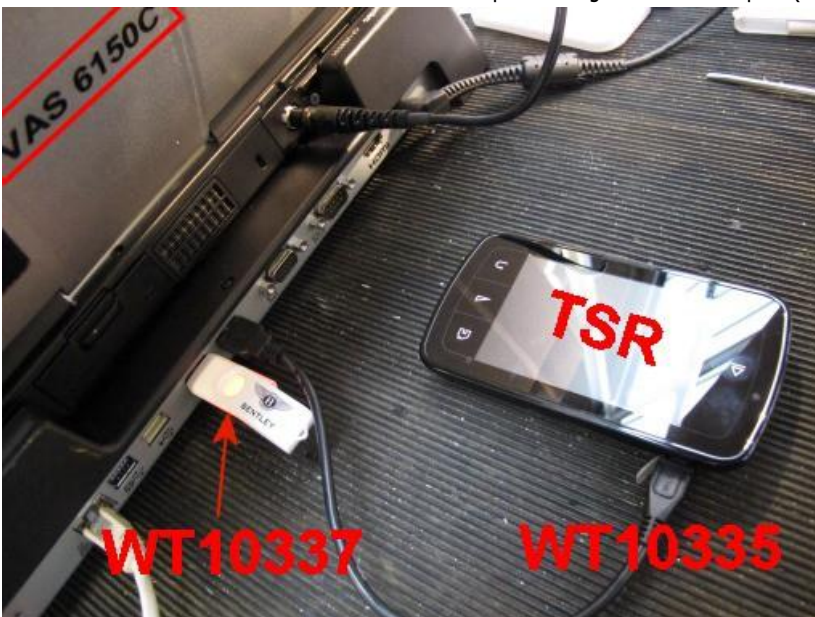
Figure 11

23. Connect the TSR to the Bentley diagnostic tool (VAS 6150C or similar) using USB cable (part number WT10335). (See Figure 11)

24. Insert the USB memory stick (part number WT10337) into a spare port on the Bentley diagnostic tool (VAS 6150C or similar). (See Figure 11)

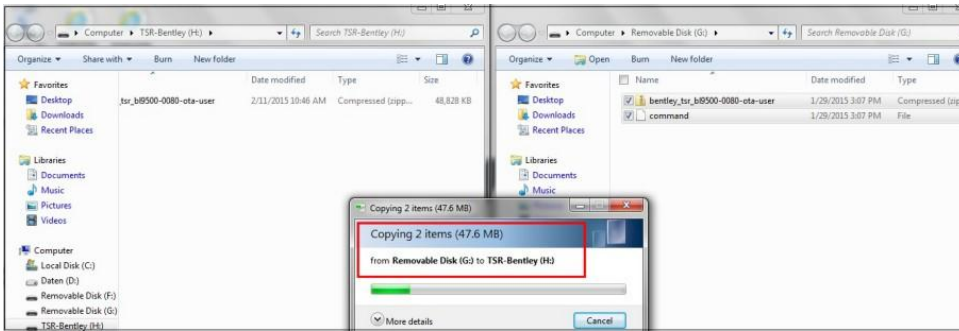
Figure 12b

25. The Bentley diagnostic tool will display two AutoPlay windows, one for the memory stick and one for TSR-Bentley. Select Open folder to view files on both windows. Arrange the two open folders side by side on the Desktop in preparation to transfer files.
26. The memory stick (Removable Disk (?)) contains two files these two files require transferring to the TSR-Bentley (?). Transfer the two files, drag and drop, from the Removable Disk (?) to the TSR-Bentley (?). (See Figure 12a,b and c)
27. Once transfer has taken place close down the two windows using the Safely Remove Hardware and Eject Media Function
28. Refit the tape over the micro USB port and refit the back onto the TSR. Avoid touching the Cancel button that will be displayed on the TSR (see Figure 13)

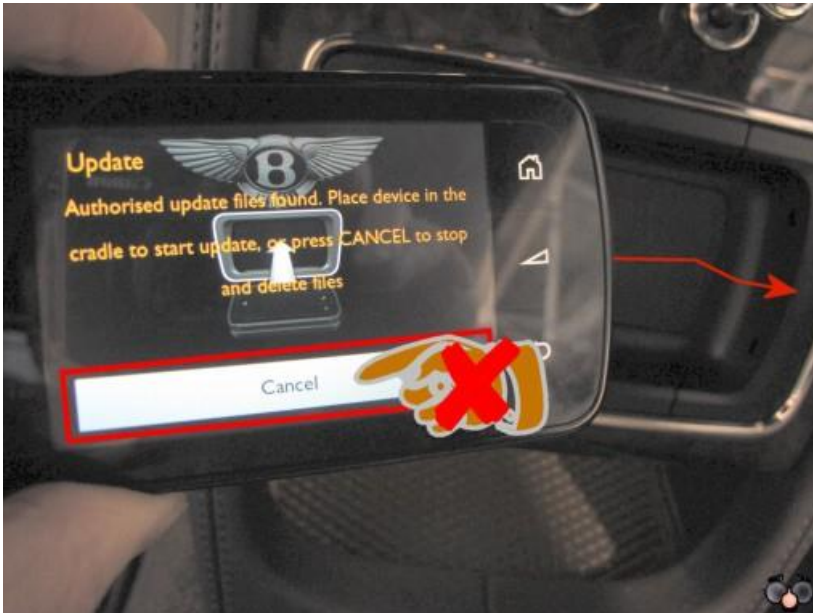
Figure 13

29. Once the TSR update is recognised as indicated on the TSR screen Place device in the cradle to start update. NOTE: When refitting the TSR into the cradle avoid touching the Cancel button (see Figure 13). If Cancel is inadvertently initiated then the process will have to be restarted from operation 21.

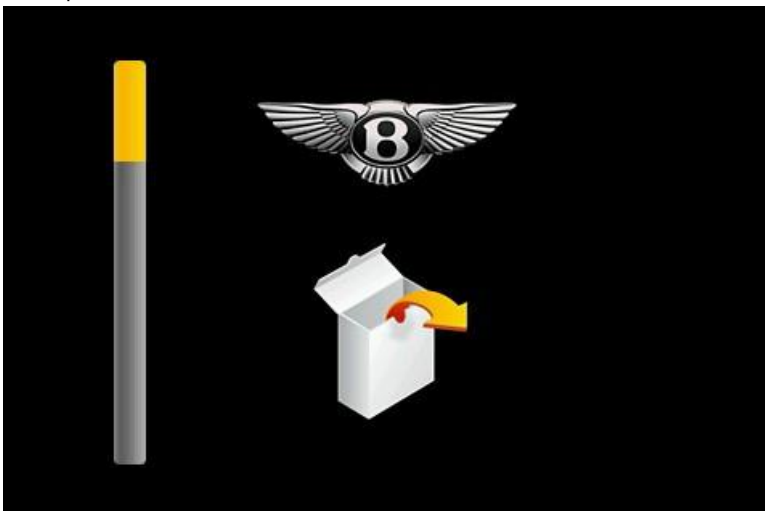
Figure 14

30. The TSR update will now take place as depicted on the TSR screen (see Figure 14)

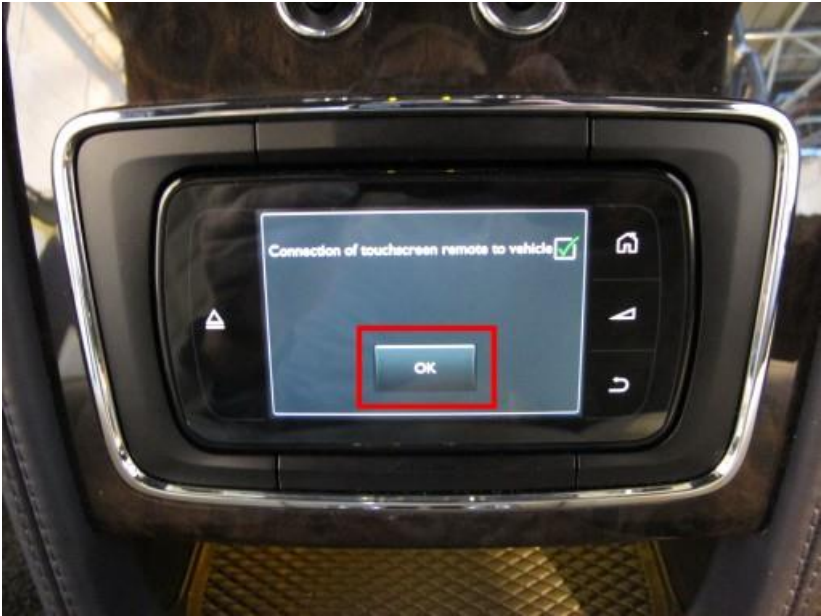
Figure 15

31. On completion the Bentley wings will be displayed for 3 minutes after which the TSR will un dock and re dock followed by the pairing of TSR screen select OK (see Figure 15)

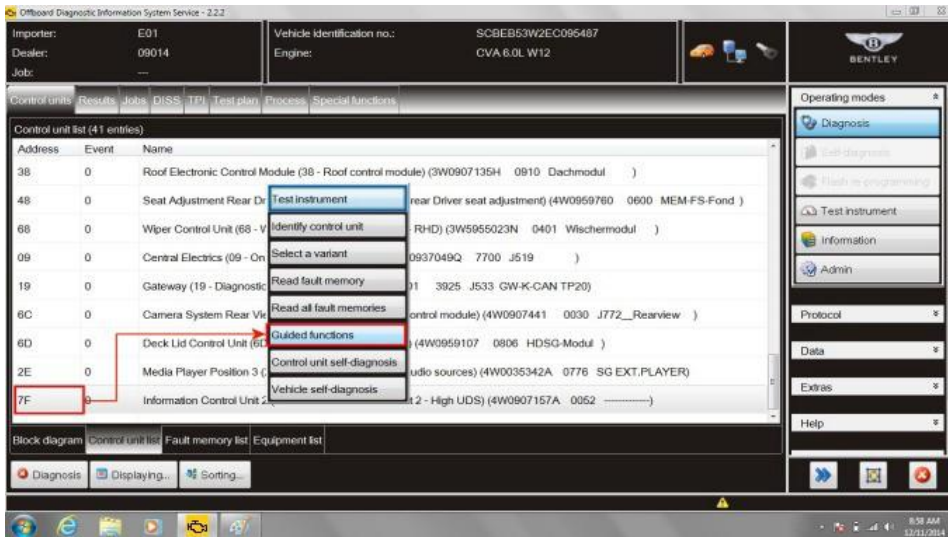
Figure 17

38. Within Control units – Select (single touch) 7F Information Control Unit 2 – Reveal drop down menu (extended touch and release), Select Guided functions (see Figure 17)

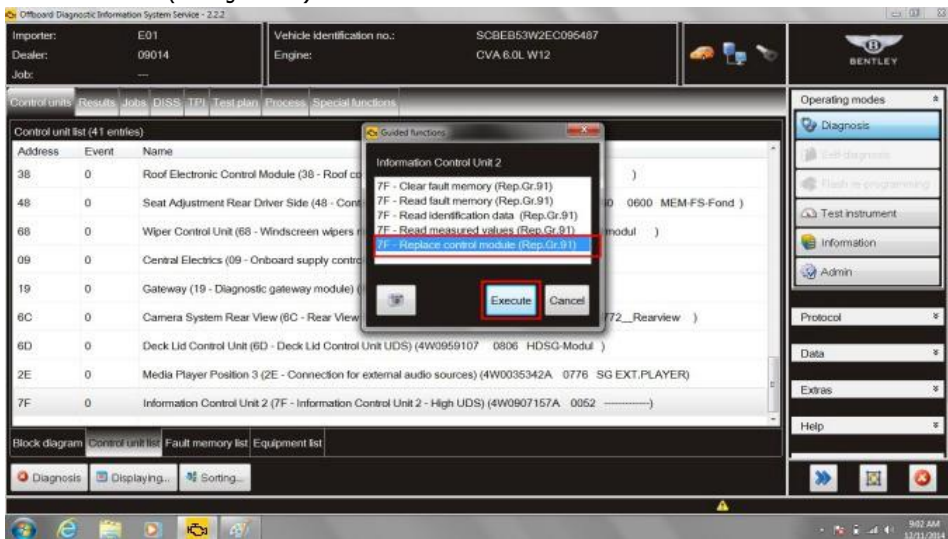
Figure 18

39. Within Control units, Information Control Unit 2, Select Replace control module and then Execute (see Figure 18)

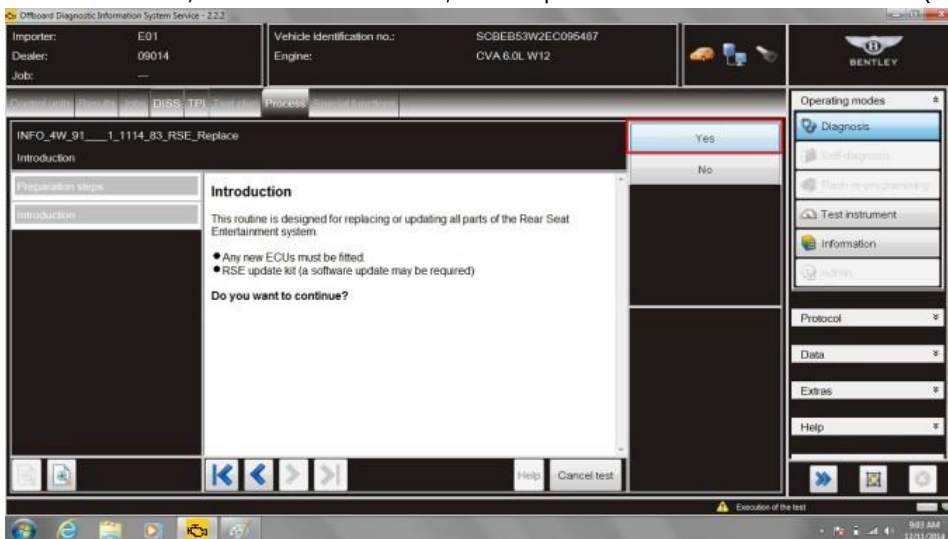
Figure 19

40. Select Yes at Introduction screen (see Figure 19)
41. This time running the replace control module test will have returned no parts requiring update and will automatically proceed to carry out and Make a Target/Actual comparison this time this action must be completed and the target actual carried out, coding will be detected follow screen prompts to perform the coding

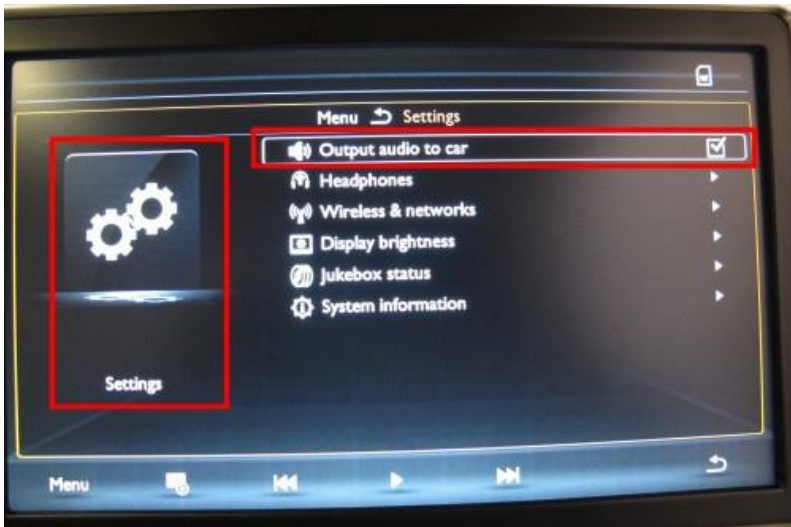
Figure 20

45. **Hint:** The additional function Output audio to car will be set to off in the settings menu check the tick box to enable this function (see Figure 20)
