## SERVICE CAMPAIGN BULLETIN

<b>TITLE:</b>	Vehicle Software Update to Platform 13
<b>CAMPAIGN REFERENCE</b>	02M
<b>DOCUMENT NUMBER:</b>	11 M 069
<b>AFFECTED VEHICLES:</b>	McLaren 12C Coupe and Spider
<b>SITUATION:</b>	<p>Quality Engineering at McLaren Automotive have released a new software platform for the 12C Coupe and Spider.</p> <p>The most noticeable changes of this software are;</p> <ul style="list-style-type: none"><li>• Fuel level full is now displayed when brimmed.</li><li>• Fuel Filler Actuator reset.</li><li>• HVAC flutter.</li><li>• Launch control improvement at altitude.</li><li>• Window Drop Ingress / Egress function included and only functional on vehicles with door buttons.</li><li>• Middle East Speed Warning - Tell-tale removal.</li><li>• DRS (Drag Reduction System) function included.</li><li>• Capability to retrofit Reverse Camera, DAB and SirrusXM to vehicles I installed with the model year 2014 IRIS.</li><li>• Intermittent loss of Meridian sound.</li><li>• Navigation day and night switching corrected.</li></ul> <p>In addition to this, to support our Customers McLaren Automotive have also created a 12C Technology Upgrade eBrochure.</p>

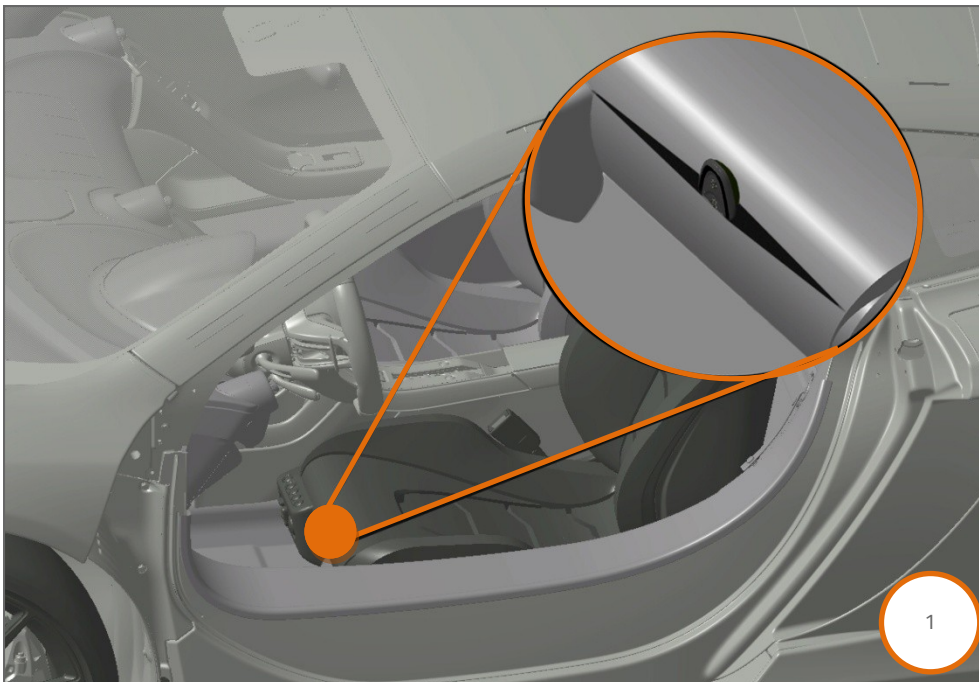
**Care Point:** The key must be positioned in the driver's seat front pocket (1).

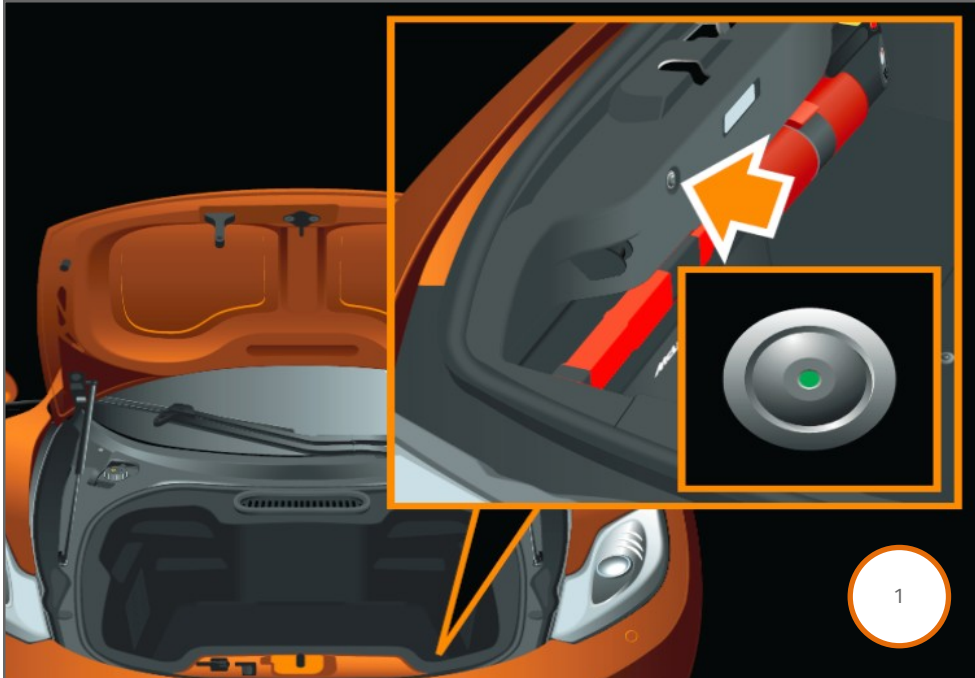
**Care Point:** Step 11 must be carried out to Federal specification vehicles only.

11. Press the internal luggage compartment switch twice and then latch the primary latch closed manually (1).

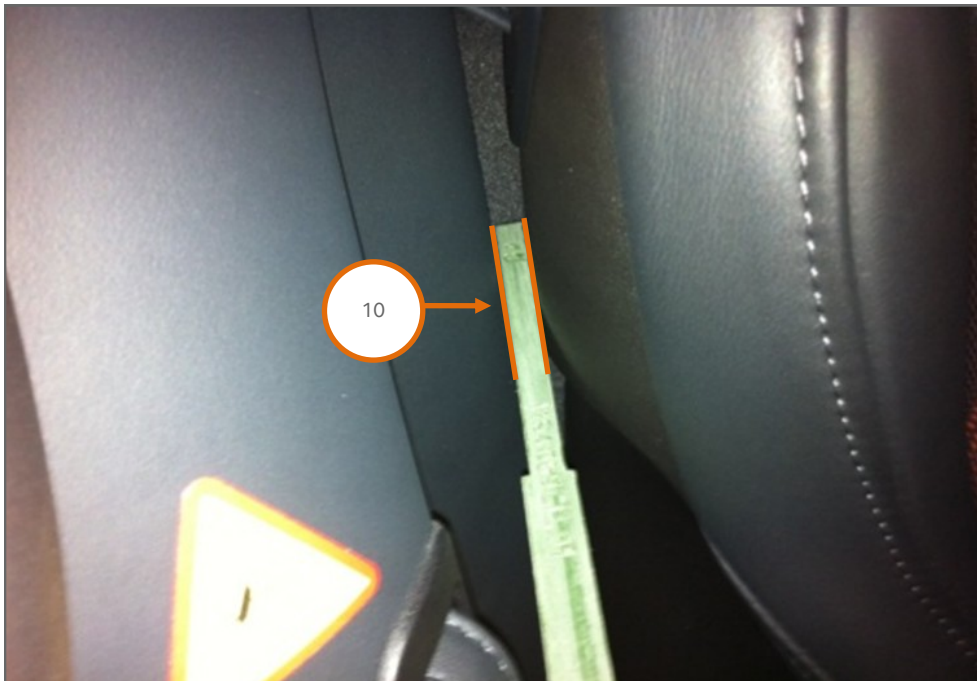
**Care Point:** The seat calibration gauge **must** be placed in the smallest gap between the seatback and the B-Pillar trim in order for the calibration to be performed correctly.

41. Adjust the backrest angle until the desired gap between the seatback and the B-Pillar has been achieved using the seat gauge. The gap **must not** be narrower than the smaller end of the calibration tool (10). The tool should move freely between the seatback and the B-Pillar.
