TECH TIP

08MY-16MY Headlamp Condensation or Water Intrusion

SUBJECT VEHICLES: 08MY-16MY Conventional trucks

Group:	0-General
Bulletin No.:	TT-15-002
Issue Date:	2-04-2015

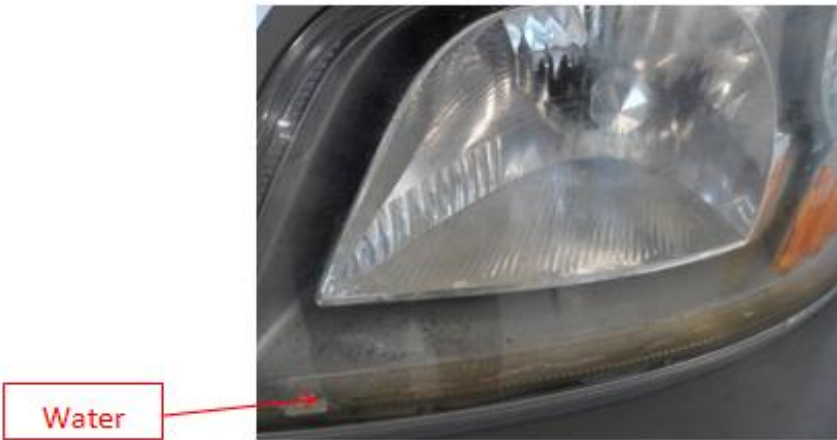
The customer may complain of water or condensation within the headlamp assembly. If the vehicle exhibits this condition, it is necessary to first verify that all of the protective covers and caps are installed before suspecting a problem with the headlamp assembly. Any loose or missing caps or covers on the headlamp will result in water entry. Note that some condensation within the headlamp at times should be considered normal.
