| L624-A.06.15 | <b>To:</b> Official After Sales Network<br><b>Subject:</b> SMLS software update<br><b>Date:</b> 02/20/2015<br><b>Pages:</b> 12 | |

SMLS software update

All Lamborghini Huracan 2015 starting from VIN **FLA00163 To FLA00752.**

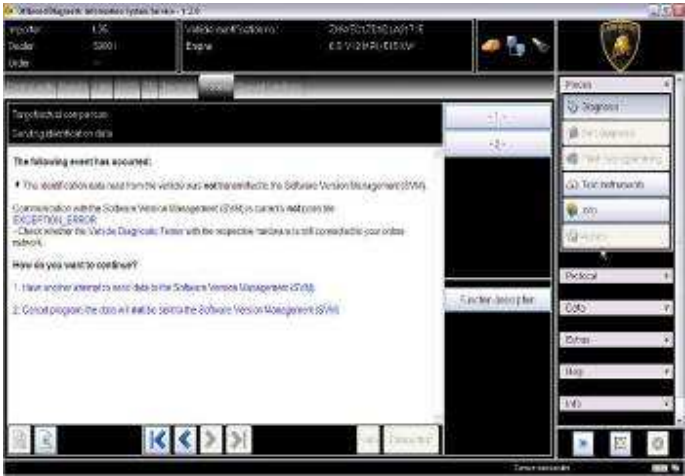
- C. If the loss of connection happens during the target/actual comparison.

- It is not possible to connect to central server, check the working connection of internet and retry by clicking “1”.
