2014 Sentra (B17) Front Strut Insulator
Dealer Service Action

Reference: PM552

Date: January 15th, 2015

PM552 Sentra (B17) Strut Insulator

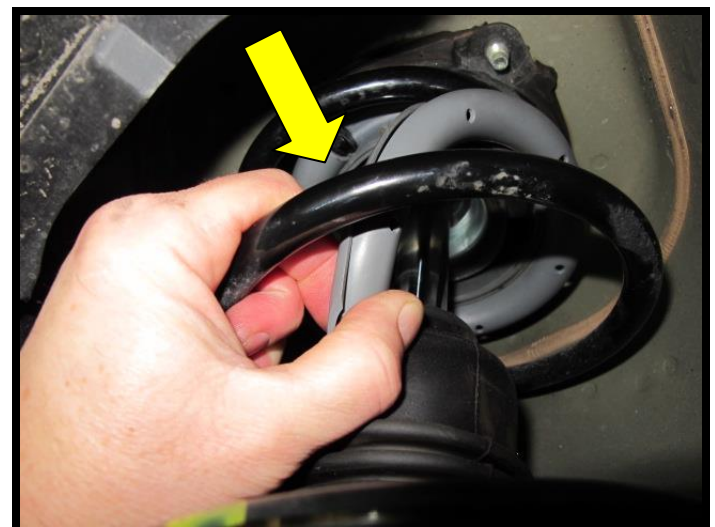
Figure 3

1. Turn the steering wheel to the full right turn position.
2. Raise the vehicle on a lift.
3. Remove left front wheel and tire assembly from the vehicle.
4. Pull down strut bumper/dust boot assembly (Figure 1).
5. Locate front strut insulator (Figure 2).
6. Pull front strut insulator down off the spring, starting at the second spring coil (Figure 3).
 - Grab the end of the front strut insulator and pull it off the spring to the point where it is trapped by the strut bearing.
