# SERVICE BULLETIN

Classification: EL13-055c	Reference: NTB14-001c	Date: March 11, 2015
------------------------------	--------------------------	-------------------------

## 2013 - 2014 LEAF; INSUFFICIENT HEATER OUTPUT

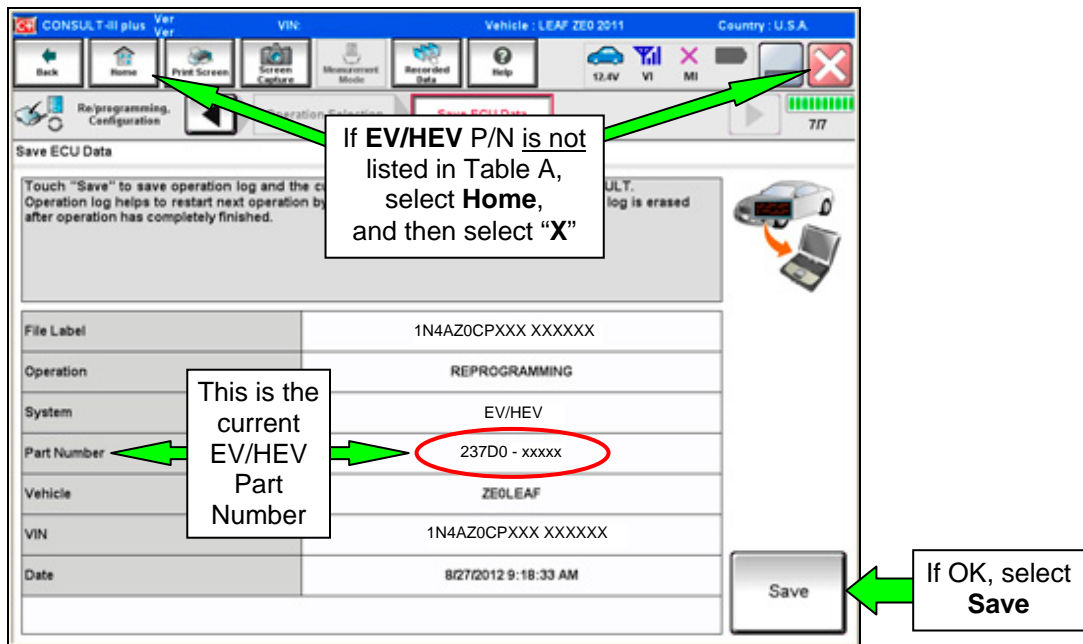
Figure 8

14. Write down the **Part Number** on the vehicle's repair order (see Figure 8).

- If the **EV/HEV** part number is in Table A below, continue with the VCM reprogramming and PTC heater replacement.
  - Select **Save**, and then go to Step 15.
- If the **EV/HEV** part number is not in Table A below, this bulletin does not apply.
  - Close C-III plus (select **Home**, and then the **“X”**), disconnect from the vehicle.
  - If the timer for either charging or climate control were turned off, turn them back.
  - Refer to ASIST or the applicable Electronic Service Manual (ESM) for further diagnostic assistance.
