SERVICE BULLETIN

EC15-019

December 17, 2015

2015 ALTIMA WITH 4 CYL ENGINE; MIL ON WITH A/F SENSOR DTC STORED

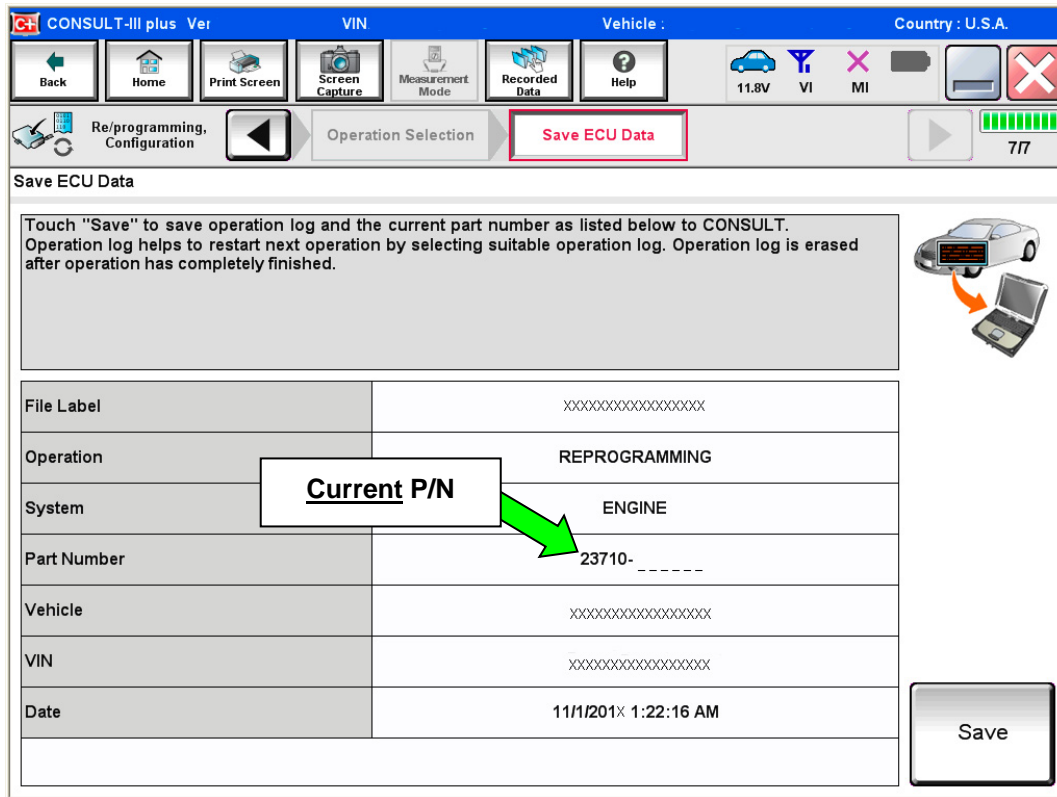
Figure 2

6. When you get to the screen shown in Figure 2, confirm this bulletin applies as follows:

A. Find the ECM **Part Number** and write it on the repair order.

NOTE: This is the current ECM Part Number (P/N).

B. Compare the P/N you wrote down to the numbers in the **Current ECM Part Number** column in **Table A** below.

- If there is a match, this bulletin applies. Continue with the reprogramming procedure.
- If there is not a match, this bulletin does not apply. Return to ASIST for further diagnostic and repair information.

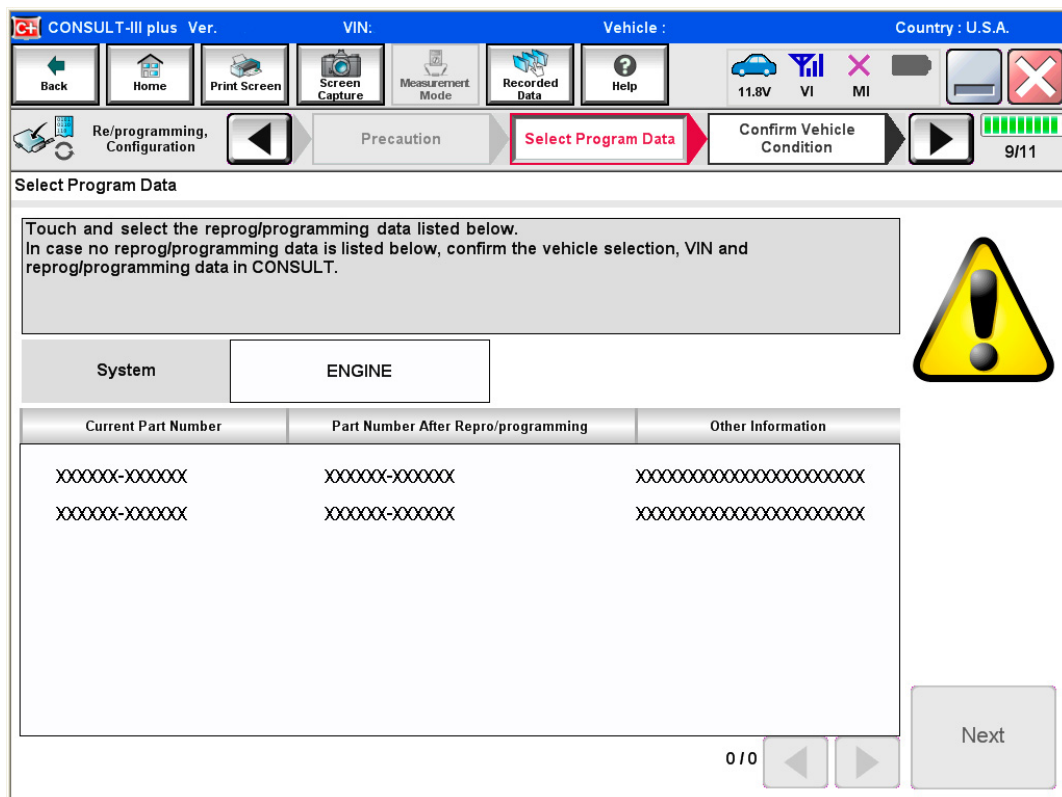
- In some cases, more than one new P/N for reprogramming is available.
 - In this case, the screen in Figure 3 displays.
 - Select and use the reprogramming option that **does not** have the message “Caution! Use ONLY with NTBXX-XXX”.
- If you get this screen and it is blank (no reprogramming listed), it means there is no reprogramming available for this vehicle.

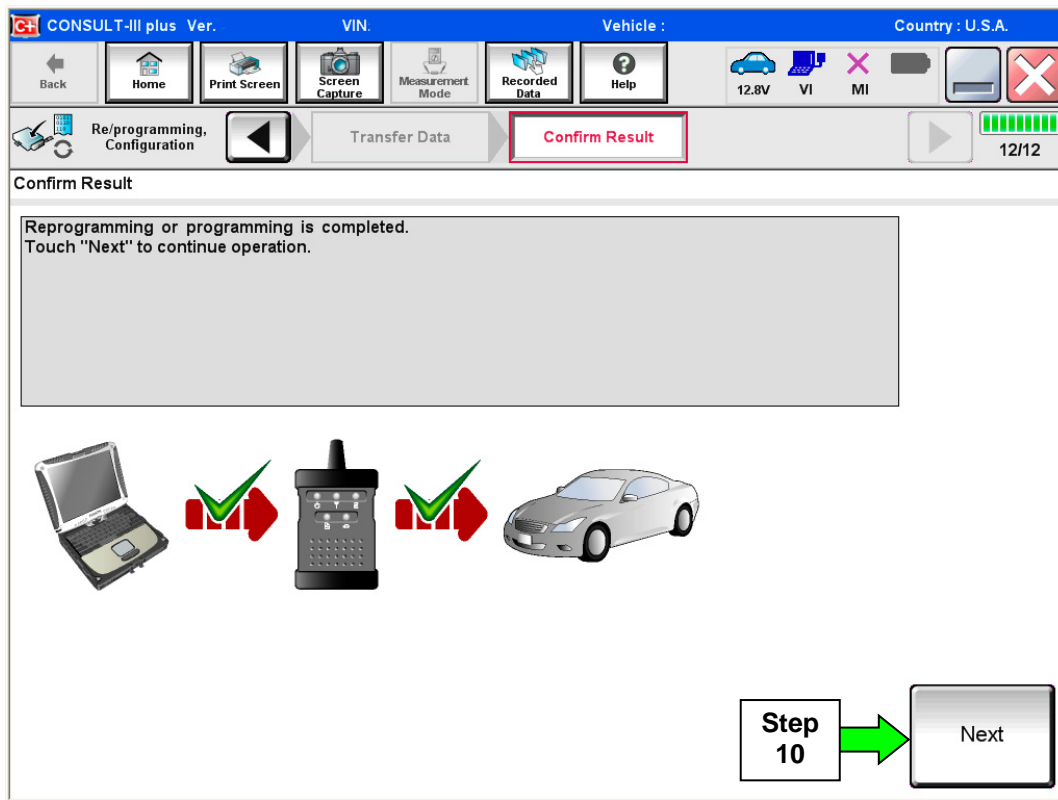
8. When the screen in Figure 4 displays, reprogramming is complete.

NOTE: If the screen in Figure 4 does not display (indicating that reprogramming did not complete), refer to the information on the next page.

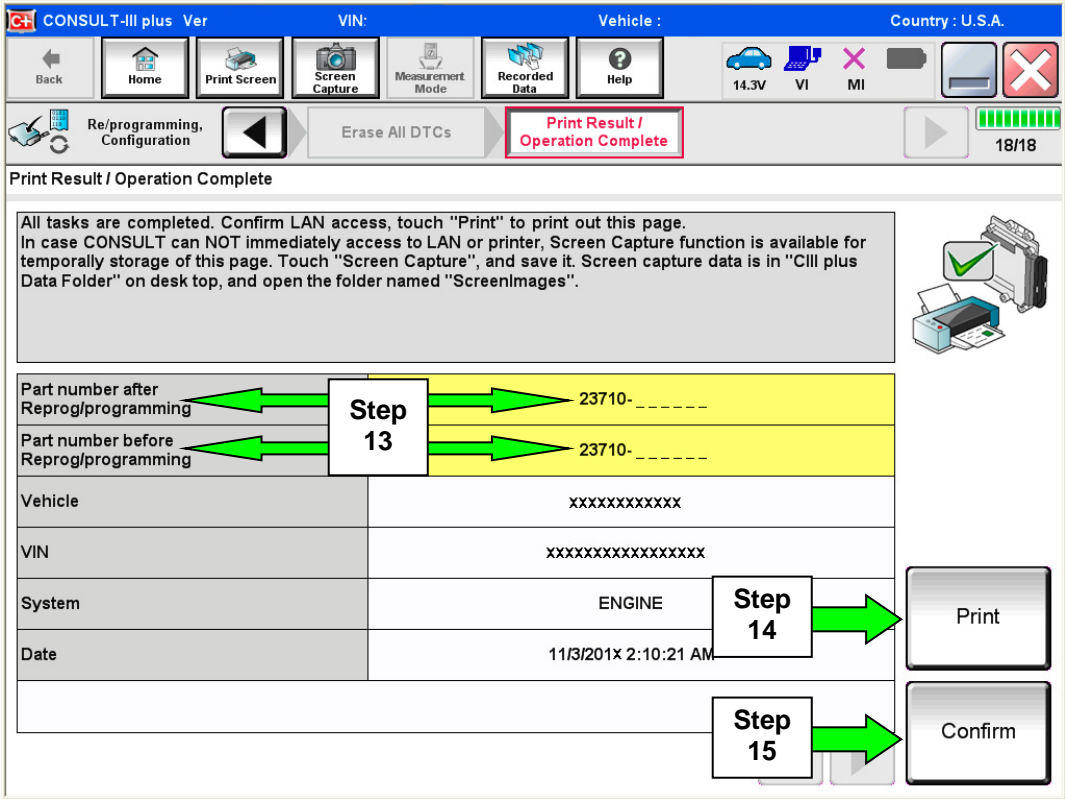
- 12. When the entire reprogramming process is complete, the screen in Figure 7 will display.
- 13. Verify the before and after part numbers are different.
- 14. Print a copy of this screen (Figure 7) and attach it to the repair order for warranty documentation.
- 15. Select **Confirm**.

- 16. Close C-III plus.
- 17. Turn the ignition OFF.
- 18. Disconnect the plus VI from the vehicle.
- 19. **Replace the A/F sensor.**
 - Refer to the ESM for A/F Sensor replacement information.
- 20. Test drive the vehicle and make sure it operates correctly and the MIL is OFF.
 - If the MIL comes ON, go back to ASIST for further diagnostic information.
 - Diagnosis and repairs beyond the contents of this bulletin are not covered by this bulletin.
