**Technical News 161**  
**January 2015**  
**Strictly Confidential**

| <b>Contents</b> | | |

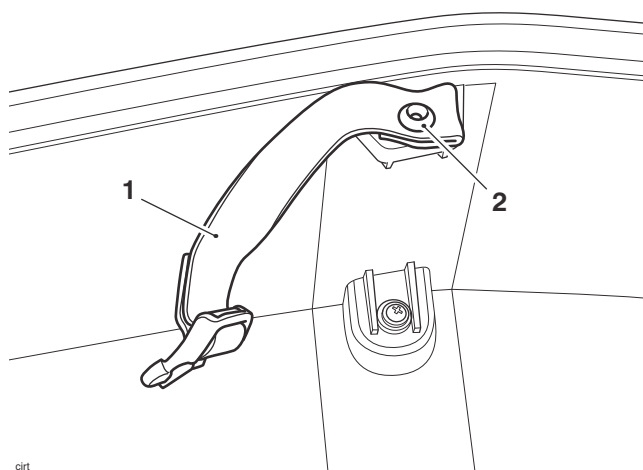
1. Pannier lid retaining strap (male shown, female similar)
2. Rivet

3. To remove the old pannier lid retaining straps, using a suitable drill, drill through the head of the rivets securing the pannier lid retaining straps to their mounting points. Remove and discard the straps, rivets and washers.

4. Carefully remove any swarf or debris created during drilling.

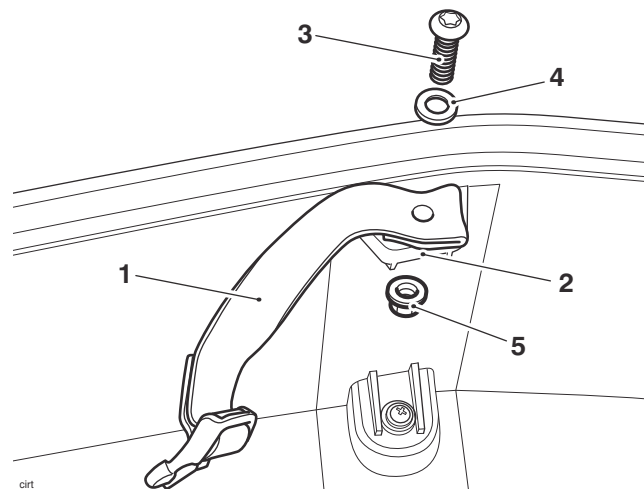
1. Pannier lid retaining strap (male shown, female similar)

5. Align the new pannier lid retaining straps to their mounting points as noted during removal and secure with the fixings as shown.

6. Ensuring that the straps remain correctly aligned, tighten the fixings to **1.5 Nm**.
7. Partially close the lid and join the lid retaining strap buckles together, then fully close the lid.

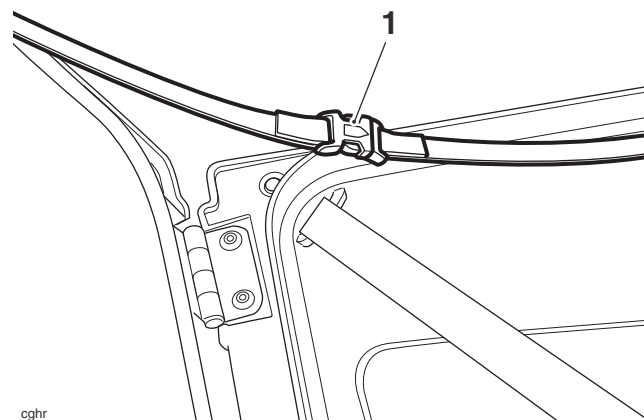
1. Buckle

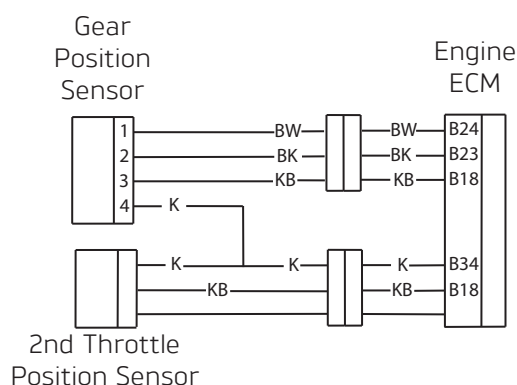
### Old Gear Position Sensor with Fly Lead

For the replacement of the main harness, the fly lead connecting the gear position sensor to the main harness is to be removed and discarded. The gear position sensor can remain on the engine as the new harness can connect directly to it.

If the gear position sensor has the three-pin multiplug, the gear position sensor must also be replaced using the parts kit T2500837.

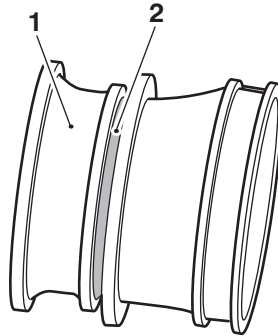
During manufacture, the throttle body intake rubbers are sealed to the airbox housing to eliminate external air leaks into the inlet ports.

1. Throttle body intake rubber
2. Mating face
3. Locate the throttle body intake rubbers into the airbox ensuring the alignment marks are aligned to the tangs on the airbox.

If the throttle body rubbers are removed or replaced for any reason the intake rubbers must be sealed to the air box using either Cemedine 540, U-Pol Tigerseal (Black) or equivalent.

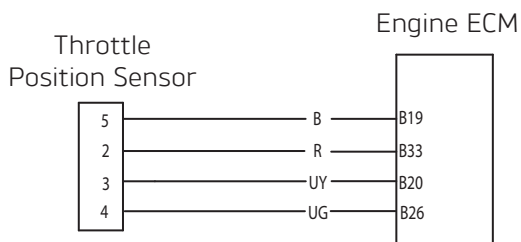
### Circuit Diagram

## Throttle Position Sensor 2 - Tiger XCx and Tiger XRx

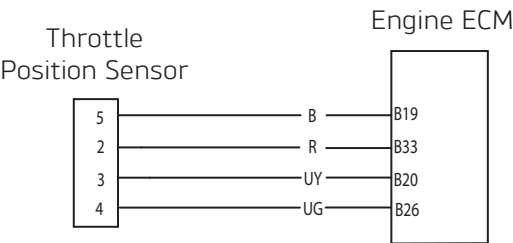
Circuit Diagram

Throttle Position Sensor 1 Correlation Error with Throttle Position Sensor 2 - Tiger XCx and Tiger XRx
