Service Bulletin

Subject: Seatbelt Pretensioner Harness Out of Position, Airbag Indicator Light ON, DTCs Set

Brand:	Model:	Model Year:		VIN:		Engine:	Transmission:
		from	to	from	to		
Chevrolet	Impala	2009	2010			All	All

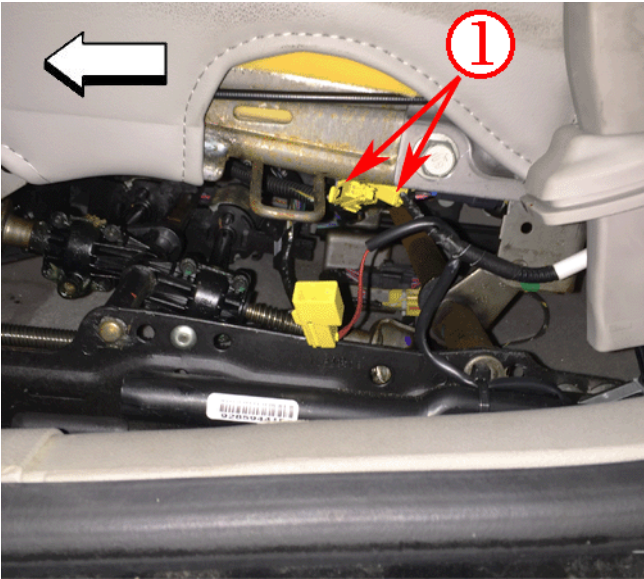
4. Inspect the seatbelt pretensioner harness for damage. (Harness (1) shown correctly looped and secured rearward, away from pinch points (2), harness connectors (3) located next to cushion).
 - If no damage found, route, or loop and secure the harness to the Side Impact Air Bag (SIAB) harness located at the rearmost part of the seat frame.
 - If harness is damaged or cut, depending on the location of the damage, replace the seatbelt pretensioner assembly or the seat harness. **Do not repair harness.** Refer to the Seat Belt Retractor Pretensioner Replacement - Front in SI. Refer to the Electronic Parts Catalog (EPC) using vehicle VIN information for correct part numbers.
