Subject: 49 CFR Part 579.5 Monthly Communications – February 2016

**INDEX OF SERVICE BULLETINS,
NOTICES, AND COMMUNICATIONS TO DEALERS**

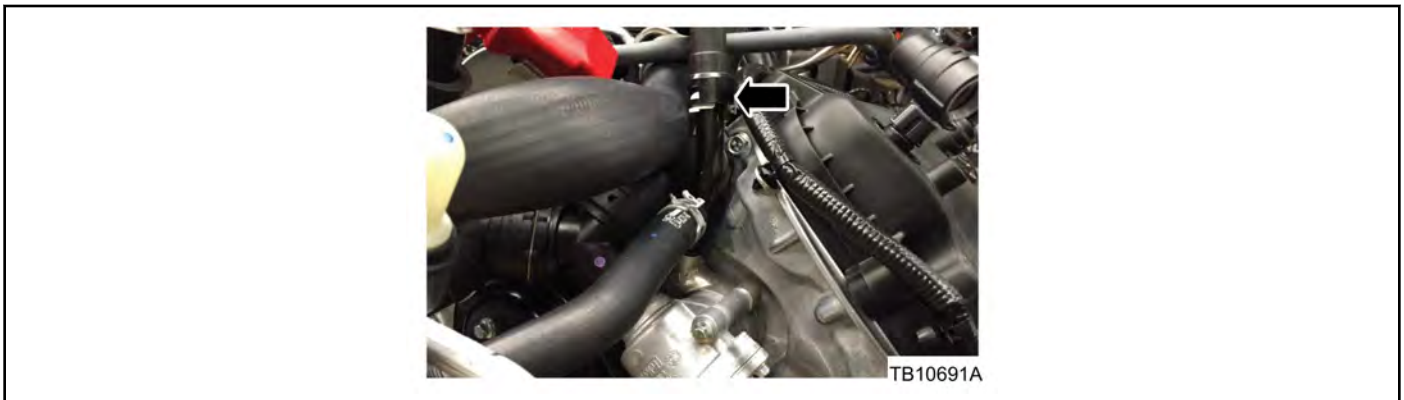
Figure 1 - Article 16-0019

1. Check the engine build date. Refer to Workshop Manual (WSM), Section 303-01. Was the engine built on 11/20/2014 and through 1/26/2015?
 - a. No - this procedure does not apply. Refer to WSM, Section 303-03 for normal diagnosis.
 - b. Yes - proceed to Step 2.
2. Is the heater outlet hose disconnected from or leaking at the heater outlet tube on the coolant pump? (Figure 1)

- a. No - this procedure does not apply. Refer to WSM, Section 303-03 for normal diagnosis.
 - b. Yes - proceed to Step 3.
3. Drain the cooling system. Refer to WSM, Section 303-03.
4. Remove the air cleaner outlet pipe. Refer to WSM Section 303-12.
5. Remove the bolts and position the degas bottle aside.
6. Completely cover the accessory drive belts with waterproof plastic.
7. Disconnect the heater outlet hose from the heater outlet tube. (Figure 2A)

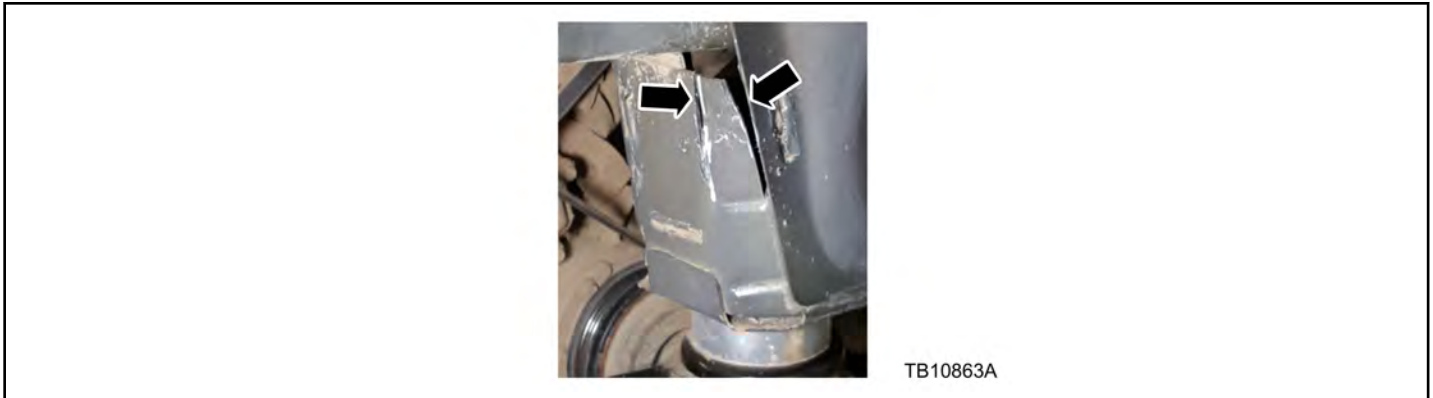
Figure 2 - Article 16-0021

Some 2016 Explorer vehicles built on or before 1/31/2016 may exhibit a pop or creak noise from the right front mounting bolt of the front subframe. This condition may be due to a mispositioned weld between the barrel nut and the subframe mounting bracket.

6. Using an abrasive cut off wheel, cut the bracket sheet metal along the marked lines. (Figure 2)

a. Make sure to only cut through the outer layer.
