To: All U.S. and Canadian Volvo Retailers  
Subject: XC90 Courtesy Upgrade C10006

**XC90 Courtesy Upgrade C10006  
Model Year 2016 XC90**

**XC90 Courtesy Upgrade (C-10006)**

REF NO:  
**TJ 30991**

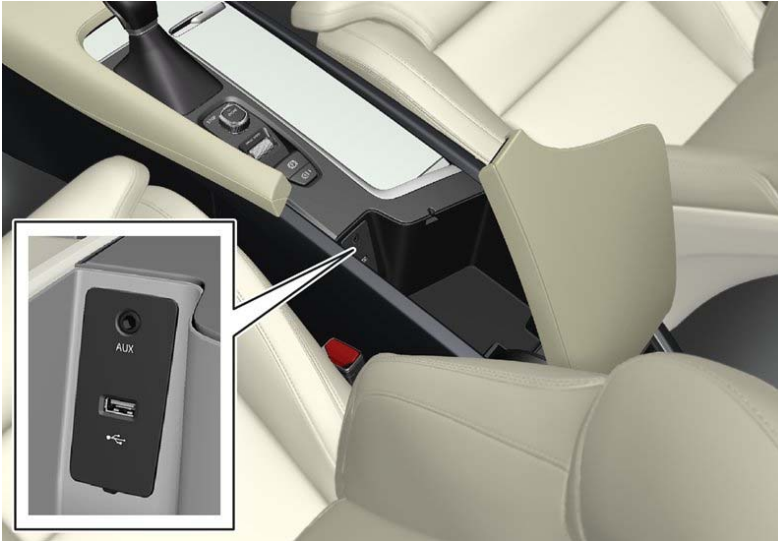
1. Switch on the infotainment system (Usage mode Convenience or higher).  
Insert the USB memory stick in the USB port.

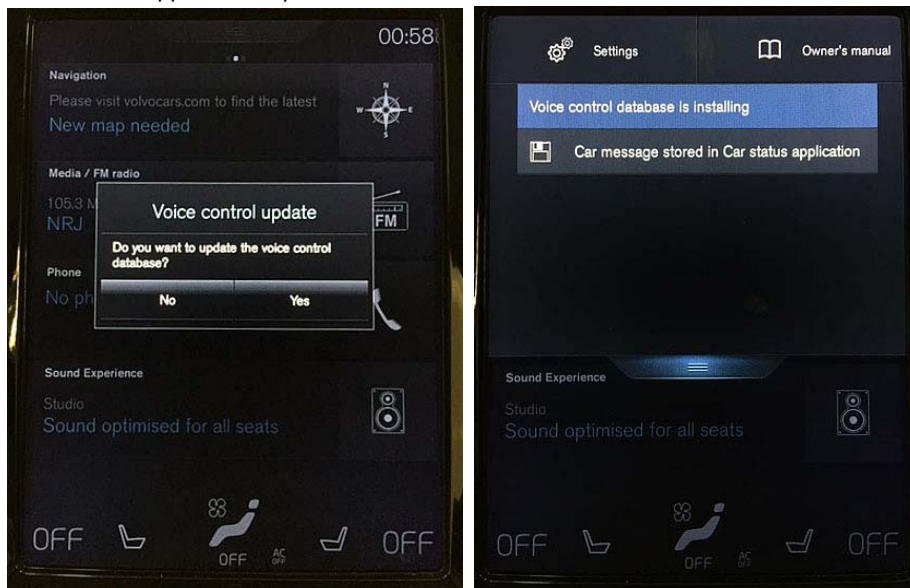
2. Press “Yes” for Voice control update. No progress bar is visible but it is possible to check that the download has started by dragging down the Settings menu from the top of the screen.  
Download time is approximately 11 minutes.

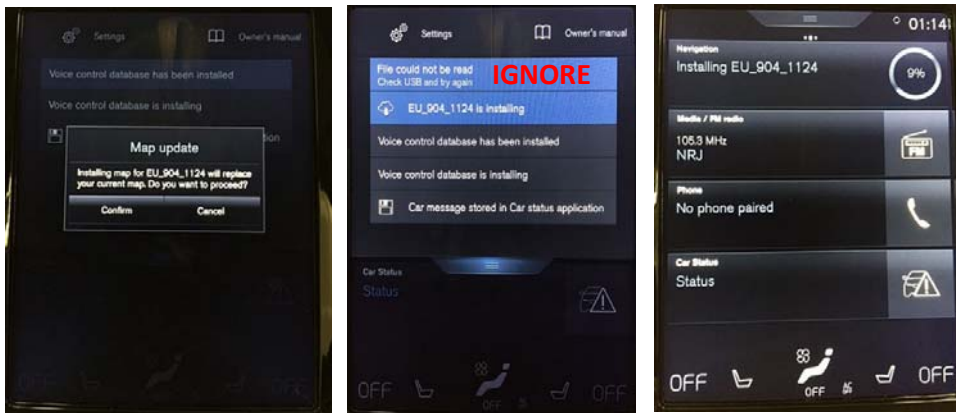
3. Maps file will start when voice control file is finished, press “Confirm”.  
Ignore the following message: “File could not be read. Check USB and try again”.  
Map data file is now being installed. This will take approximately 40 minutes.

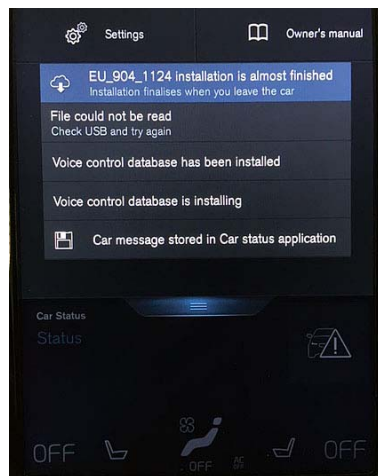
4. When the installation is complete this message is shown in top menu.  
Remove the USB-stick, turn off the ignition and leave the car for 3 minutes.

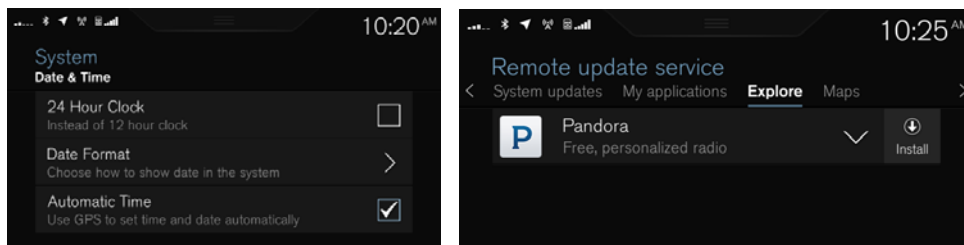
5. Start the vehicle and drive it outside so that it has a clear view of the sky.  
Confirm that automatic time update is selected under Car Settings.  
Within a few minutes, a GPS signal will be received and the clock time will be updated.  
Download and/or Update Apps using the Remote Update Service.
