Subject: TPMS WARNING LIGHT ON	Bulletin No: 02-002/15
	Last Issued: 11/03/2015

BULLETIN NOTE

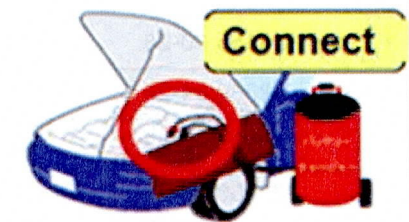
Do NOT use vehicle battery outlet as power source for the PC.

- c. When performing this procedure, we recommend using the “Power Supply” mode in the Battery Management System to keep the vehicle battery up to capacity. If a different charger is used, make sure it does not exceed 20 AMPS. If it exceeds 20 AMPS, it could damage the VCM.
