Subject: MAZDA SERVICE PROGRAM (MSP45) – TIRE PRESSURE MONITORING SYSTEM WARNING LIGHT	Bulletin No: 02-006/15
	Last Issued: 11/03/2015

2014 - 2015 Mazda6 vehicles built from October 26, 2012 through November 26, 2014

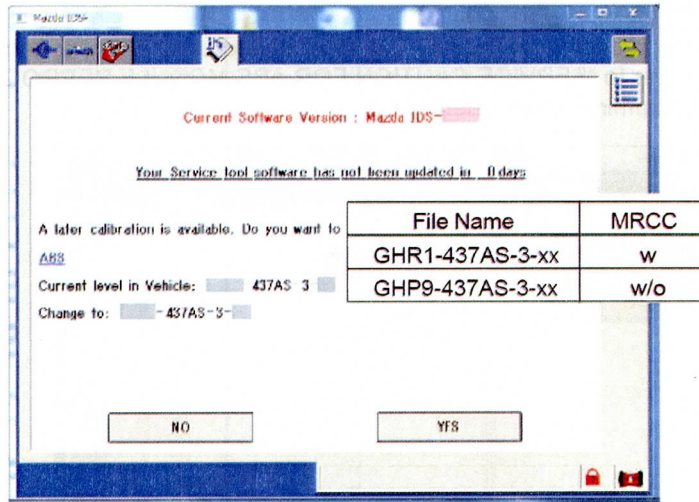
If the message "No later calibration is available on the system for this ABS" is displayed, the ABS module is already at the latest calibration. "Current level in Vehicle" will show the new file name. This service bulletin does not apply.

b. The following screen will be displayed:

Click "YES" and follow the M-MDS instructions to reprogram the ABS module.
