Program Bulletin

CUSTOMER SATISFACTION PROGRAM

SUBJECT: Material Over Sensing and Diagnostic Module Retaining Moisture

MODELS: 2007-2009 Chevrolet Silverado
2007-2009 GMC Sierra
Currently or Previously Registered in Alaska, Connecticut, Delaware, District of Columbia, Illinois, Indiana, Iowa, Maine, Maryland, Massachusetts, Michigan, Minnesota, Missouri, New Hampshire, New Jersey, New York, Ohio, Pennsylvania, Rhode Island, Vermont, West Virginia, Wisconsin

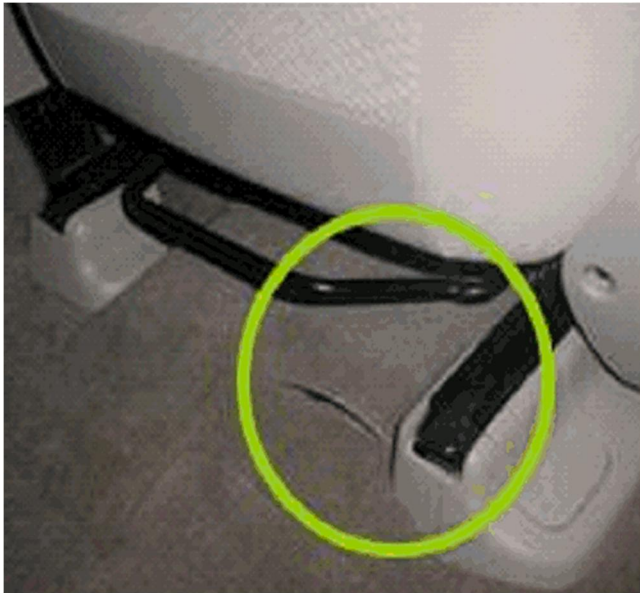
Note: Driver seat removal is NOT required for crew cab or extended cab vehicles. Certain 2009 regular cab vehicles built after approximately March 1, 2009 with carpet that has a 2-sided cutout over the SDM, however, will require driver seat removal. Refer to *Front Seat Replacement-Bucket* in SI. After the seat removal, proceed to step 4 in the bulletin. Regular cab vehicles with carpet that has a 3-sided cut over the SDM do NOT require seat removal.

3. Move the driver's seat to the full forward or rearward position.
