SERVICE CAMPAIGN BULLETIN

SUBJECT: SB-10056921-8103		No: SC-14-003REV	
i-MiEV UNDERCARRIAGE RUST –		DATE: April, 2015	
SERVICE CAMPAIGN – REVISED		MODEL: 2012 i-MiEV	
CIRCULATE TO:	<input checked="" type="checkbox"/> GENERAL MANAGER	<input checked="" type="checkbox"/> PARTS MANAGER	<input checked="" type="checkbox"/> TECHNICIAN
<input checked="" type="checkbox"/> SERVICE ADVISOR	<input checked="" type="checkbox"/> SERVICE MANAGER	<input checked="" type="checkbox"/> WARRANTY PROCESSOR	<input checked="" type="checkbox"/> SALES MANAGER

Certain 2012 MY i-MiEV Models

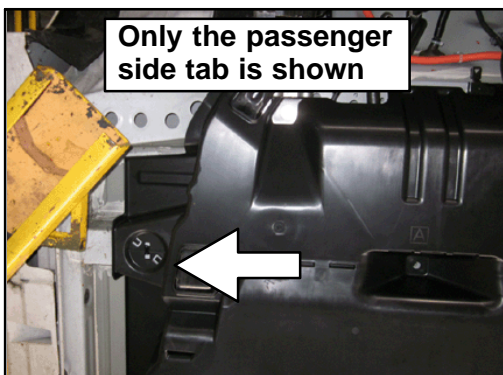
16. New under covers with ground bus bars installed.

15. Repeat Step 14 for the new front under cover, and ensure the driver side and passenger side mounting tabs are properly mounted into the frame.
