# Program Bulletin

## SB-10057679-3041

### CUSTOMER SATISFACTION PROGRAM

**SUBJECT:** Electronic Power Steering Loss of Power Assist

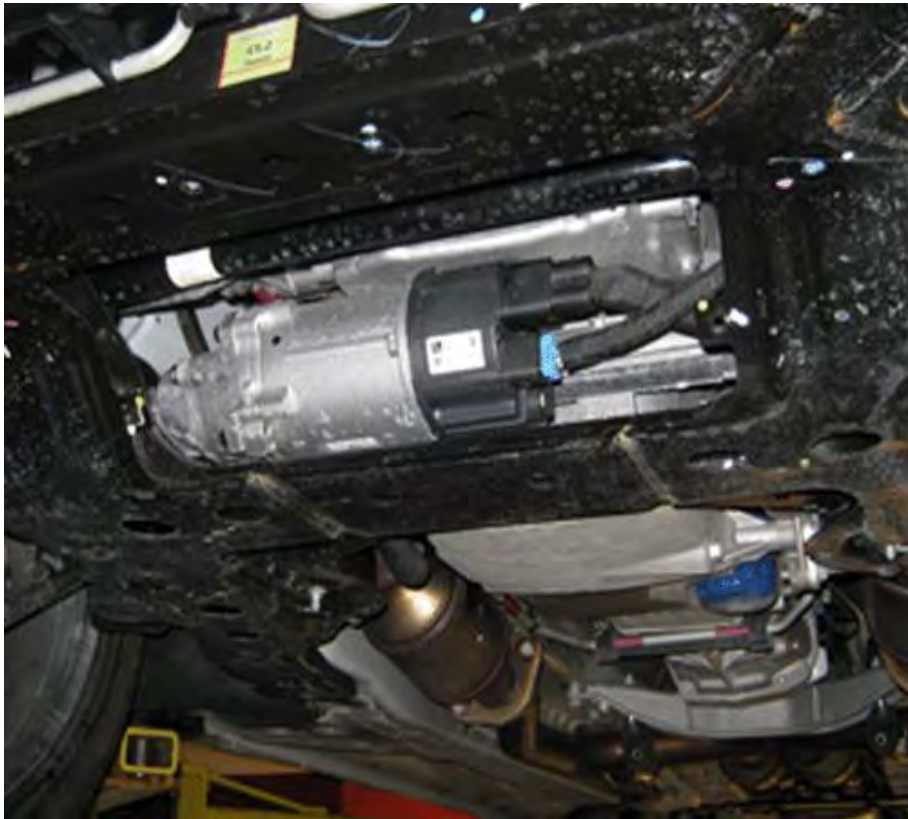
4062454

The EPS control module is now accessible.

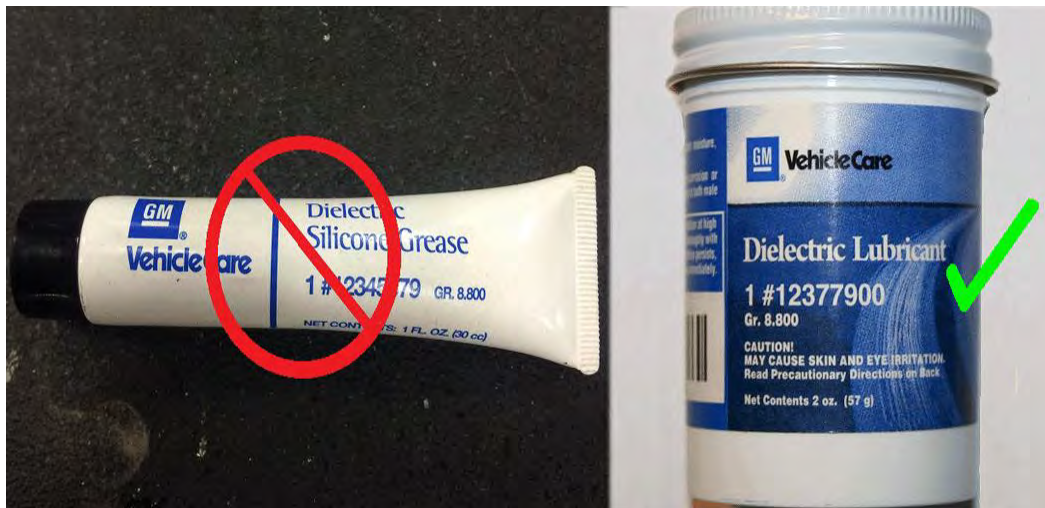
4078535

- 10. Visually inspect the connector for any signs of contamination or damage. If contamination or damage is found, this will need to be repaired as required prior to performing the next step. Refer to *Repairing Connector Terminals (Terminal Repair)* in SI.

**Note:** Only GM Dielectric Lubricant must be used for this procedure. No substitutions are allowed.
