HYUNDAI NEW THINKING. NEW POSSIBILITIES. Technical Service Bulletin	GROUP BODY ELECTRICAL	NUMBER 15-BE-002
	DATE FEBRUARY 2015	MODEL(S) 2006 - 2008 SONATA (NF)
SUBJECT:	AIRBAG MIL ON WITH DTC B1701/B1706

Description: This bulletin provides diagnostic and service procedures to repair the symptom of an airbag warning illuminated with DTC (Diagnostic Trouble Code) B1701 and/or B1706. The service procedure includes inspection of the seat belt buckle pretensioner connector and adding a cable tie to secure the connector.

SUBJECT: REPAIR PROCEDURE FOR AIRBAG MIL WITH DTC B1701/B1706

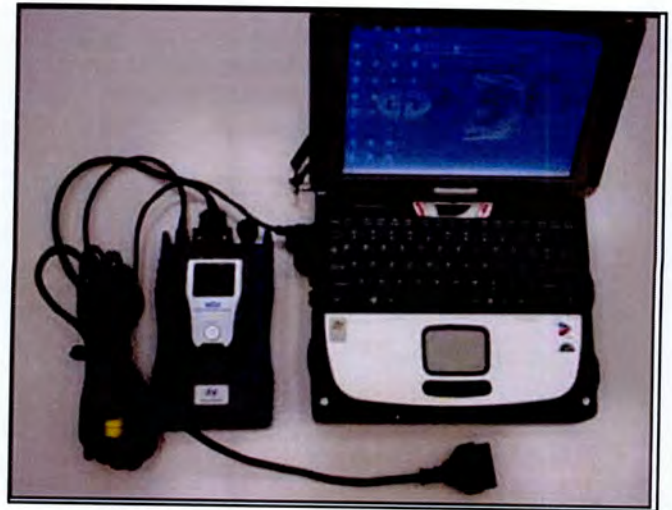
1. Turn the ignition ON and wait 10 seconds.
2. Connect the GDS scan tool to the vehicle and scan for DTCs.

If any of the following active or history codes are present, proceed to step 3 below.

- B1701
- B1706

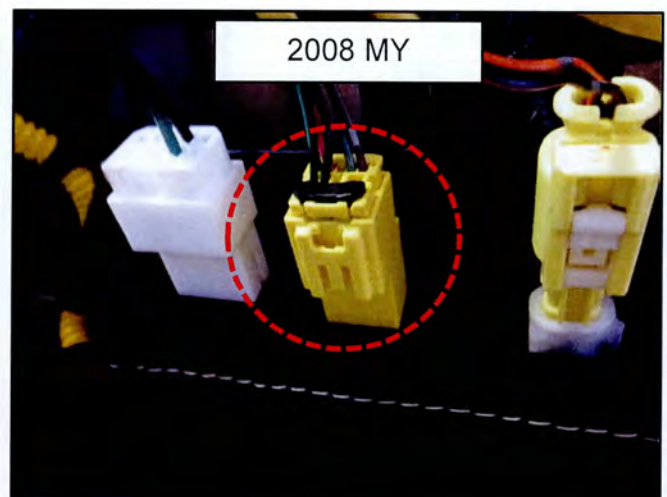
Inspect the connector pins for any abnormalities or indications of damage. Replace any damaged components.

8. Disconnect the buckle pretensioner connector.

Using compressed air, remove any debris from the connectors.

The air gun (70-130 psi) should be placed at least 1 foot away from the wire harness connector to prevent damaging the pins.
