# Service Bulletin

**SUBJECT: Special Coverage Adjustment – Transmission Clutch Wave Plate**

**MODELS:** 2007-2009 Buick Enclave  
 2008-2009 Chevrolet Equinox, Malibu  
 2009 Chevrolet Traverse  
 2007-2009 GMC Acadia  
 2007-2009 Pontiac G6  
 2008-2009 Pontiac Torrent  
 2007-2009 Saturn AURA, OUTLOOK  
 2008-2009 Saturn VUE  
 Equipped with FWD or AWD and 6-Spd Automatic Transmission  
 (RPO MH2, MH4, MH6, or MY9)

**This bulletin is being revised to add the 2008-2009 Saturn VUE, add transmission RPO codes, and update the Warranty Transaction information section. Please discontinue use, and discard all copies of Special Coverage Recall 14404.**

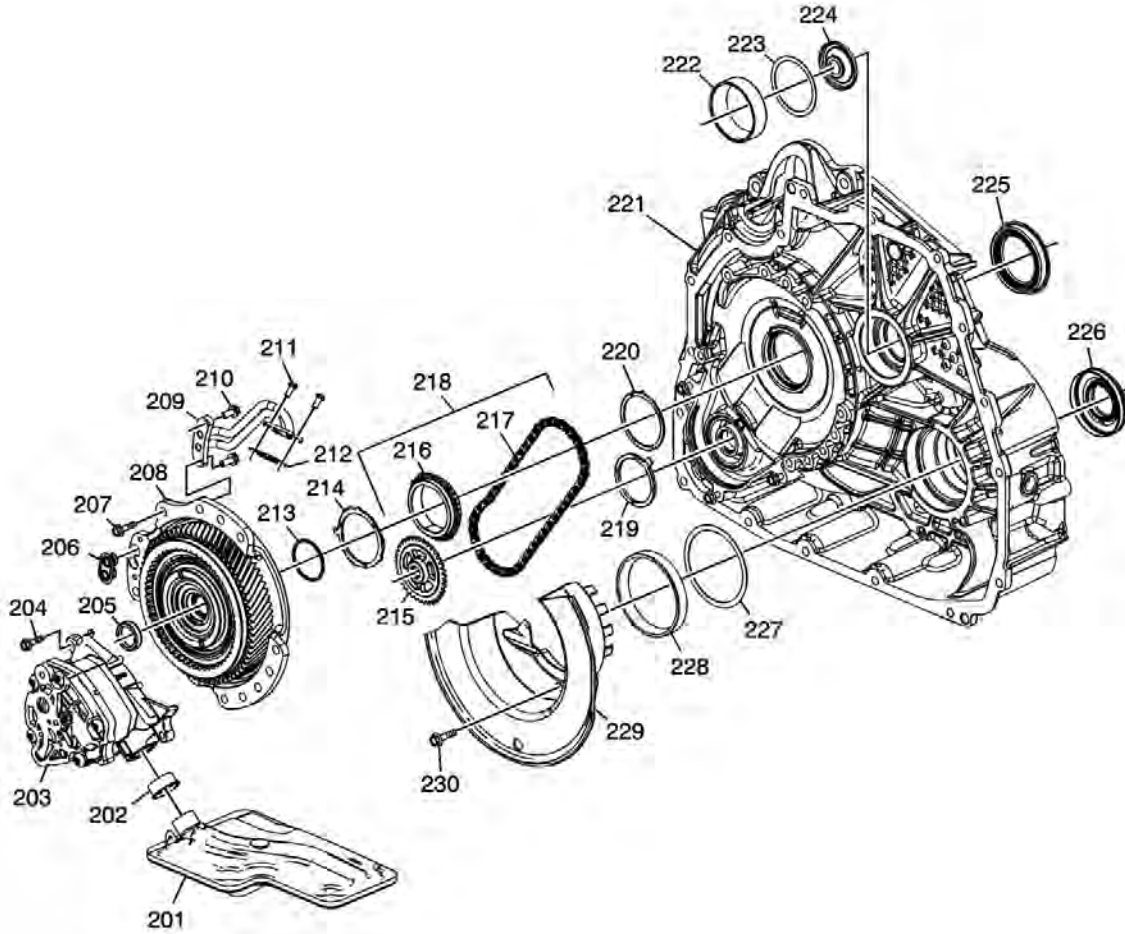
1725882

A broken 35R wave plate can generate varying amounts of debris inside the transmission. In most cases this debris has not passed through the pump fluid filter (201) potentially damaging the pump, valve bodies or torque converter. This debris can be cleaned and the transmission successfully repaired.

**Note:** Debris generated by the condition must be cleaned from the entire transmission and the pump fluid filter (201) and the control solenoid filter plate (16) must be replaced. Failure to separate the case halves, disassemble the transmission, clean the debris and replace the pump fluid filter (201) and the control solenoid filter plate (16) could lead to repeat transmission damage and repairs.
