SERVICE BULLETIN

Classification:	Reference:	Date:
EC14-002c	NTB14-009c	June 17, 2015

2014 VERSA NOTE; MIL ON WITH DTC P059F STORED

APPLIED VEHICLE: 2014 Versa NOTE (E12)

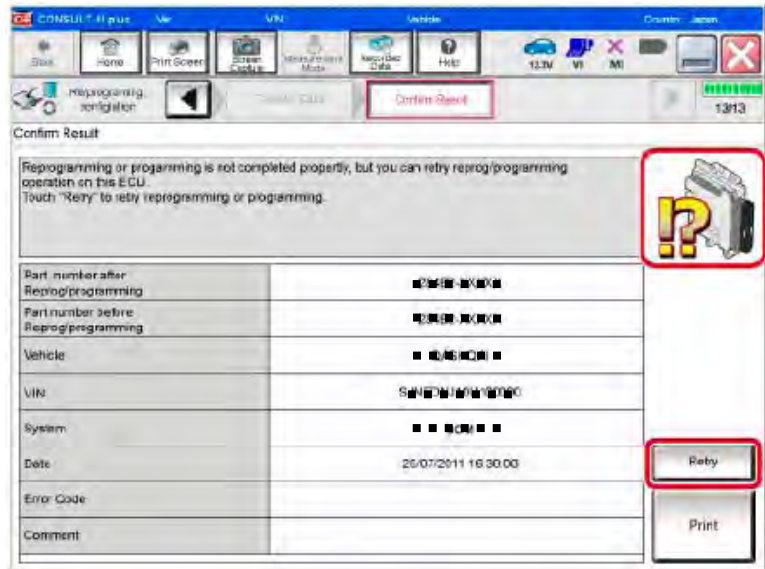
Figure 5

If reprogramming does not complete and the “!?” icon displays as shown in Figure 5:

- Check battery voltage (12.0–15.5 V).
- Ignition is ON, engine OFF.
- External Bluetooth® devices are OFF.
- All electrical loads are OFF.
- **Select retry and follow the on screen instructions.**
- “Retry” may not go through on first attempt and can be selected more than once.

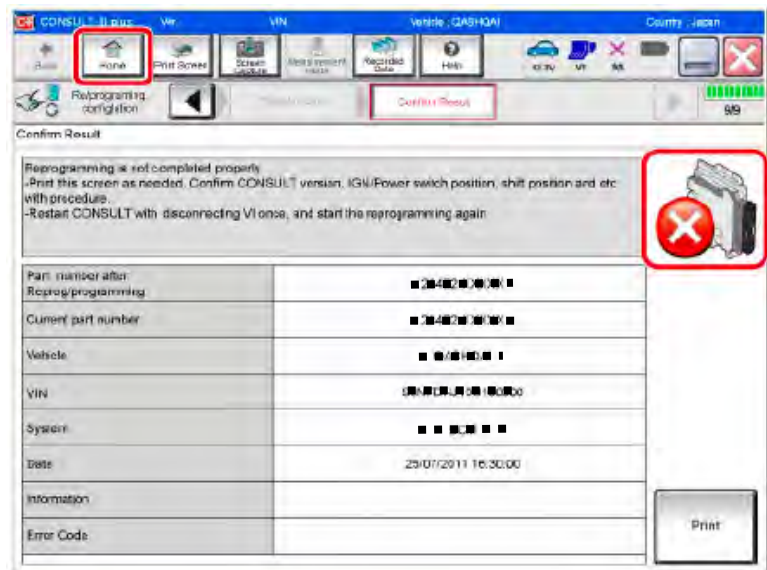
Figure 6

If reprogramming does not complete and the “X” icon displays as shown in Figure 6:

- Check battery voltage (12.0–15.5 V).
- CONSULT A/C adapter is plugged in.
- Ignition is ON, engine OFF.
- Transmission is in Park.
- All C-III plus / VI cables are securely connected.
- All C-III plus updates are installed.
- **Select Home, and restart the reprogram procedure from the beginning.**
