August 20, 2015

SUBJECT: **DELIVERY HOLD - Customer Satisfaction Program 15B21 – Supplement #2**
 Certain 2015 Model Year Edge Vehicles
 A-Pillar Water Leak Inspection and Repair

CERTAIN 2015 MODEL YEAR EDGE VEHICLES — A-PILLAR WATER LEAK INSPECTION AND REPAIR PROCEDURE

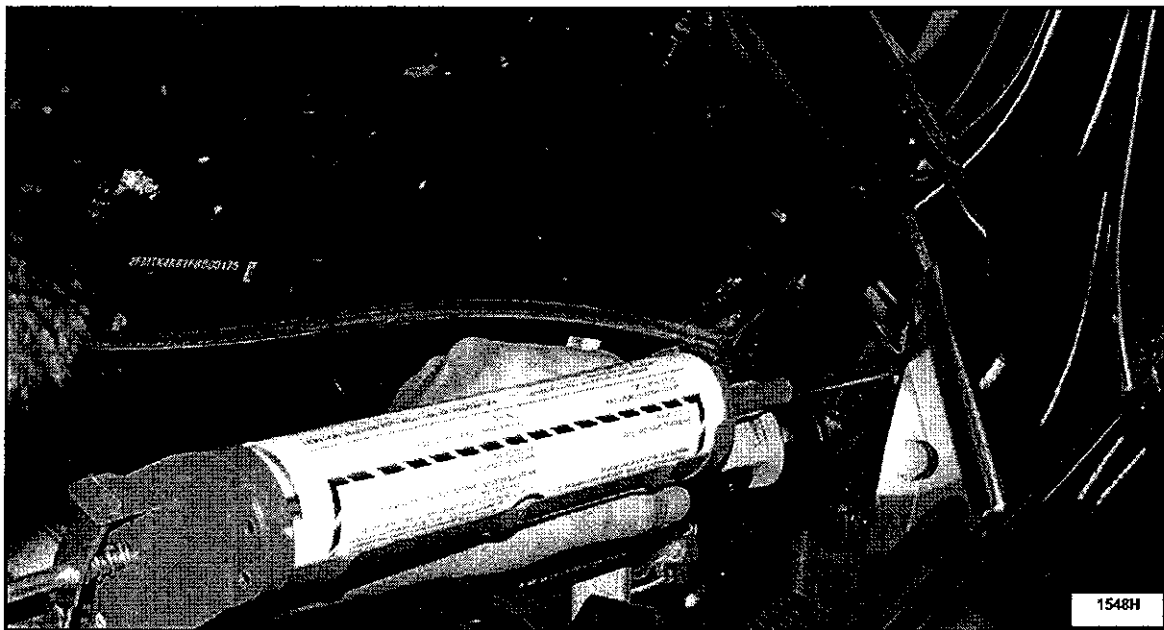
FIGURE 11

In some of the affected vehicles, water may leak into the cabin through the sheet metal joint in the A-pillar area directly behind the hood hinge on both sides of the vehicle. The water enters the cabin at the lower A-pillar areas behind the lower dash panel trim panels.

4. Use a flashlight to locate the body seam that runs behind and along the side of the LH and RH hood hinges. Apply a bead of sealer to the body seam. See Figures 9, 10 and 11.
