SB-10058251-1199

SUBJECT: **Regional Program 15R01 – Supplement #1**
Certain 2013-2015 Model Year Fusion and MKZ and 2015 Model Year Edge Vehicles
Not Covered Under Safety Recall 15S14
Steering Gear Motor Bolt Corrosion

REF: **Safety Recall 15S14 – Supplement #3**
Dated July 10, 2015

**CERTAIN 2013 THROUGH 2015 MODEL YEAR FUSION AND MKZ AND 2015
MODEL YEAR EDGE VEHICLES NOT COVERED UNDER SAFETY RECALL 15S14
— STEERING GEAR MOTOR BOLT CORROSION**

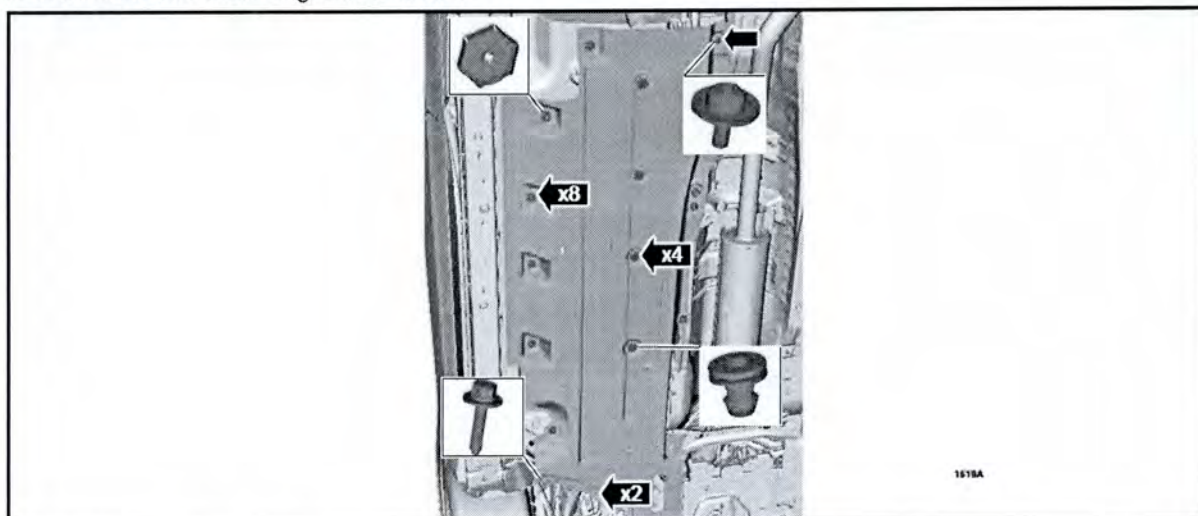
FIGURE 1

NOTE: Left side shown right side similar.

1. Remove the engine front undershield and the engine undershield. Please follow the Workshop Manual (WSM) procedures in Section 501-02.
2. Remove both underbody side shields. See Figure 1.

1. *Install the underbody crossbrace and the six nuts. See Figure 2.*
 - *Tighten to 45 Nm (33 lb-ft).*
2. *Install both underbody shields. See Figure 1.*
 - *Tighten to 9 Nm (80 lb-in).*
3. *Install the engine front undershield and the engine undershield. Please follow the WSM procedures in Section 501-02.*

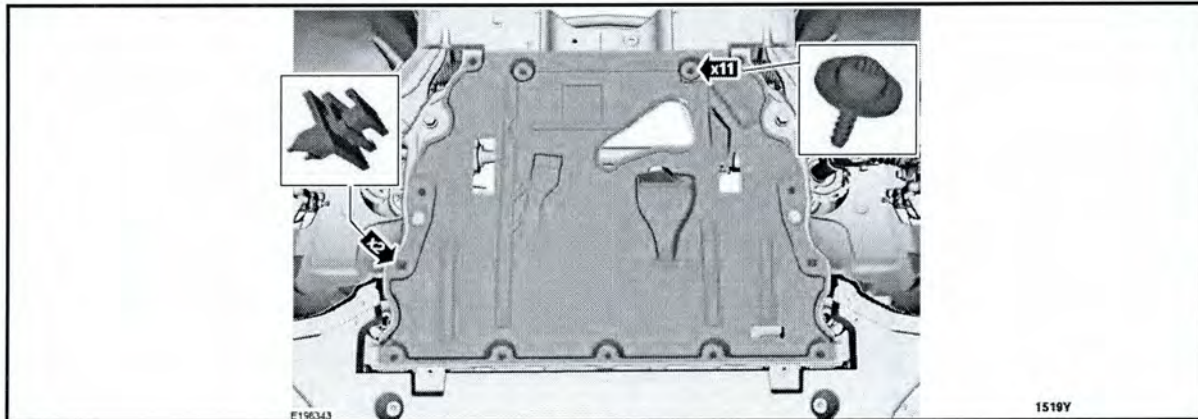
FIGURE 3

NOTE: One piece underbody shield shown two piece underbody shield similar.

1. Remove the underbody shield. See Figure 3.

1. *If equipped, install the steering gear motor heat shield. See Figure 5.*
 - *Tighten to 8 Nm (71 lb-in).*
2. *If equipped, install the center underbody shield. See Figure 4.*
3. *Install the underbody shield. See Figure 3.*

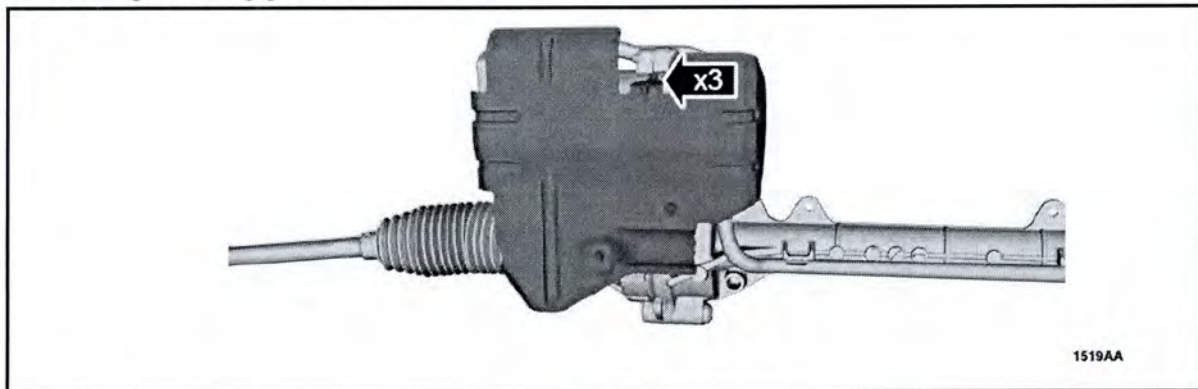
FIGURE 7

NOTE: Edge steering gear motor heat shield shown MKZ similar.

3. With the help of an assistant using a pry bar between the subframe and roll restrictor bracket, position the engine forward to provide clearance. Remove the steering gear motor heat shield. See Figure 7.

1. *With the help of an assistant using a pry bar between the subframe and roll restrictor bracket, position the engine forward to provide clearance. Install the steering gear motor heat shield. See Figure 7.*
 - *Tighten to 8 Nm (71 lb-in).*
2. *Install the RH roll restrictor bolt. See Figure 6.*
 - a. *Clean the bolt threads using a suitable wire brush.*
 - b. *Apply Motorcraft Threadlock 262/TA-26 to restrictor bolt.*
 - *Tighten to 115 Nm (85 Lb-ft).*
3. *Install the exhaust y-pipe. Please follow the WSM procedures in Section 309-00B.*
