Technical Service Bulletin

94 Daytime running light (DRL) inoperative (DTC 02895 or 02897)

94 15 68 2032184/5 June 29, 2015. Supersedes Technical Service Bulletin Group 94 number 14-43 dated June 9, 2014 for reasons listed below.

Model(s)	Year	VIN Range	Vehicle-Specific Equipment
Q5	2013 - 2015	All	Not applicable

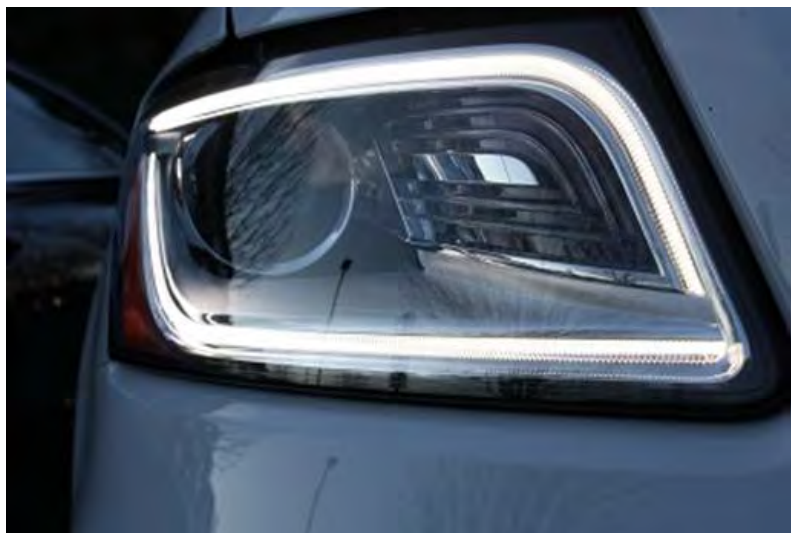
The MY2013+ Audi Q5 LED DRLs use light-emitting “pipes” or “guides” instead of multiple, individual LEDs. There are two light pipes per headlight. Each light pipe uses a single LED for illumination (Figure 1).

Figure 1. Upper and Lower light pipes illuminated.

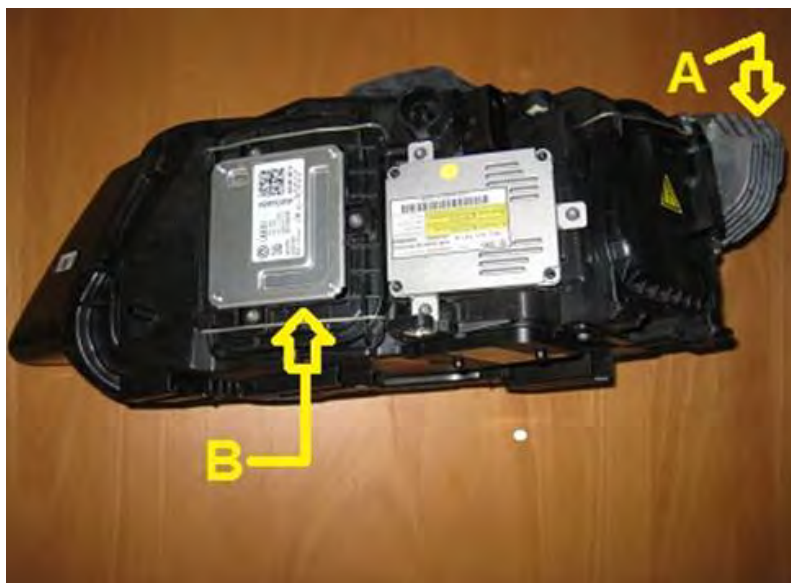
The LEDs with heatsinks are contained in a single module (Figure 2, A) mounted to the outer backside of each headlight.

Figure 2. Backside of headlight with LED heat sink (A) and LED control module (B).

The LED unit with heat sink utilizes a gasket and is keyed into the headlight housing to maintain proper alignment of each LED and light pipe. The LED units (L176 and L177, left and right, respectively) are controlled via a control module (J860 and J861, left and
