SB-10058671-7184

January 2015

Emissions Recall P35 Diesel Particulate Filter Wiring

- 2013 (DJ) RAM Pick Up Truck (2500 series)
(D2) RAM Pick Up Truck (3500 series)

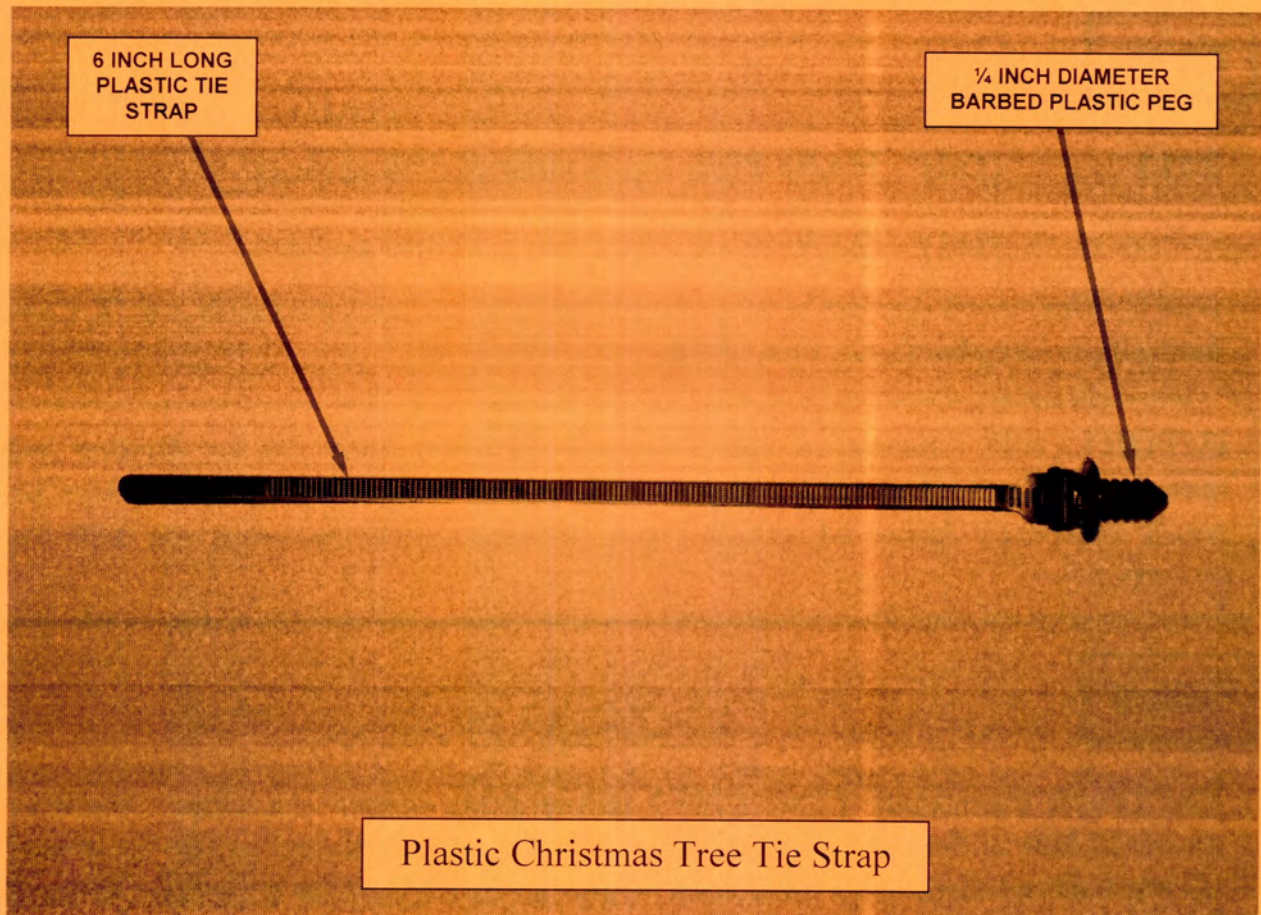
The Diesel Particulate Filter (DPF) temperature sensor electrical connectors on about 28,000 of the above vehicles may have been connected to the incorrect body wiring harness electrical connectors. This can cause tailpipe emissions of oxides of nitrogen (NOx) to exceed the Federal and California emissions standard.

The DPF temperature sensor electrical connectors must be connected to the correct body wire harness connectors.

NOTE: Two plastic Christmas tree tie straps are required to repair one vehicle.
