NUMBER: 23-029-15

Water In Right Front Floor Footwell

This bulletin involves correcting a sealant void between the cowl plenum lower panel and dash crossmember.

2015 (KL) Jeep Cherokee

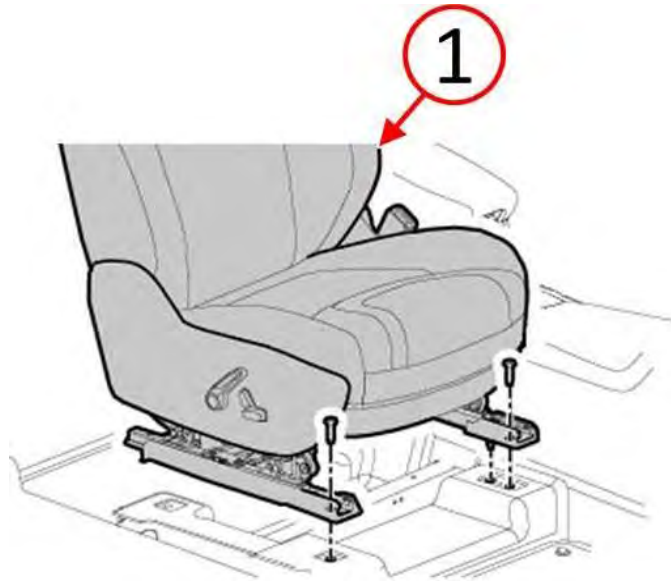
Fig. 2 Remove Right Side Front Seat

1 - Right Front Seat

1. Remove the right side front seat (1) in order to remove the carpet (Fig. 2). Refer to the detailed service procedures available in DealerCONNECT> TechCONNECT under: Service Info> 23 - Body> Seats, Front> SEAT> Removal.

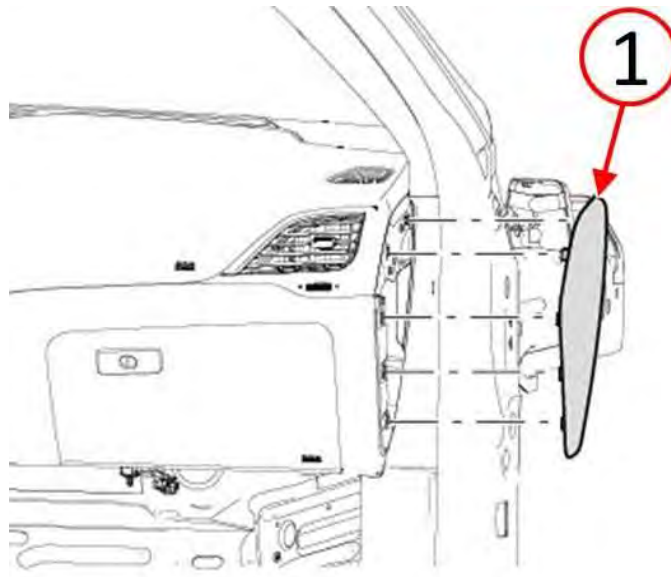
Fig. 3 Remove Right Side Instrument Panel End Cap

1 - Instrument Panel End Cap

-
2. Using a trim stick or equivalent, release the clips and remove the right side end cap (1) from the instrument panel (Fig. 3).

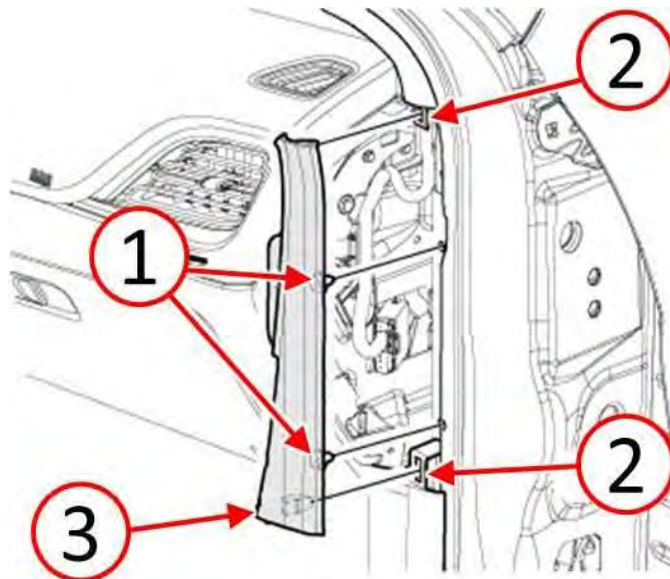
Fig. 4 Remove Right Side A-Pillar Extension Trim

1 - A-Pillar Extension Trim
2 - Retaining Tabs
3 - Push Pin Fasteners

3. Using a trim stick or equivalent, release the push pin fasteners (1) and the retaining tabs (2) then remove the right side A-pillar extension trim (3) from the door sill scuff plate (Fig. 4).

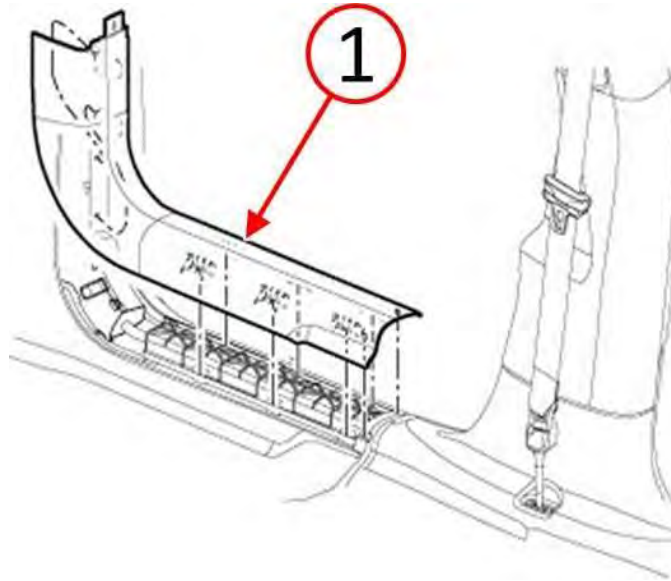
Fig. 5 Remove Right Front Door Sill Scuff Plate

1 - Door Sill Scuff Plate

- Using a trim stick or equivalent, disengage the retaining clips and remove the front door sill scuff plate (1) from the door sill and lower B-pillar trim (Fig. 5).

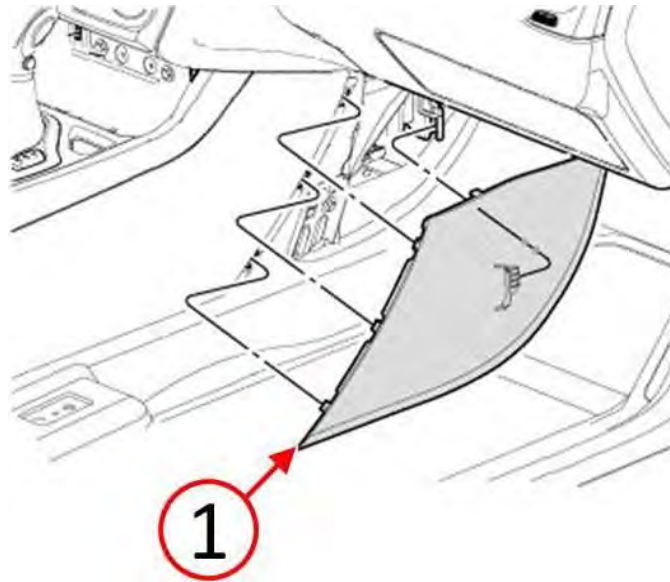
Fig. 6 Remove Right Side Floor Console Panel

1 - Floor Console Panel

- Using a trim stick or equivalent, disengage the retaining tabs then remove the right side floor console panel (1) (Fig. 6).

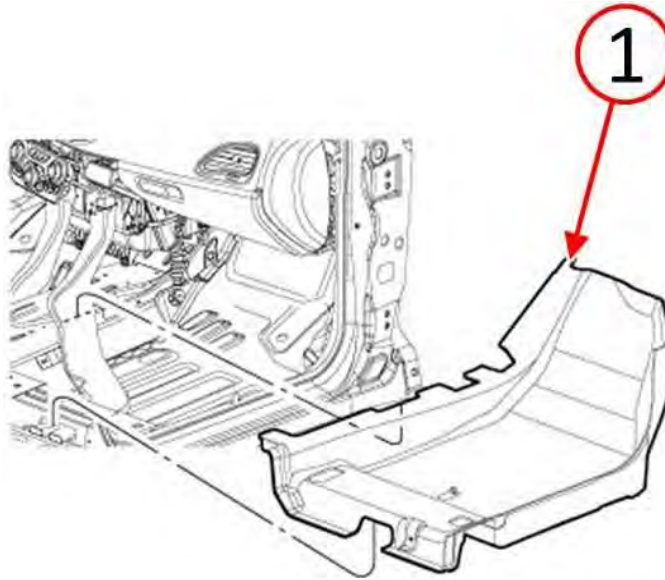
Fig. 7 Remove Right Side Front Footwell Carpet

1 - Carpet

6. Remove the carpet (1) from the vehicle through the passenger door opening (Fig. 7).

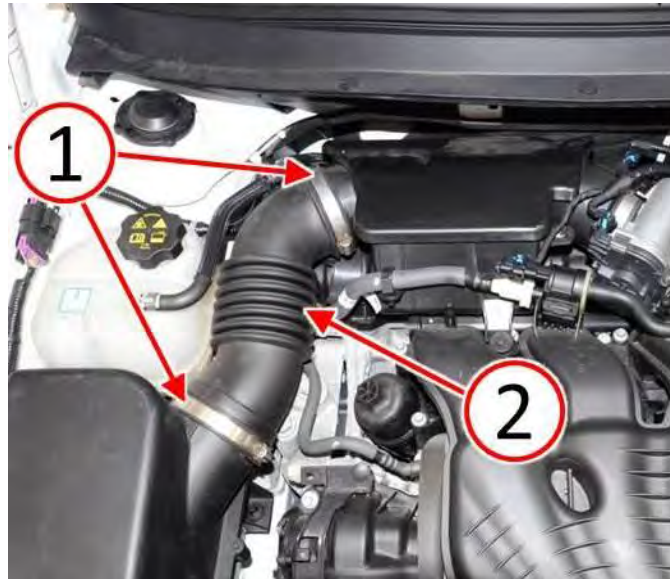
Fig. 8 Remove Engine Air Inlet Duct

1 - Clamps

2 - Air Inlet Duct

8. Remove the engine cover for access to the air inlet duct.
9. Loosen the air inlet duct clamps (1) and remove the air inlet duct (2) to provide sealant spray can access clearance ([Fig. 8](#)).

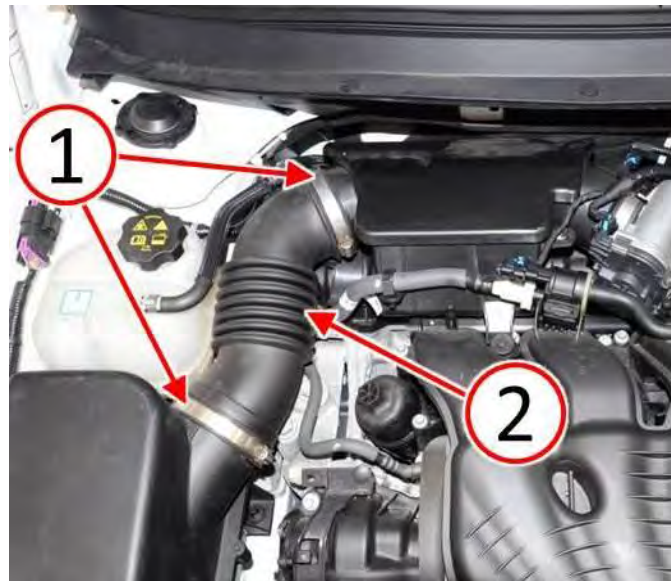
Fig. 13 Install Engine Air Inlet Duct

- 1 - Clamps
- 2 - Air Inlet Duct

15. Install the air inlet duct (2) and tighten the air inlet duct clamps (1) to 4 Nm (35 in. lbs.) (Fig. 13).

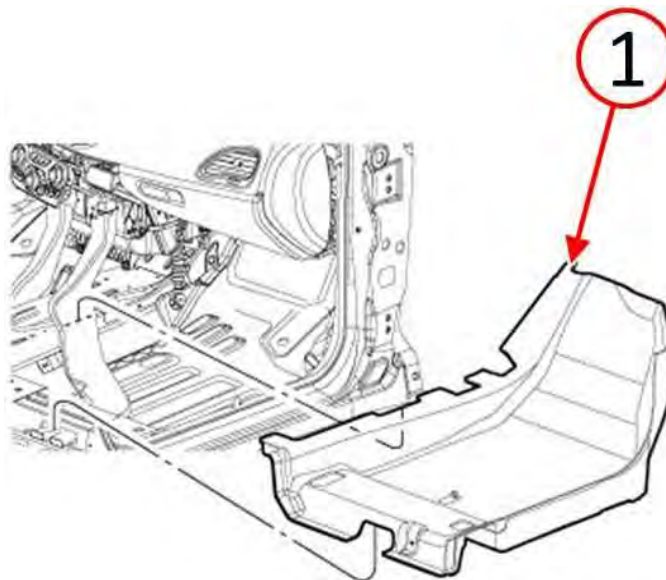
Fig. 14 Install Right Side Front Footwell Carpet

- 1 - Carpet
-

-
16. Install the engine cover.
17. Install the carpet (1) to the right front footwell (Fig. 14).

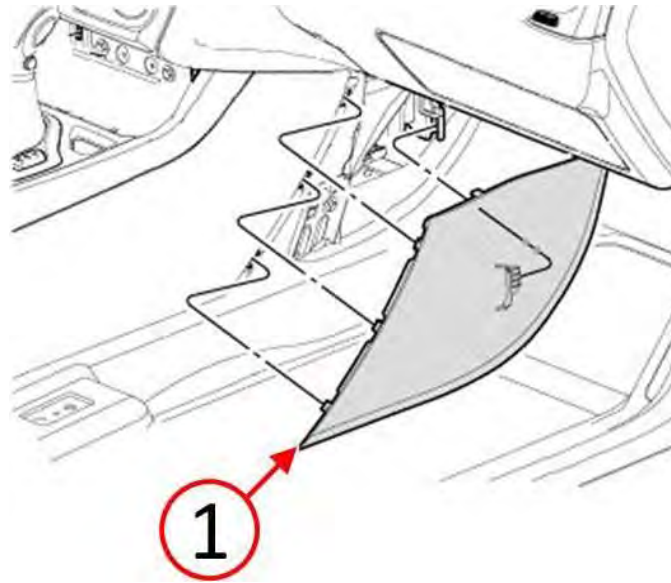
Fig. 15 Install Right Side Floor Console Panel

1 - Floor Console Panel

18. Align and position the right side floor console panel (1) then hand tap to engage the retaining tabs securing the panel to the console (Fig. 15).

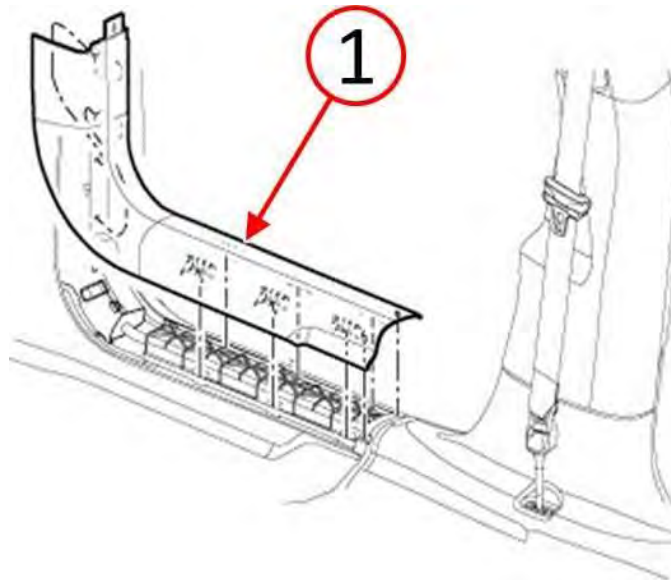
Fig. 16 Install Right Front Door Sill Scuff Plate

1 - Door Sill Scuff Plate

19. Position the front door sill scuff plate (1) then hand tap to engage the retaining clips securing it to the door sill and lower B-pillar trim (Fig. 16).

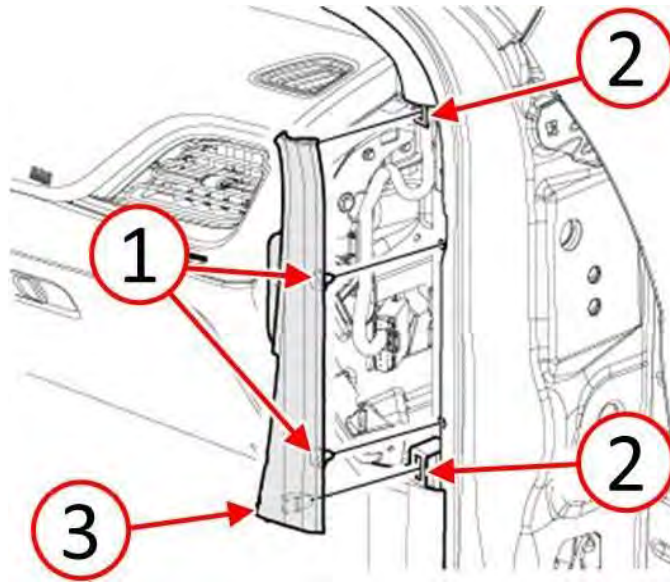
Fig. 17 Install Right Side A-Pillar Extension Trim

- 1 - A-Pillar Extension Trim
 - 2 - Retaining Tabs
 - 3 - Push Pin Fasteners
-

20. Position the closeout trim panel (3) located between the A-pillar trim and the front scuff plate then seat the retaining clips (1 and 2) fully (Fig. 17).

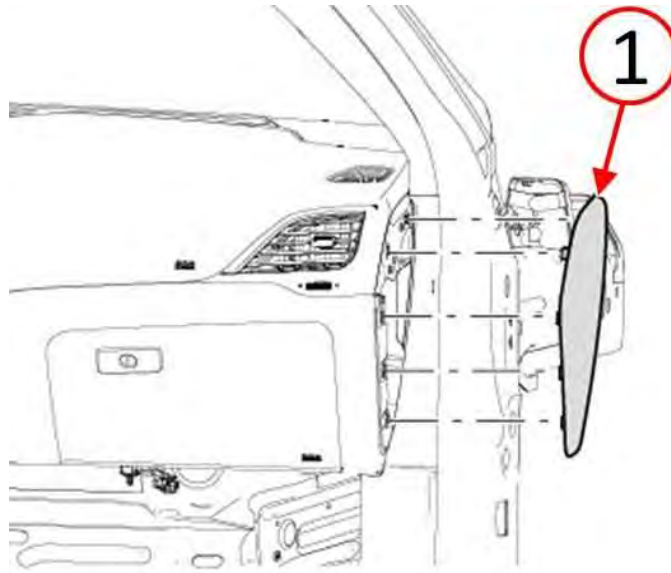
Fig. 18 Install Right Side Instrument Panel End Cap

1 - Instrument Panel End Cap

21. Position the instrument panel end cap (1) over retaining slots and firmly snap into place (Fig. 18).

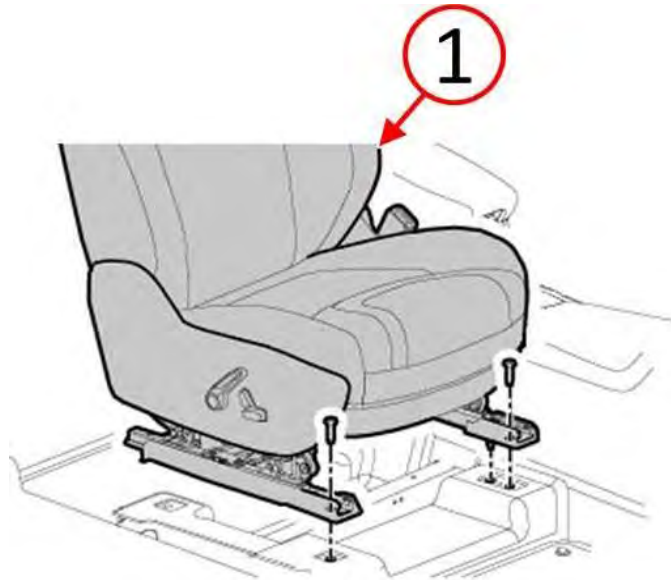
Fig. 19 Install Right Side Front Seat

1 - Right Front Seat

22. Install the right side front seat (1) (Fig. 19). Refer to the detailed service procedures available in DealerCONNECT> TechCONNECT under: Service Info> 23 - Body> Seats, Front> SEAT> Installation.
