**Subject: 49 CFR Part 579.5 Monthly Communications – November 2015**

**INDEX OF SERVICE BULLETINS,  
NOTICES, AND COMMUNICATIONS TO DEALERS**

**HEADLAMP BULB FLICKERING OR IS INOPERATIVE - BUILT ON OR BEFORE 1/11/2015****TSB 15-0168****LINCOLN:**

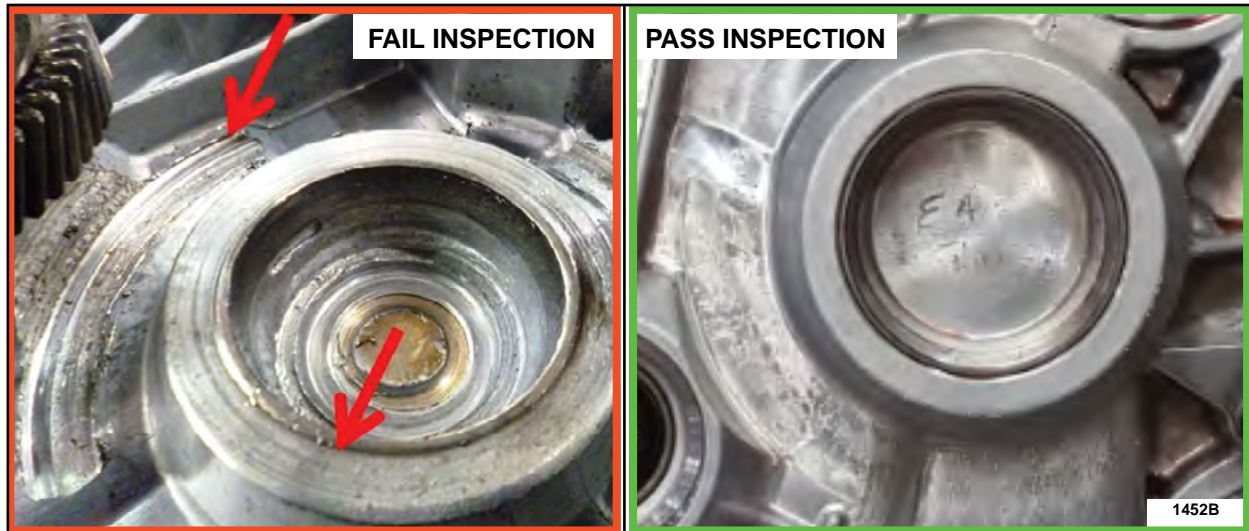
FIGURE 3

3. Inspect the damper housing for contact or wear from the transfer shaft gear assembly. See Figure 3. Also inspect all gears and bearings (removed in Step 2) for damage or excessive wear. Are any concerns present?

- No - Proceed to Transmission - Repair and Assembly Procedure starting on Page 4.
- Yes - Install a *new* transmission assembly. Please follow the WSM procedures in Section 307-01.

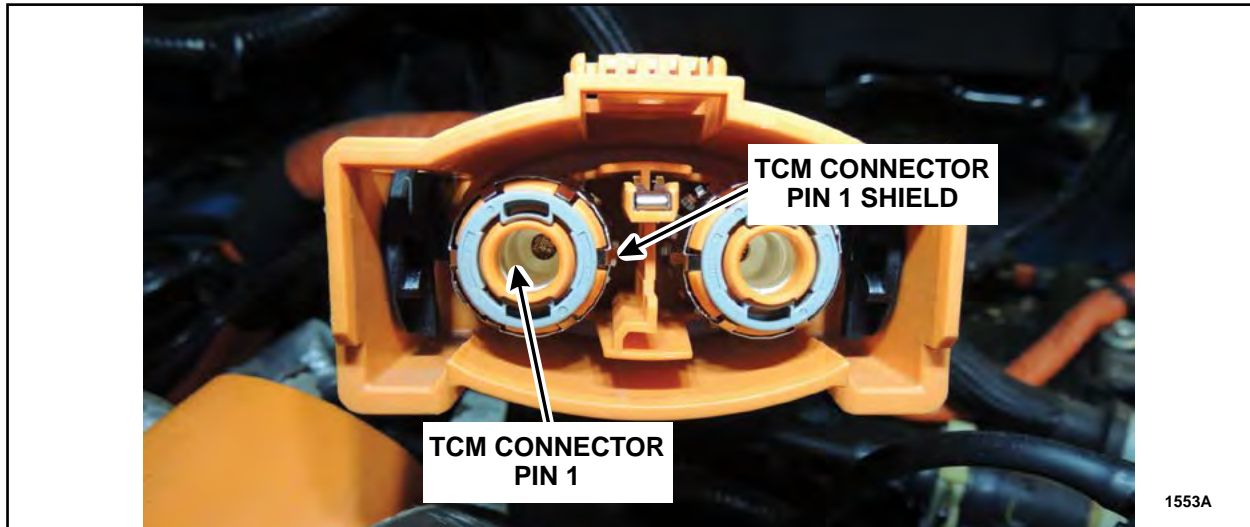
**FIGURE 11**

13. Measure electrical resistance (ohms) at the following TCM connector locations while wiggle testing the high voltage wire harness at each connector that was previously disconnected in this procedure.
- a. TCM C1822B Pin 1 to C1822 Pin 1 shield. See Figure 11.
  - b. TCM C1822B Pin 2 to C1822 Pin 2 shield. See Figure 12.

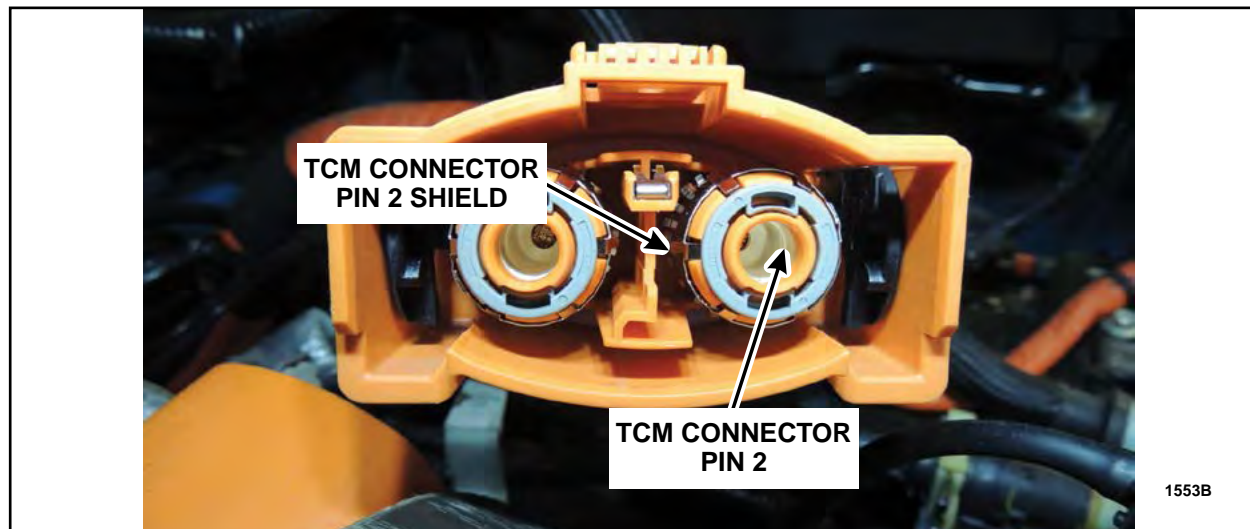
**FIGURE 12**

14. Are the measured resistances greater than 173,000 ohms?
