# Service Bulletin

Bulletin No.: PIP5296B

**Subject:** Growl Or Grind Noise - Front Differential Drive Pinion Gear - Or Differential Carrier Bearing

**Models:** 2015 Buick Enclave, LaCrosse, Regal  
2015 Cadillac SRX, XTS  
2015 Chevrolet Equinox, Impala, Malibu, Traverse  
2015 GMC Acadia, Terrain  
Equipped with 6T70 or 6T75 Automatic Transmission (RPOs M7U, M7V, M7W, M7X, MH2)

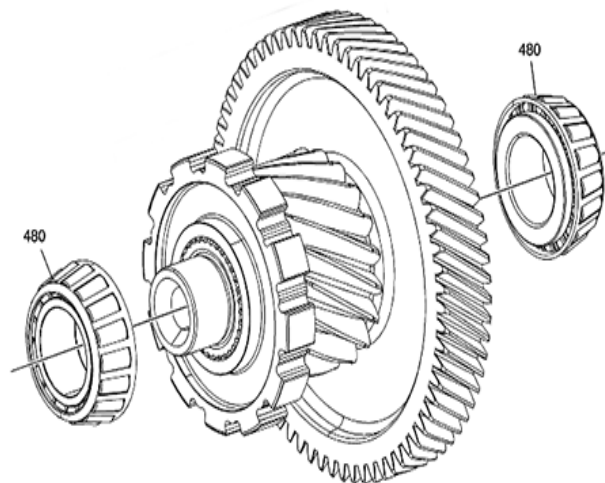
If a pitted or spalled Front Differential Drive Pinion Gear bearing(s) (480), SI# 1726803, and/or Differential Carrier bearing(s) (485, 487), SI# 1726804, are found please contact TAC prior to attempting to remove the distressed bearing(s) from

Front Differential Drive Pinion (w/Transfer Gear) Gear Assembly, and/or the Front Differential Carrier Assembly.

Do not proceed with any further repairs.
